Bulletin No.: PIT5998

PIT5998 Diagnostic Tip- Steering Wheel Shake After Hitting Bump(s)

Brand:	Model:	Model Years:	VIN:		Engine:	Transmissions:
			from	to		
Buick	Envision	2019 - 2020	All	All	All	All

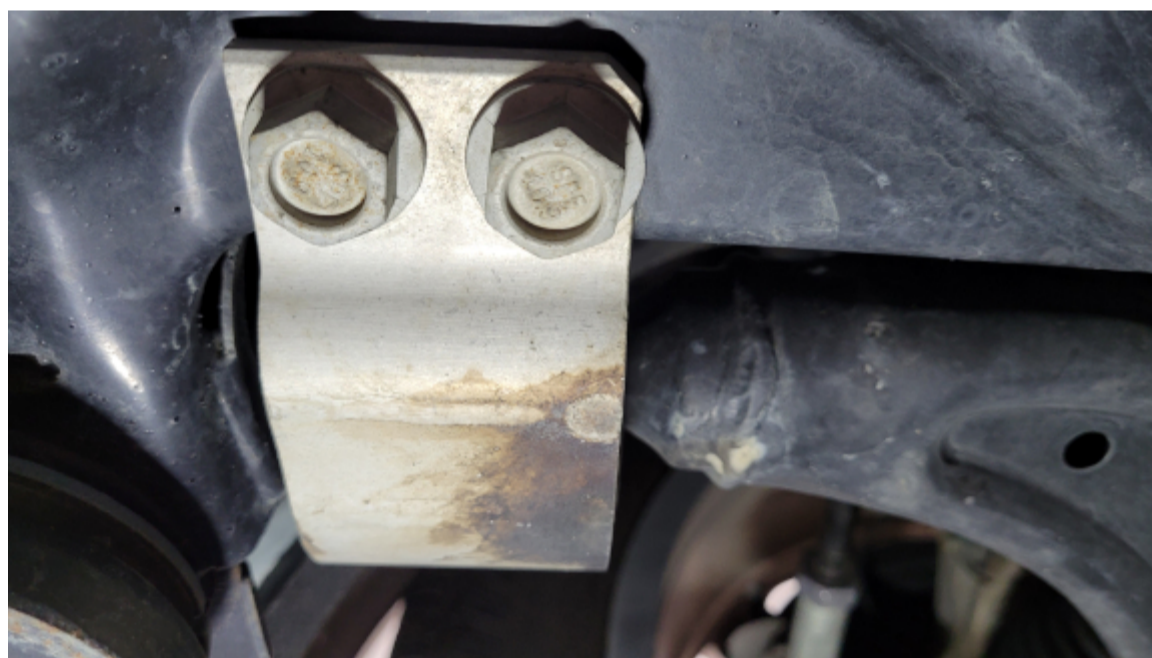
Involved Region or Country	North America
Condition	Some customers may comment on a continued shaking from the steering after hitting a bump or series of bumps.
Cause	Front control arm rear hydraulic bushings leaking oil.

Correction: Inspect the front control arm rear bushings for evidence of oil leaking. If evidence of a leak is found replace the affected control arm.
