Preliminary Information

PIP5853C TCCM Drivability DTCs and Possible Low Battery Charge Models

Brand:	Model:	Model Years:	VIN:		Engine:	Transmissions:
			from	to		
Chevrolet	Silverado 4500HD, 5500HD, 6500HD	2019 - 2023	All	All	All	All

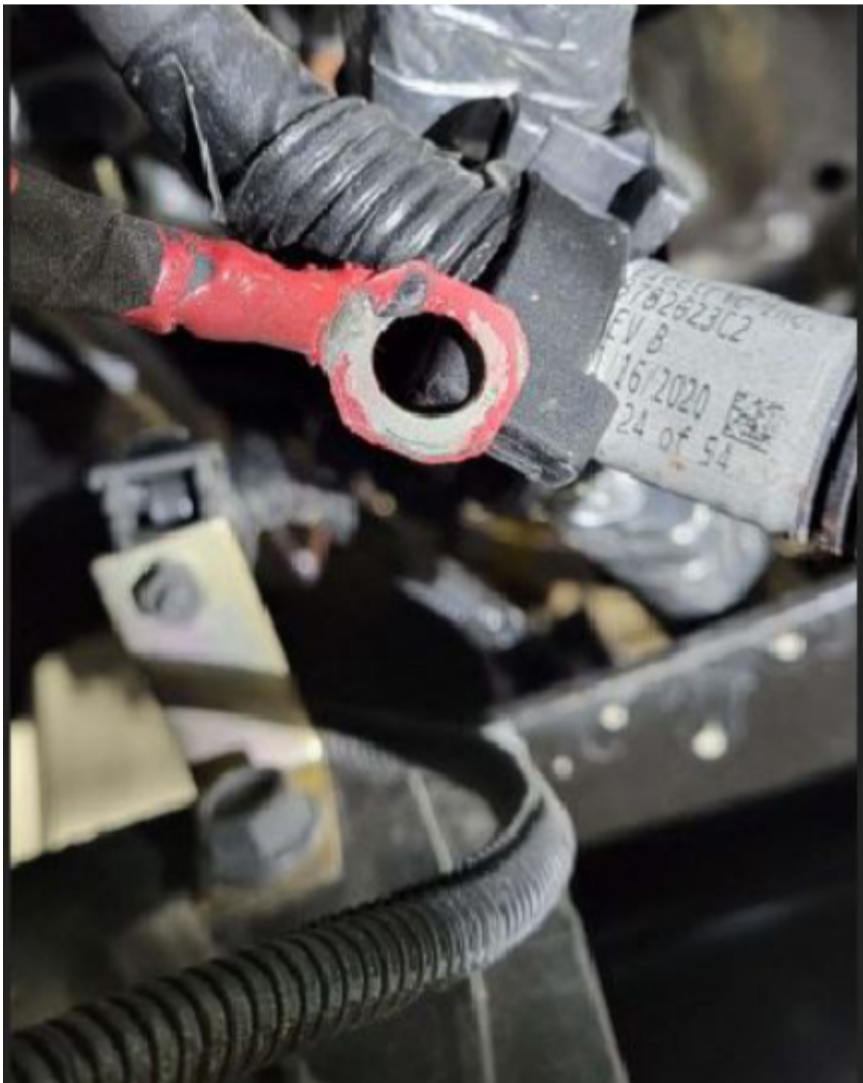
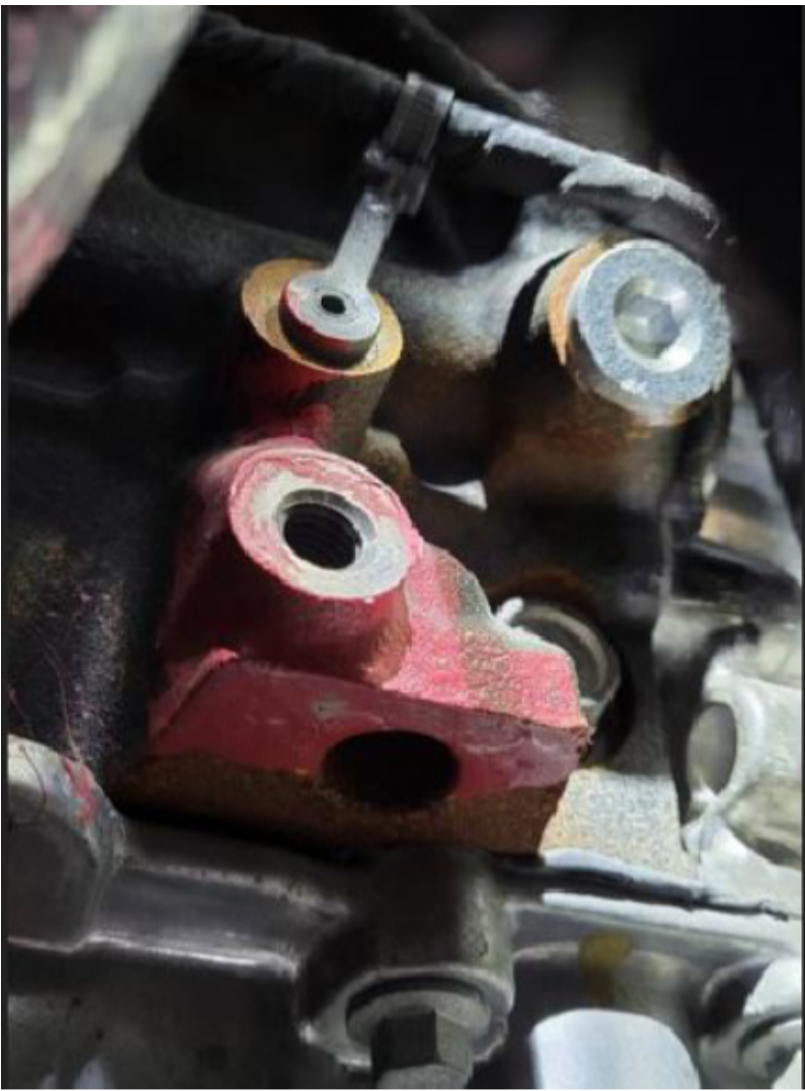
Also, there may be an issue at G110

This ground may be loose; however, it will feel tight due to the anti-corrosion paint that has been applied. This paint will not only make the ground feel tight but will also seep behind the ground and cause a poor connection

See the pictures below

If no concern is seen with the ignition 1 voltage G110 should be removed and inspected for a poor connection, for the presence of anti-corrosion paint behind the eyelet, or for a too long bolt installed.
