# Water Entry From One or More Roof Rail Garnish Clips

YEAR(S)	MODEL(S)	ADDITIONAL INFORMATION
2021	RAV4 Prime	
2019 - 2021	RAV4, RAV4 HV

Some 2019 – 2021 model year RAV4 and RAV4 Hybrid and 2021 model year RAV4 Prime vehicles may exhibit water entry from one or more roof rail garnish clips. Follow the procedures in this bulletin to address this condition.

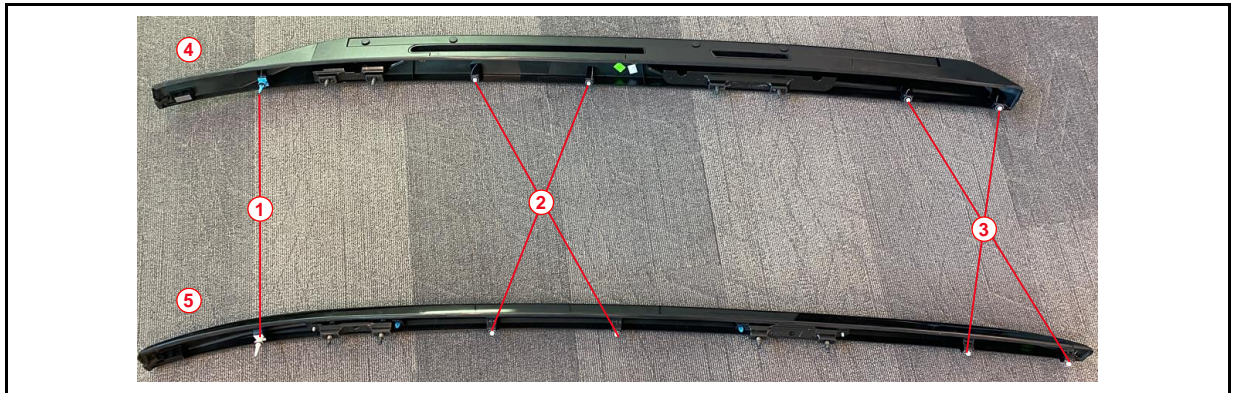
**Figure 1. Clip Position Reference**

<b>1</b>	Front Clip
<b>2</b>	Middle Clip
<b>3</b>	Rear Clip
<b>4</b>	Off-road Roof Rail
<b>5</b>	Normal/Panoramic Roof Rail

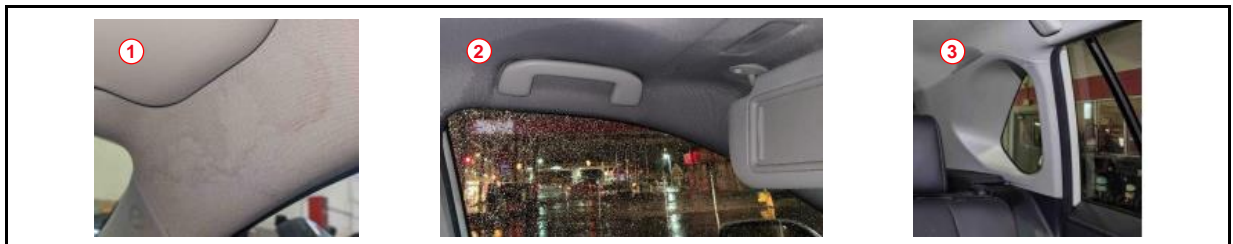
**Figure 2.**

1. Check the A, B, and C pillar areas to confirm there are indications of water entry present on the headlining assembly by checking for water and/or water stains.

<b>1</b>	Water Stain at A Pillar
<b>2</b>	Water at B Pillar
<b>3</b>	Water at C Pillar

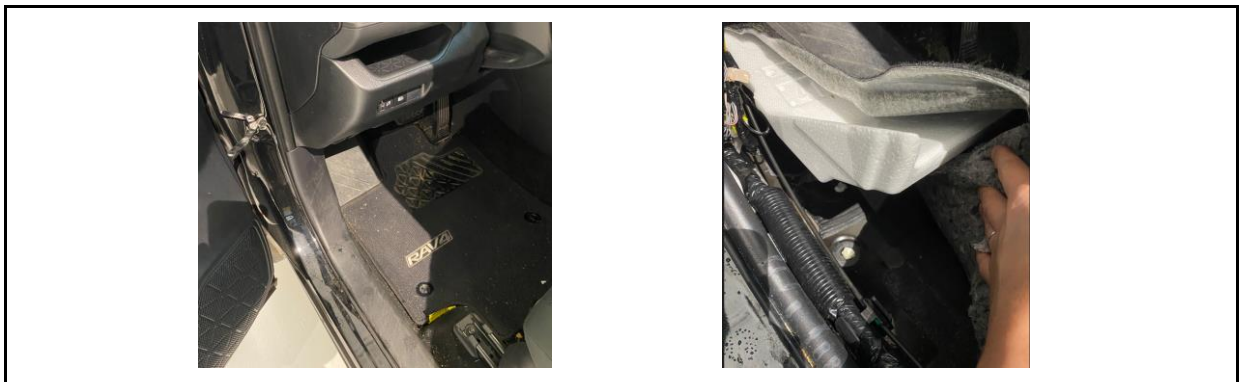
**Figure 3. Front Floor Under A Pillar**

- If signs of water leak are NOT shown on the headliner, but the customer is stating concerns of a roof rail water leak, check the customer complaint areas as instructed below.

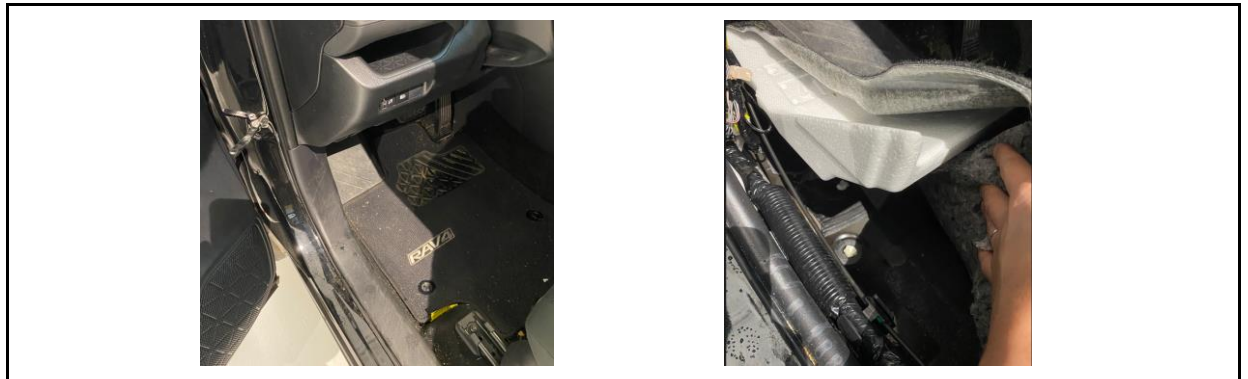
**Figure 12. Front Floor Under A Pillar**

1. Lift the necessary trim and carpet pieces to inspect for organic growth based on the location water entry was identified.
  - If there is water entry present at pillar A, check for organic growth on the front floor under A pillar.

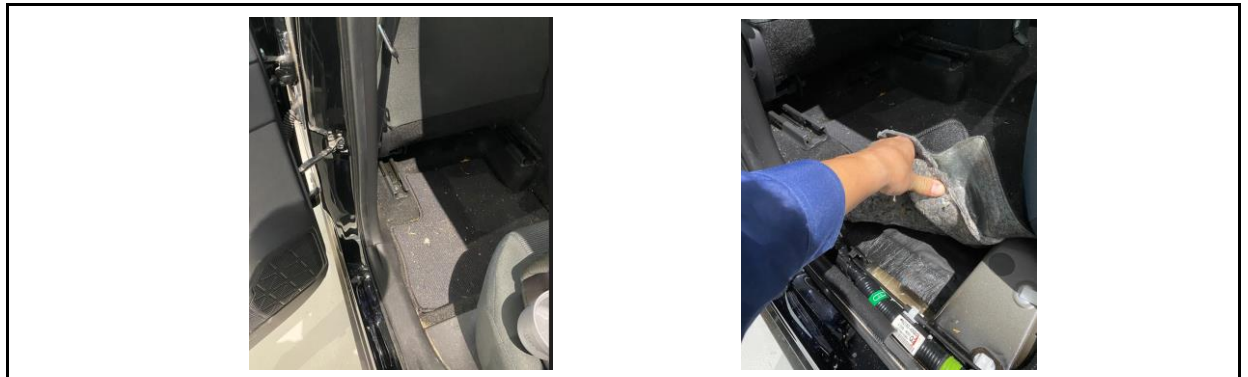
**Figure 13. Floor Under B Pillar**

- If there is water entry present at pillar B, check for organic growth on floor under B pillar.

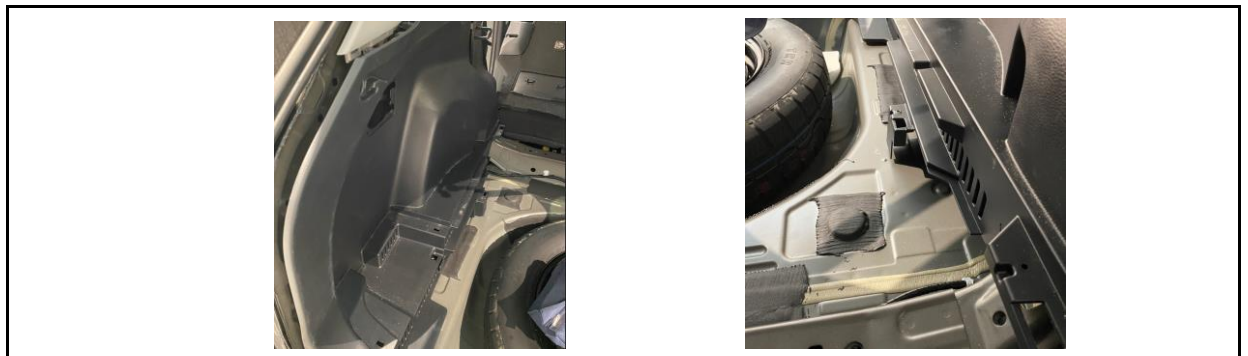
**Figure 14. Rear Floor Under C Pillar**

- If there is water entry present at pillar C, check for organic growth on the rear floor under C pillar.

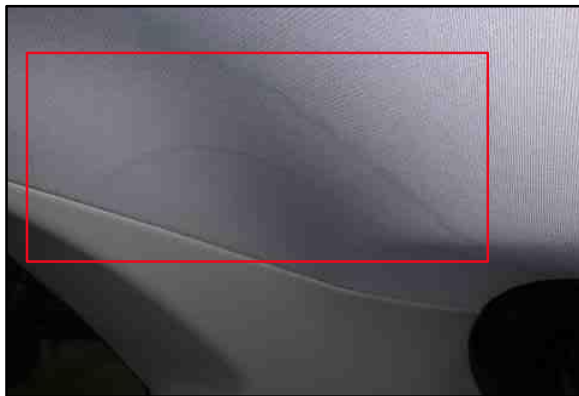
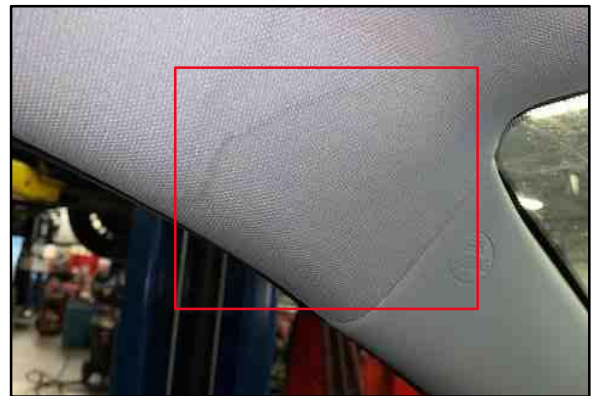
1. Inspect the vehicle headlining assembly for water stains.  
Are there water stains present on the vehicle headlining assembly?

**Figure 15. Water Stain Example**

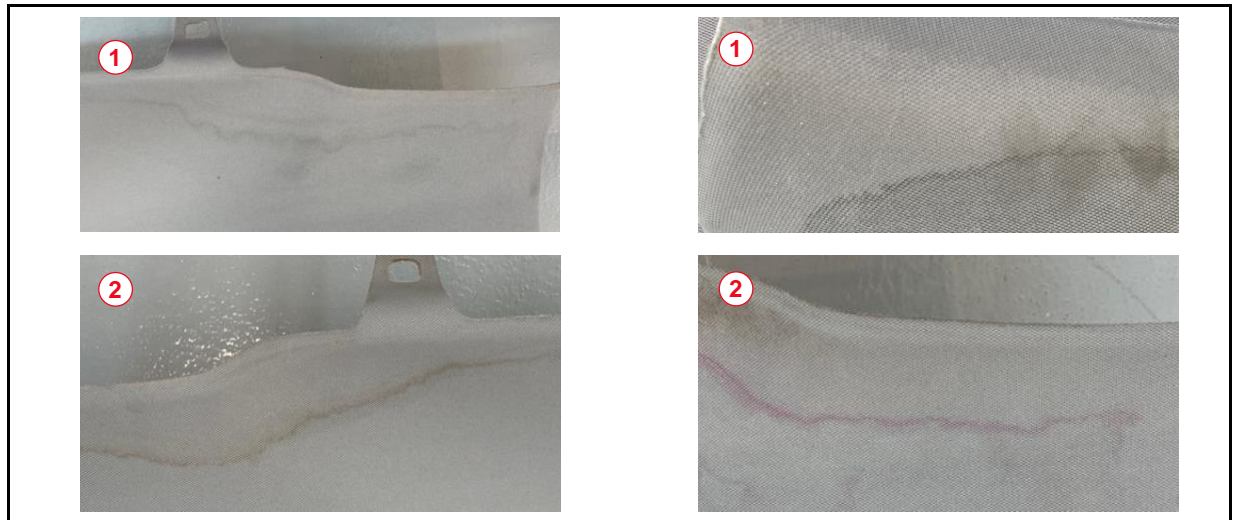
**Figure 17. Water Stain Color Examples**

- Reference Figure 17 and determine the water stain color on the headlining assembly.

<b>1</b>	Example of a Gray Color Stain
<b>2</b>	Example of a Different Color Stain

- YES** — Continue to step 4.
- NO** — The headlining assembly will require replacement. Go to the [CSP Inspection Website Submission Procedures](#) section.

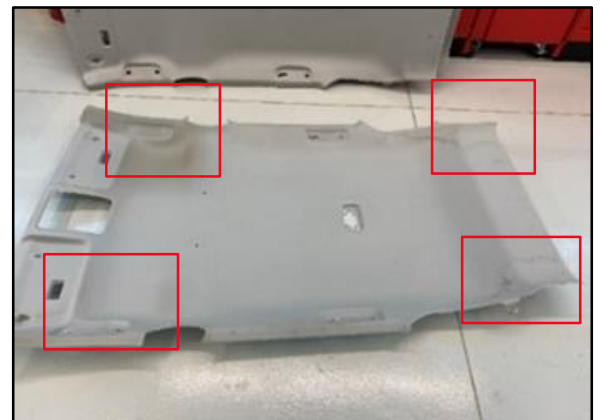
- Confirm the number of stains present.  
Are there four or more stains on the vehicle headlining assembly?

**Figure 18. Example of Four Stains, One on Each Corner**

- YES** — The headlining assembly will require replacement. Go to the [CSP Inspection Website Submission Procedures](#) section.
- NO** — Continue to the [Headlining Assembly Cleaning Procedure](#) section.
