T-SB-0020-23 April 27, 2023

Stop and Start System - Intermittent No Restart During Wiper Operation

YEAR(S)	MODEL(S)	ADDITIONAL INFORMATION
2022 - 2023	Corolla Cross

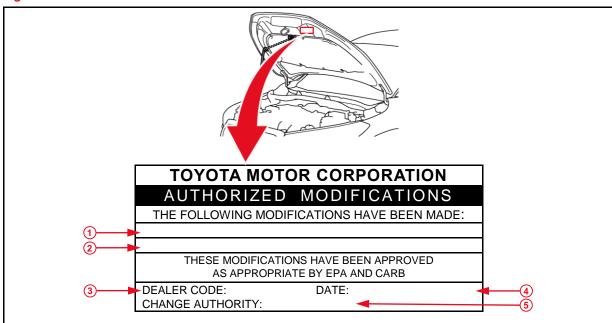
Figure 1. Location of Authorized Modifications Label on 2022 – 2023 Corolla Cross

Use Techstream to confirm if the stop and start ECM (PCM) calibration has been updated and check for the Authorized Modifications Label affixed to the vehicle in the location shown below.

Is the calibration ID listed in Techstream and on the label the latest stop and start ECM (PCM) calibration?

- 4. Prepare and install the Authorized Modifications Label.
 - A. Using a permanent marker, enter the following information on the label:
 - Stop and start ECM (PCM) part number [Refer to the Parts Information section for the NEW PART NUMBER]
 - Calibration ID(s) [Refer to the Calibration Information section for the NEW CALIBRATION ID]
 - Dealer Code
 - Repair Date
 - Change Authority [This bulletin number]
 - B. Install the Authorized Modifications Label onto the vehicle at the location shown in Figure 1. The Authorized Modifications Label is available through the MDC, P/N 00451-00001-LBL (USA) or 00451-00002-MEX (Mexico).
- 5. Test-drive the vehicle to confirm proper operation.
