# VW Elsa Newsletter

Edition 174: February 22, 2016

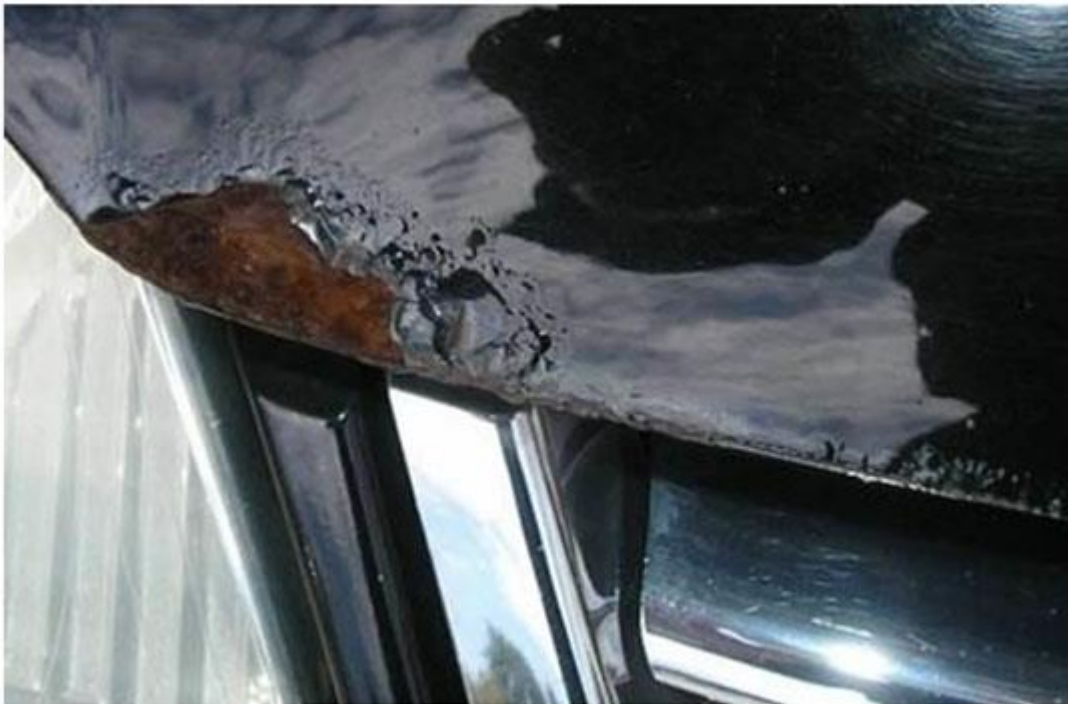
**Corrosion Hood Edge**

Corrosion may be found on the folded edge of the hood. The corrosion may be found on this edge anywhere around the hood.

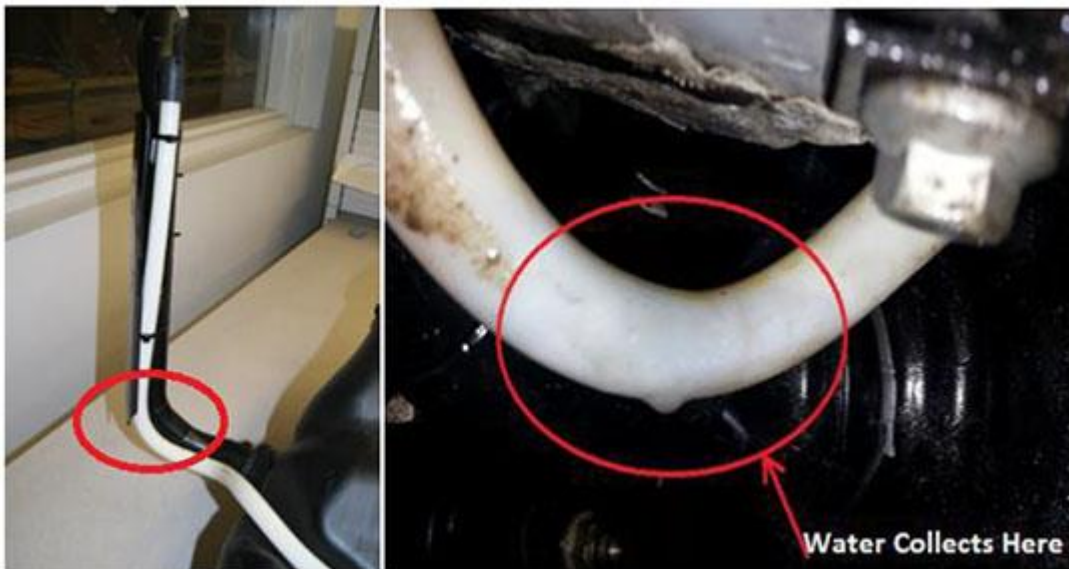
### 20-16-01 Fuel Tank Hard to Fill in Temperatures Below Freezing

Condensation build up in the fuel filler neck vent line causes blockage or restriction not allowing fuel vapors to vent. Inspect fuel tank vent tube for debris, water and/or ice. Backlighting the tube with a flashlight or using a bore scope will aid in diagnosis.

If the vent path is blocked or restricted, install a Shepard's crook (U-shaped) vent to stop moisture from entering the vent line.
