## TECHNICAL SERVICE BULLETIN

### Audio System Inoperative Or No Access To FM, AM Or Satellite Radio Modes - Built on or Before 06-Jan-2023

**23-2116**

<b>Ford</b> 2022 Expedition	Built on or before 28-Oct-2022
2022-2023 F-150 Lightning	Lariat/Platinum trim levels Built on or before 06-Jan-2023

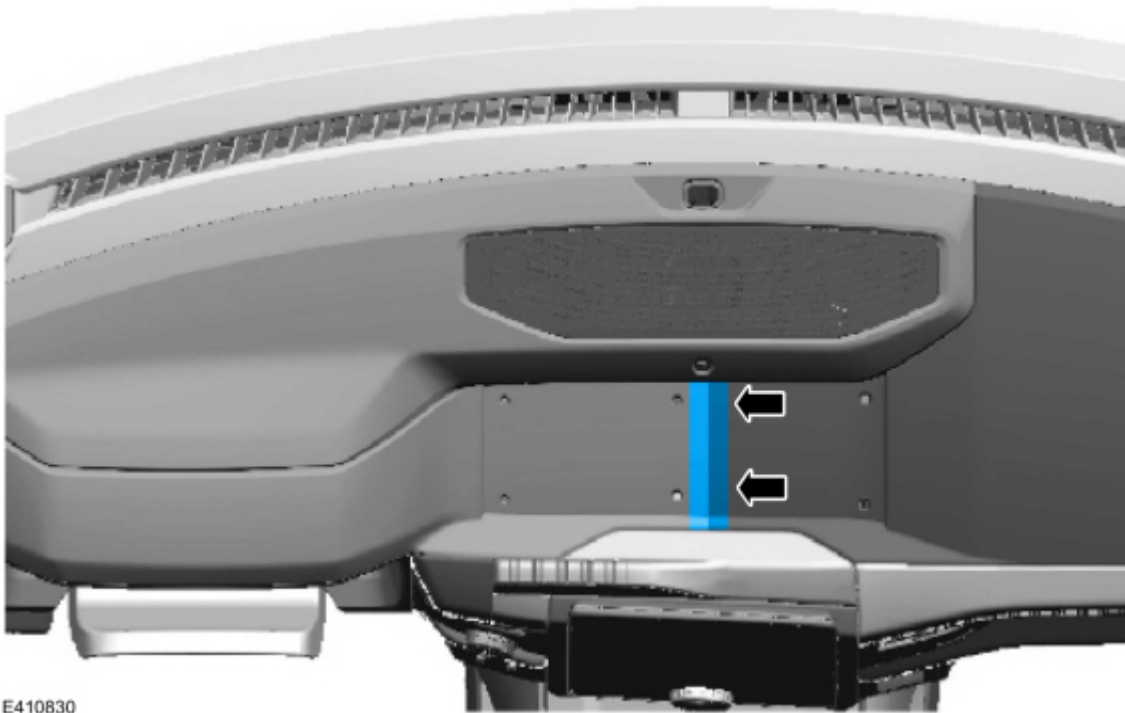
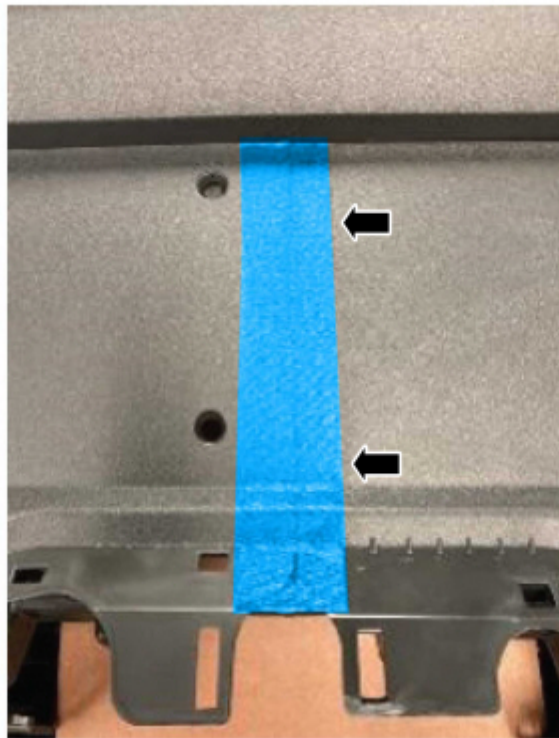
**Issue:** Some 2022-2023 F-150 Lightning vehicles with Lariat/Platinum trim levels built on or before 06-Jan-2023 and 2022 Expedition vehicles built on or before 28-Oct-2022 may exhibit a concern with the audio system inoperative or no access to FM, AM or satellite radio modes. This may be due to liquid ingress in the audio front control module (ACM) from the top of the dash area. To correct the condition, follow the Service Procedure to replace the ACM and seal the dash seam.

3. Clean the areas where seal tape will be installed on the dash seam in Figures 2-3 and on the underside of the dash in Figures 4-5 by wiping with a clean damp cloth and then wiping a second time with clean cloth that is damp with isopropyl alcohol.

4. Install 1 piece of 165 mm x 35 mm (6.5 in x 1.4 in) seal tape on the dash seam as indicated in Figures 2-3.
5. Cut 1 piece of seal tape to 35 mm (1.4 in) long.
6. Install a piece of 35 mm x 35 mm (1.4 in x 1.4 in) seal tape on the underside of the dash to cover the bottom of the locator hole indicated in Figures 4-5.
7. Reinstall the instrument panel storage tray mat.
8. Install a new ACM. Refer to WSM Section 415-00.
