Technical Service Bulletin

27 48V Vehicle electrical system warning, DTC P0CA700 and/or U046900 stored in the starter/generator control module/ECM

27 23 55 2058831/8 May 8, 2023. Supersedes Technical Service Bulletin Group 27 number 23-51 dated March 30, 2023, for reasons listed below.

Model(s)	Year	VIN Range	Vehicle-Specific Equipment
A6, A7 and Q8	2019 – 2023	All	48 V MHEV
A8	2019 – 2021		
A6 allroad, and Q7	2020 – 2023		
S8	2020 - 2022

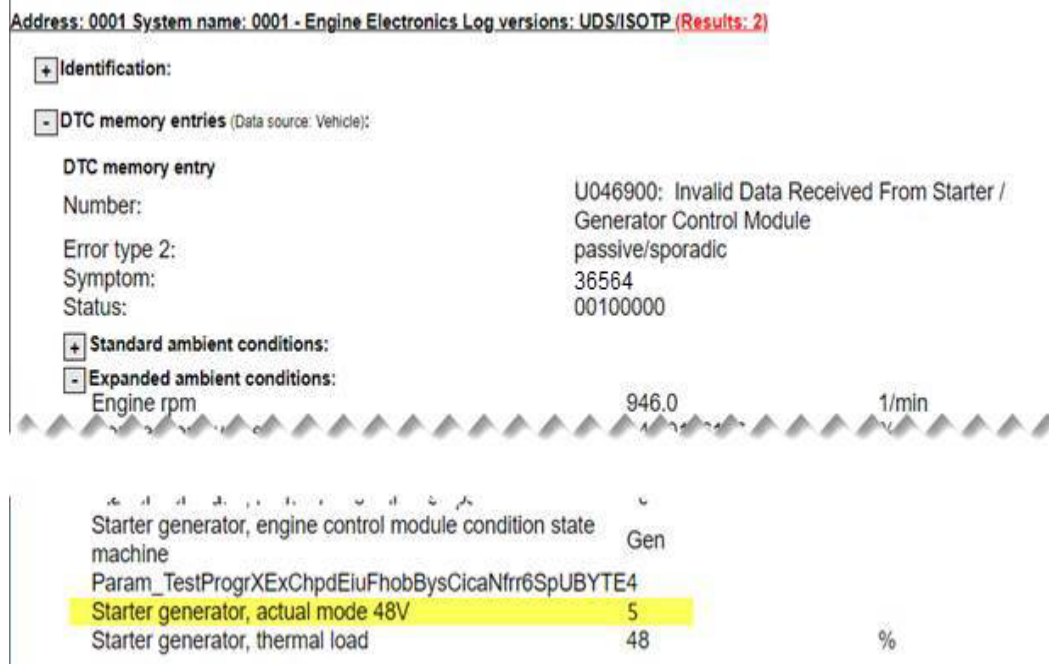
If the value displayed for *Starter generator, actual mode 48V* is not shown, or a value other than 5 is displayed (see Figure 1) please check the software version of the BSG (address word 00CC).

Figure 1: Extended ambient data in ODIS GFF log.

If the software is older than, but not including SW 0527, please update the BSG via the SVM update instructions at the end of this TSB, then follow up with the checks listed under Criterion 2.
