Technical Service Bulletin

63 Paint peeling from the rear bumper cover

63 23 11 2064279/4 May 16, 2023. Supersedes Technical Service Bulletin Group 63 number 23-10 dated March 3, 2023, for reasons listed below.

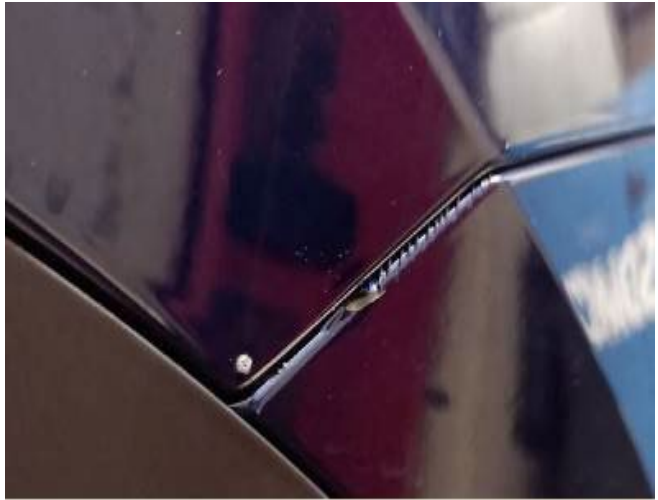
3. Figure 3 shows the condition in its early stages that may evade notice.

Figure 3. Early stages of the peel.

Should the condition described in this TSB occur the rear bumper cover is to be replaced. Do not attempt to refinish the original bumper cover. Due to the technical nature of the root cause refinishing the original bumper cover will only reintroduce a subsequent paint peel in these areas of the rear bumper cover over time.

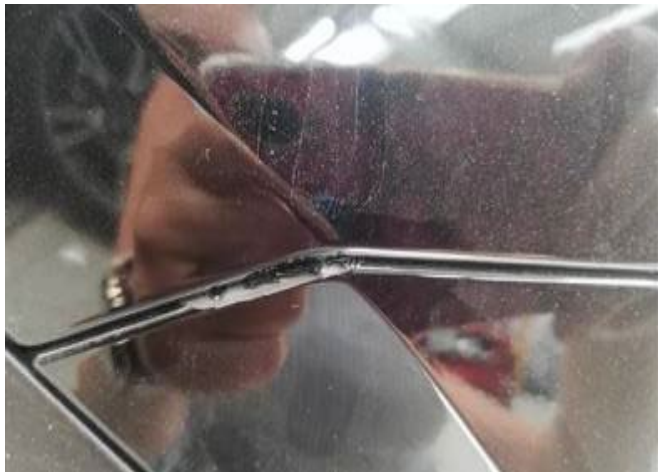
4. Figure 4 shows an intermediate loss of paint in this area.

Figure 4. Moderate loss of adhesion.
