# Technical Service Bulletin

## 68 Noises from the dash panel around the MMI display

68 23 42 2056298/5 May 19, 2023. Supersedes Technical Service Bulletin Group 68 number 21-33 dated April 20, 2021, for reasons listed below.

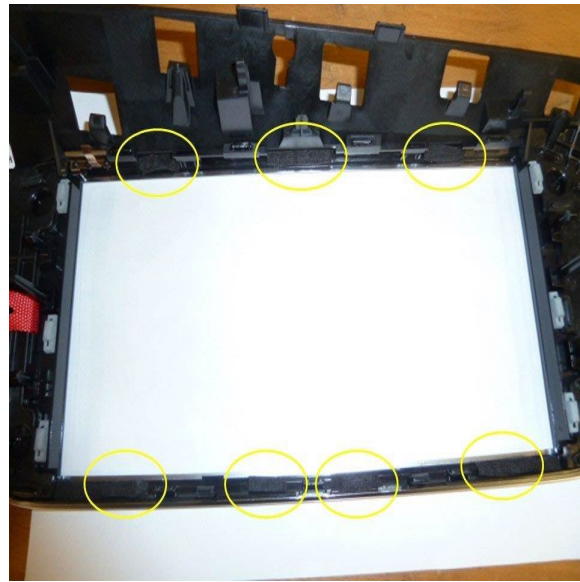
The dash panel trim can cause noise at the contact points.

*Figure 1. Apply felt strips to the circled areas.*

Remove the trim strip of the dash panel and stick the felt adhesive tape on the areas marked with yellow circles (Figure 1).

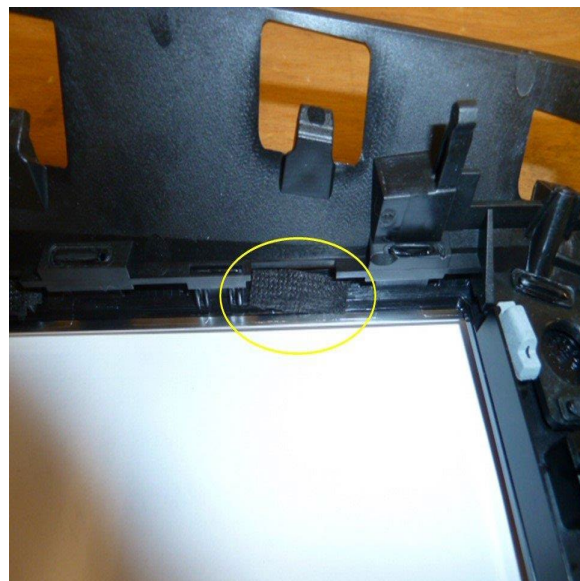
*Figure 2. Close-up of Figure 1.*

The felt strips shown in Figure 1 and 2 must be stuck on and folded back behind the clip (Figures 3 -4).

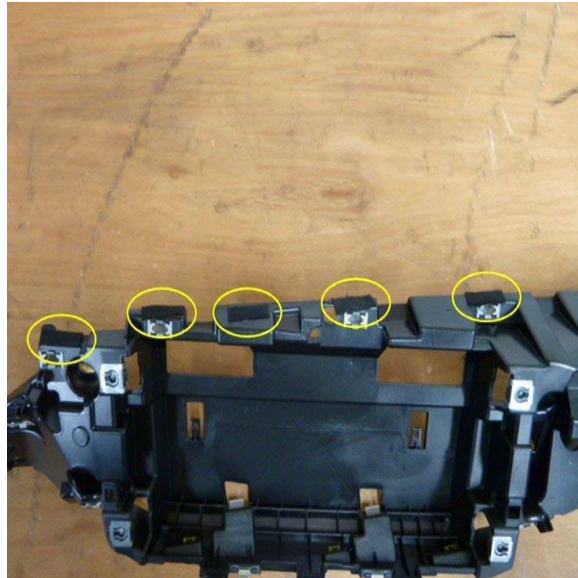
**Figure 3.** Apply felt strips to the circled areas.

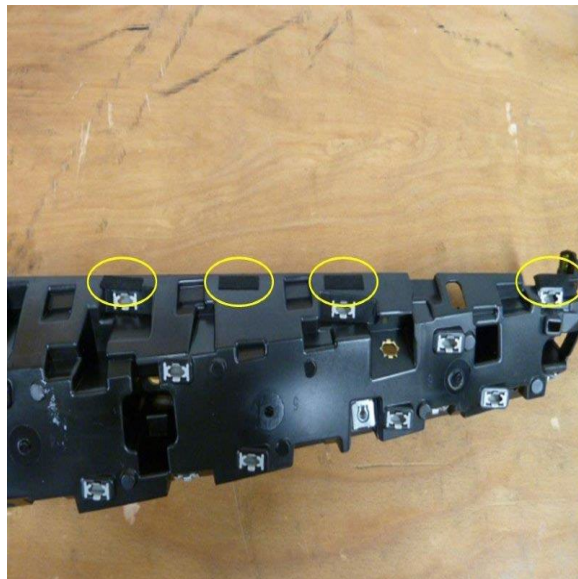
**Figure 4.** Apply felt strips to the circled areas.
