Technical product information

Topic	DTC B17B801 and/or B17B804 - evident within address 0019 and/or DTC U112300 evident in 00A5
Market area	Russische Föderation (5RU),Australia E04 Bentley rest Asia and Australia (6E04),China 796 VW Import Comp. Ltd (Vico), Beijing (6796),Germany E02 Bentley rest Europe (6E02),Japan E03 Bentley Japan (6E03),Korea, (South) E08 Bentley South Korea (6E08),United Arab Emirates E06 Bentley Middle East and Africa (6E06),United Kingdom E01 Bentley UK (6E01),United States E05 Bentley USA and rest America (6E05)
Brand	Bentley
Transaction No.	2063855/8
Level	EH
Status	Approval
Release date

New Continental GT/GTC - New Flying Spur - Bentayga Series

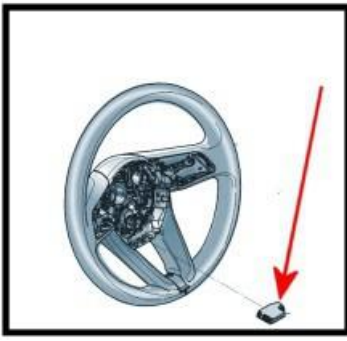
- DTC - B17B801 - Steering Wheel Touch Recognition Control Module evident within **address 0019**

- DTC B17B804 - Steering Wheel Touch Recognition Control Module electrical error - evident within **address 0019**

- DTC U112300 with symptom Code 1123220 within **address 00A5**

- 1) Referring to Rep.Gr 69 - Remove the driver's air bag
- 2) Referring to Figure 1 - Fit a Control Unit for Steering Wheel Contact Detection control unit (J1158) to the new steering wheel

- 3) Referring to Rep.Gr 69 - Refit the driver's air bag
- 4) Using ODIS - Erase all applicable DTC's
- 5) Carry out a short road test (Not exceeding 15 minutes)
