## Technical product information

### New Continental GT/GTC - New Flying Spur, Bentayga - W12 TSI

Engine warning light illuminated within the DIP during acceleration - DTC P029900 evident - W12 TSI only

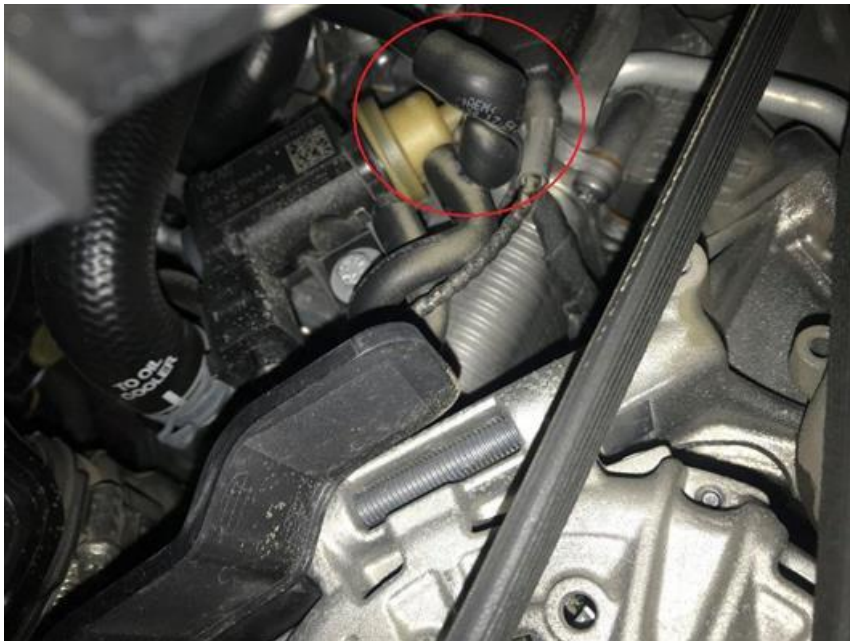
3) Carry out a visual inspection of the engine vacuum system TIP: Referring to the example shown in Figure 2, Check there are no kinks or damaged vacuum hoses

NOTE: The issue shown in Figure 2 is an example of a kinked vacuum hose which is fitted to the Boost pressure valve vacuum solenoid

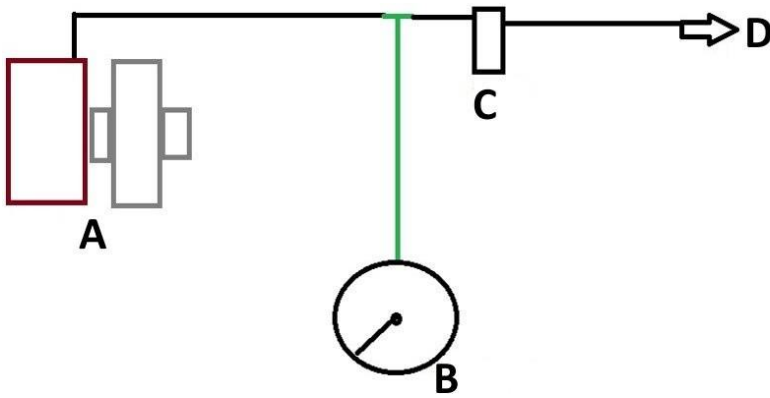
4) Referring to Figure 3 - Attach a manual vacuum gauge (B) between the following components: (Depending on the bank which is suspected to be at fault)

- Turbocharger wastegate (A) and (C) Boost pressure valve vacuum solenoid

N249 (Bank1)

Or

N547 (Bank 2)

**NOTE: Point (D) refers to the engine vacuum system**

The manual vacuum gauge must be connected as shown, the hose must be long enough to allow the gauge/readings to be viewed from inside the cabin

4) The vehicle should be driven whilst the second operative monitors the gauge to confirm if the Boost pressure valve vacuum solenoid is being actuated in a plausible manner **For example: Vacuum supplied to build boost pressure/vacuum supply closed when the target boost pressure is achieved**

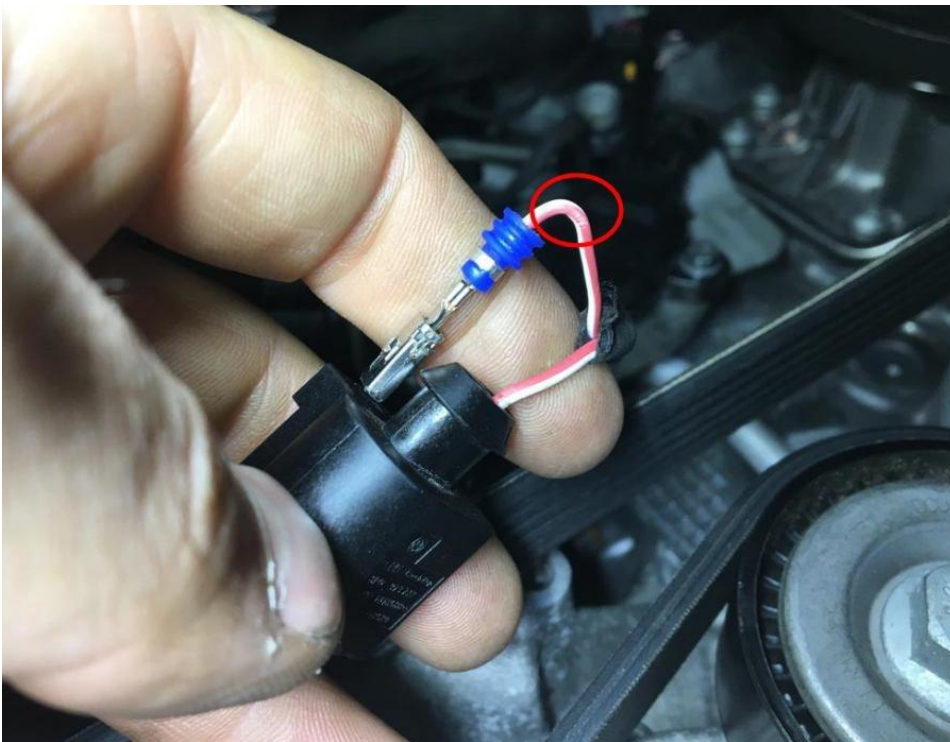
- Figure 4 shows a location which should also be checked for damage/kinks *NOTE: The disconnected pin is shown for photographic purposes only*

7) In the event an issue is suspected, for test purposes the operative should overlay the suspected wiring as follows:

- Make and temporarily fit an overlay wire between the applicable boost pressure valve vacuum solenoid and the signal wire to the applicable Engine Control Module (ECM)
- Attempt to erase the DTC and carry out a road test to confirm the issue has been successfully diagnosed
- The overlay **MUST** not be left in place under any circumstances, the operative should repair the wiring as per Rep.Gr 97
