Technical Service Bulletin

93 DTCs P0C4A00, P2B2800 and/or P0CFF00 Stored in the Hybrid Battery Management control unit
93 23 06 2068363/3 May 9, 2023. Supersedes Technical Service Bulletin Group 93 number 23-04 dated April 25, 2023, for reasons listed below.

Model(s)	Year	VIN Range	Vehicle-Specific Equipment
Q4 e-tron, and Q4 Sportback e-tron	2022 – 2023	All	Not Applicable

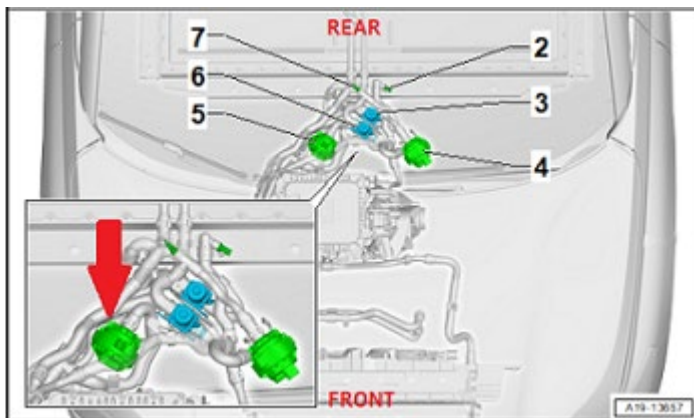
Figure 1. V590 location.

Residual air in the cooling system may cause dry running of the coolant pump.

- The coolant pump (V590) must be replaced according to the Workshop Manual.
