HYUNDAI Technical Service Bulletin	GROUP CAMPAIGN	NUMBER 23-01-036H
	DATE MAY 2023	MODEL(S) ELANTRA (CN7A) SONATA (DN8A) SANTA FE (TMA)
SUBJECT: HECU MODULE DARK CURRENT MEASUREMENT AND REPLACEMENT (SERVICE CAMPAIGN 990)

Description: Some Elantra (CN7A), Sonata (DN8A) and Santa Fe (TMA) vehicles may exhibit the Electronic Parking Brake (EPB) warning light on due to brake fluid entering the HECU electrical connector. DTC C1501 (EPB Switch Failure) may be present, but EPB performance remains unaffected. This bulletin describes the procedure to inspect, and if necessary, replace the Hydraulic Electronic Control Unit (HECU).

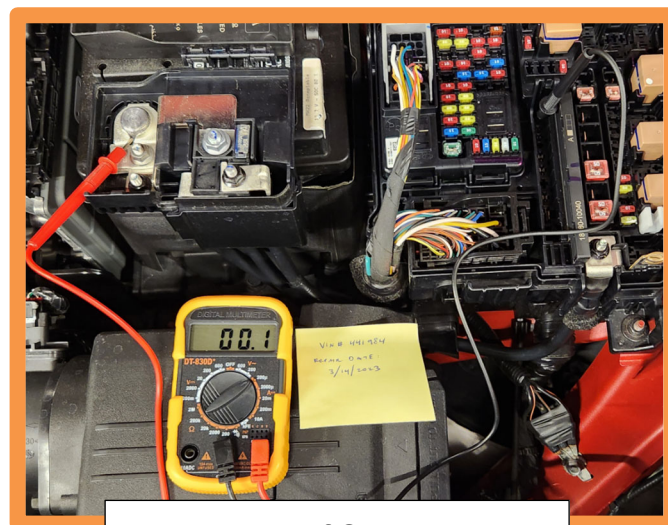
Example of STUI Photo

Using STUI, take a photo showing the multi-meter dark current reading, and the open junction box. Include the last 6 digits of the VIN and the date of repair on a piece of paper.

8.
 - If current draw value is **below** the maximum dark current value as listed above in the **Service Inspection Guidance** on page 4:
 - Reinstall the removed parts in the reverse order. No further action is required.
 - If current draw value is **equal to OR over** the maximum dark current value as listed above in the **Service Inspection Guidance** on page 4:
 - Replace the Hydraulic Electronic Control Unit Assy (HECU) by referring to the shop manual.

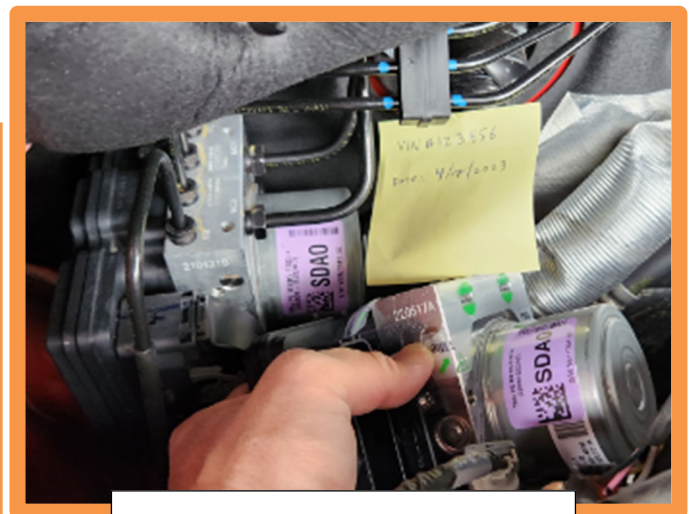
Example of STUI Photo

If HECU is replaced: Using STUI, take a photo showing the newly installed HECU, along with the removed original HECU. Include the last 6 digits of the VIN and the date of repair on a piece of paper.

9. Reassemble vehicle in the reverse order of removal.
10. Start the engine. Confirm the “ABS”, “ESC” and “Brake” indicator lamps are not illuminated, clear any incidental DTCs and reprogram the customer’s radio preset stations.
11. The service procedure is now complete.
