Technical Service Bulletin: TSB190165

Released Date: 24-May-2023

Soot or Ice Deposits in the Intake Air Connection and Fault Codes: 1866, 3361, 3382, 3383, 3389, 7232, 7233 and/or 4729

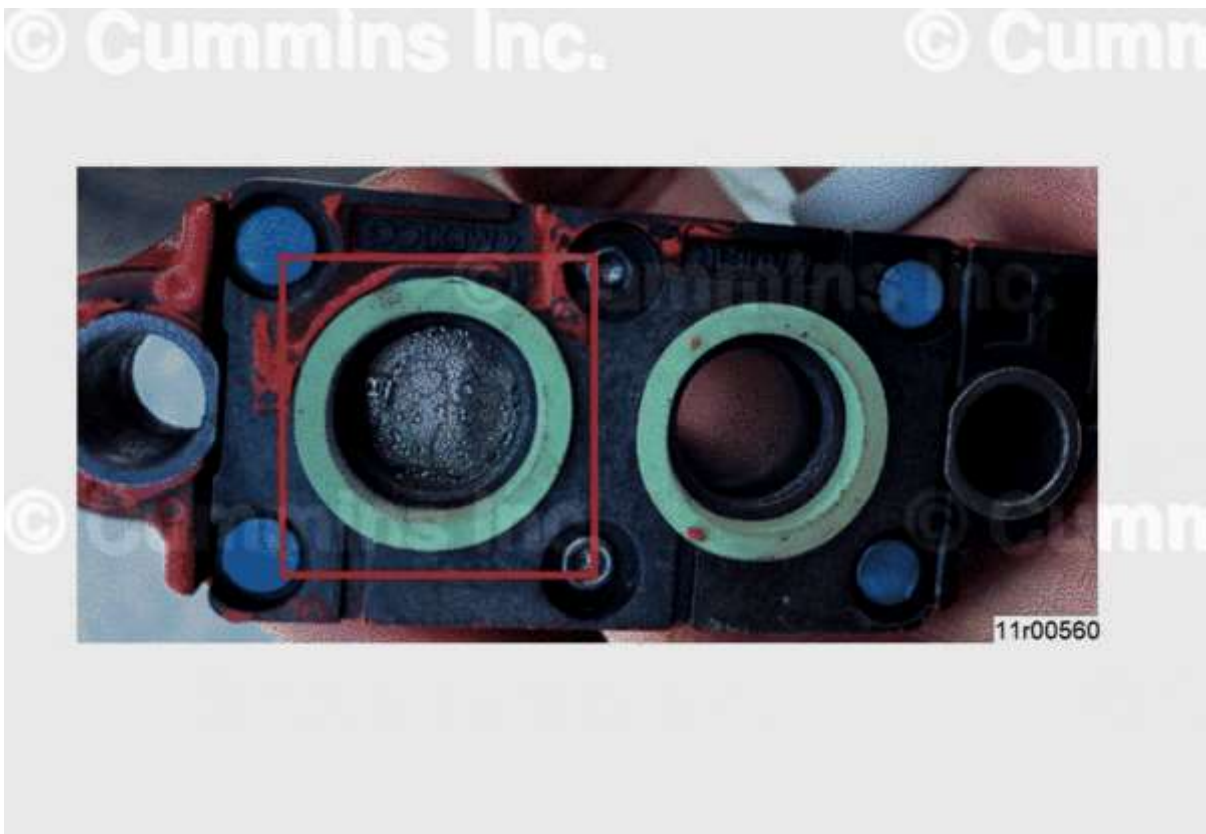
- Icing may **not** be present at the time of the repair, but presence of condensation/water droplets in the EGR Differential Pressure sensor indicates that icing of the sensor is the root cause of this issue.

Figure 1, Condensation on the EGR Differential Pressure Sensor.

- If soot is found, gently wipe away with a clean towel. Be sure not to apply too much pressure on the sensor elements, as they can become damaged.
 - If ice or condensation is found (See Figure 1 below), gently wipe away with a clean towel. Be sure **not** to apply too much pressure on the sensor elements, as they can become damaged.
