# Service Bulletin

Bulletin No.: 21-NA-142

Date: May, 2023

**Subject: Front Brake Grind/Groan Noise After Sitting Overnight**

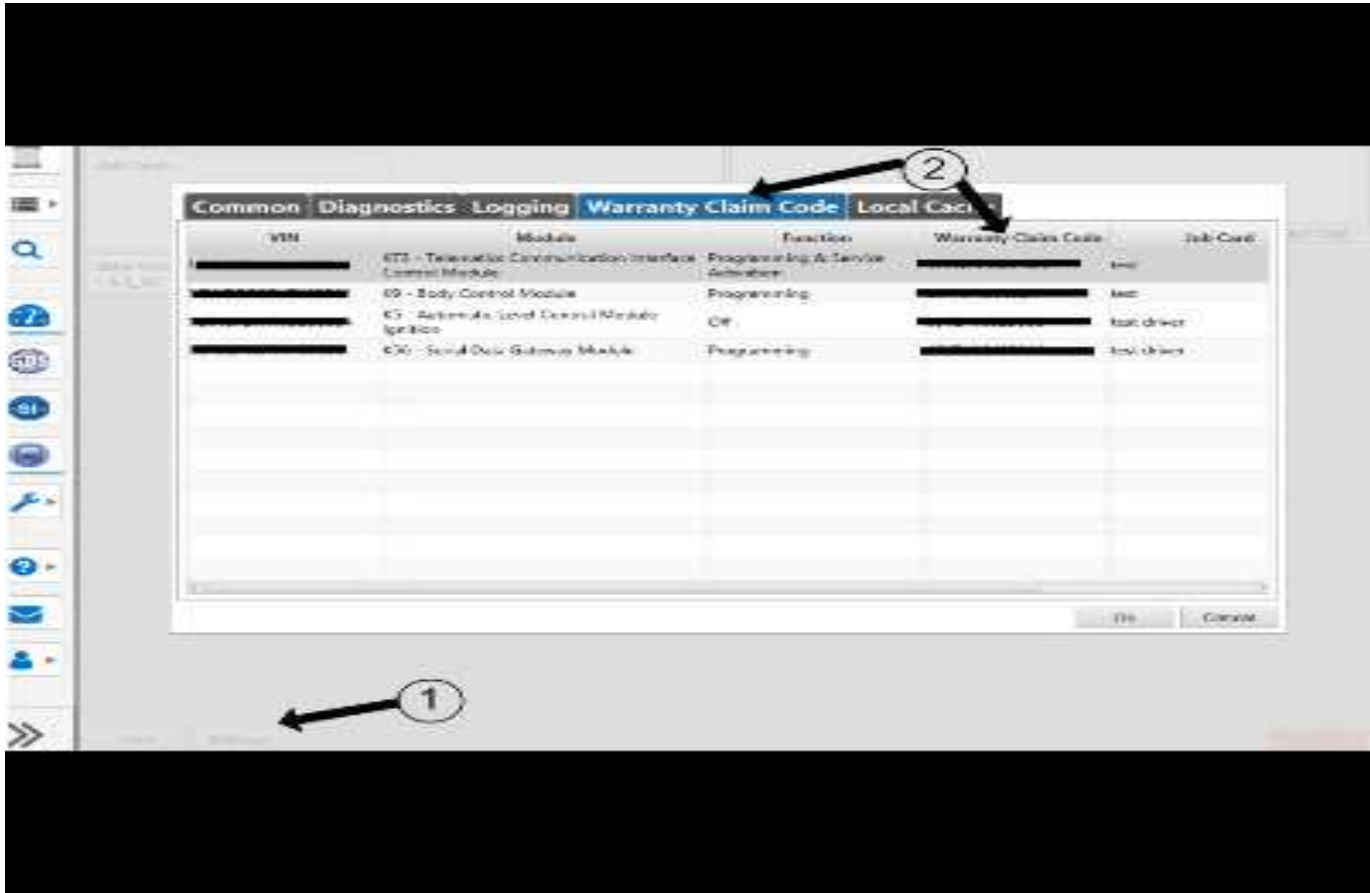
6125774

If the Warranty Claim Code was not recorded on the Job Card, the code can be retrieved in the SPS2 system as follows:

1. Open TLC on the computer used to program the vehicle.
2. Select and start SPS2.
3. Select Settings (1).
4. Select the Warranty Claim Code tab (2).

The VIN, Warranty Claim Code and Date/Time will be listed on a roster of recent programming events. If the code is retrievable, dealers should resubmit the transaction making sure to include the code in the SPS Warranty Claim Code field.
