Service Bulletin

Bulletin No.: 23-NA-060

Subject: Creak/Tick Noise from the Left (Driver) Side Rear of the Vehicle When Traveling Over Bumps/Uneven Surfaces

Brand:	Model:	Model Year:		Build Date:		Engine:	Transmission:
		from	to	from	to		
Buick	Enclave	2023	2023	SOP	February 1, 2023		
Chevrolet	Traverse	2023	2023

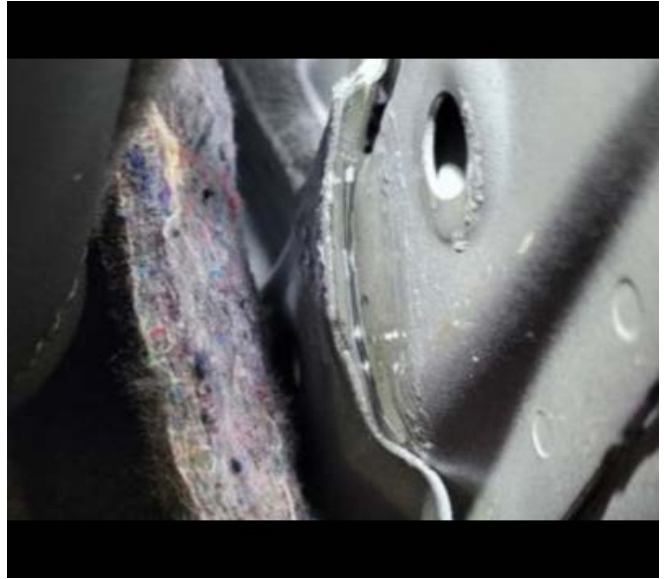
6305287

Photo shows the area after repair is complete.

4. Apply a liberal amount of structural adhesive into the gap between the panels and allow to cure overnight.
