Diagnostic Trouble Code (DTC) P215A-64, Fault Code SPN 84 FMI 19

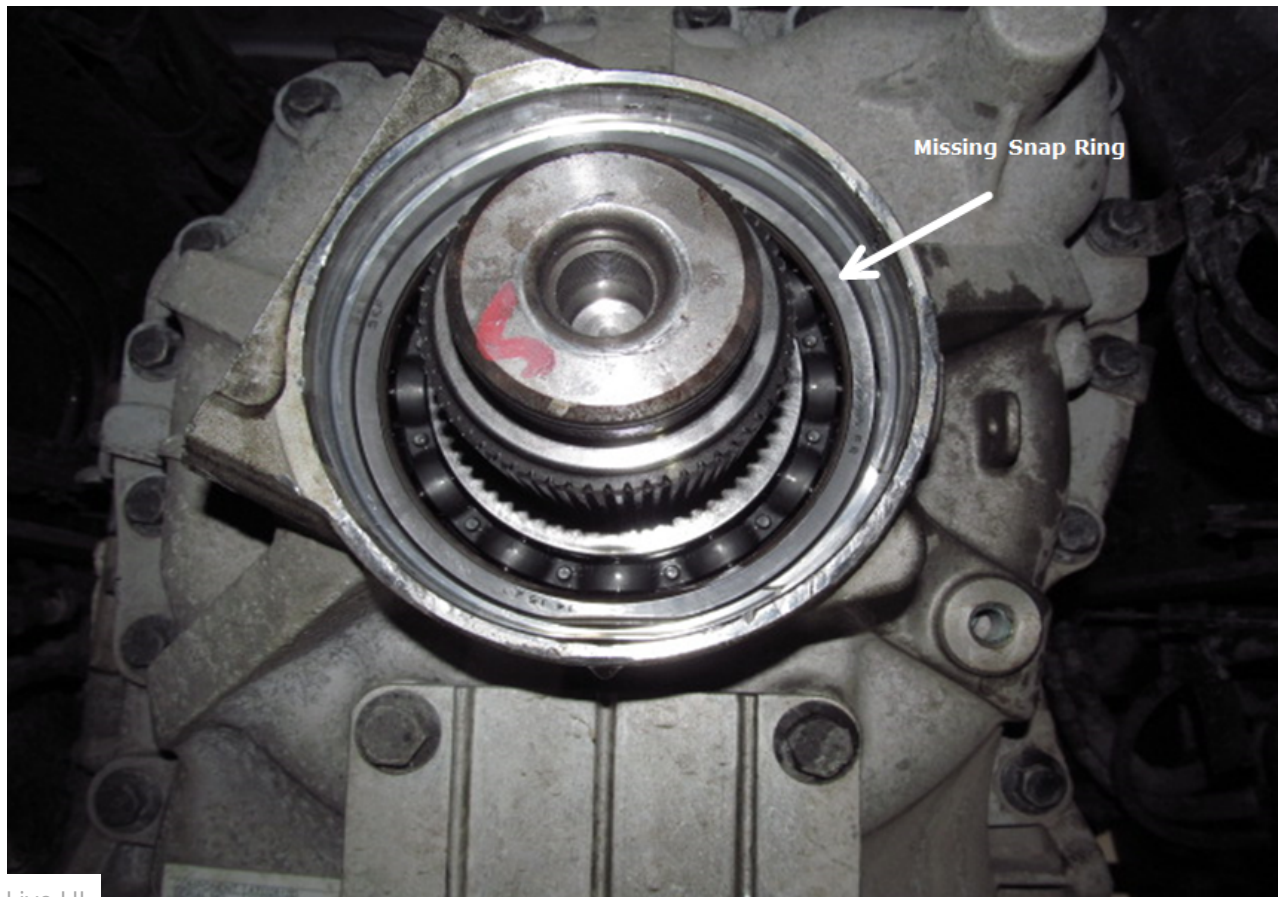
This condition may be caused by a missing or dislodged output shaft bearing snap ring, which results in a damaged transmission speed sensor.

1. Follow instructions for removal and replacement of the output shaft seal, [4317-03-02-03 Seal, Output Shaft, Replacement](#).
2. Reposition the output shaft bearing forward in the auxiliary housing.
 - If the snap ring is still present but has come out of the groove:
 - Inspect for damage to the groove.
 - If no damage is found, re-install the snap ring and ensure it is fully seated in the groove.

- If the snap ring is missing:

- IMPACT shows 4 different thickness rings. Obtain all four thicknesses. The correct thickness snap ring is the one that provides the tightest fit for the bearing.

Part Number	Thickness (mm)
1652802	3.70
1652803	3.80
1652804	3.90
914556	4.00

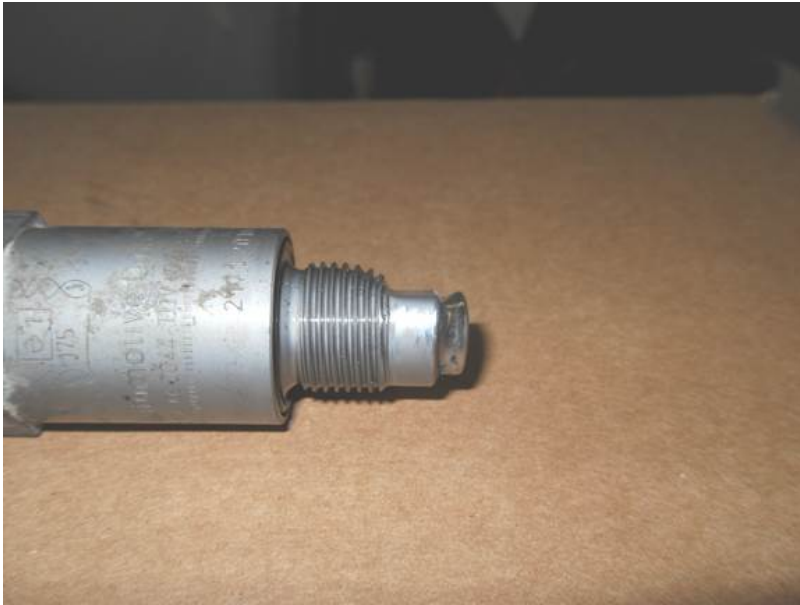
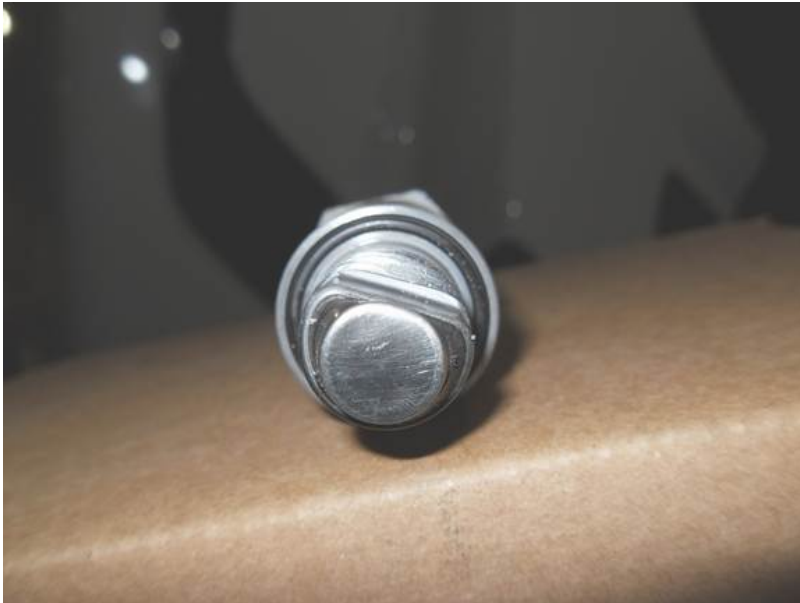
During replacement of the sensor for SPN 84 FMI 19, if the technician finds the sensor damaged in this manner (see below) the snap ring for the tail shaft bearing is missing or not seated. This repair can be done in the field.

- There are 4 different thickness snap rings:

- 1652802, THK 3.70
- 1652803, THK 3.80
- 1652804, THK 3.90
- 914556, THK 4.00

- Follow instructions for R&R the output shaft seal, [4317-03-02-03 Seal, Output Shaft, Replacement](#).
- Reposition the tail shaft bearing forward in the auxiliary housing.
- To find the correct size snap ring start with the thickest and use the largest one that fully seats in the groove.
- Reassemble
