End of Line (EOL) Resistor and Gateway Diagnostics

Model and Serial Numbers Included:

2021 - 2023	Alpine,	All Models
2021 - 2023	Cougar,	All Models
2020 - 2023	Raptor,	All Models
2020 - 2023	Montana,	Legacy Models with iN·Command®

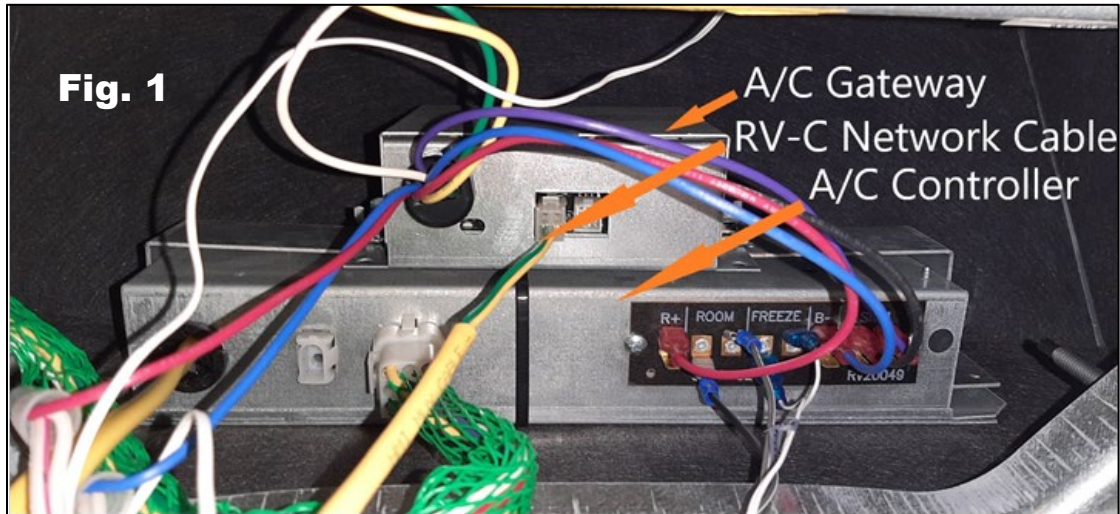
Components involved are located in Roof A/C cavity. See Figure 1.

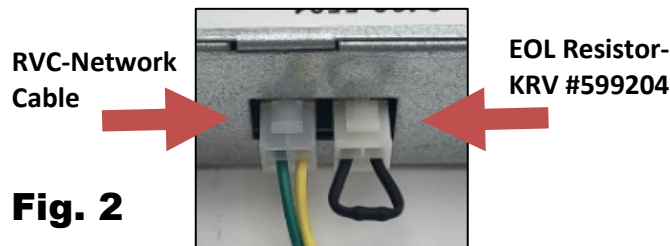
The Gateway is a part of the A/C system that allows its components to communicate with the iN·Command® system. The End of Line (EOL) resistor is installed in the Gateway to provide signal back to iN·Command®, that there are no other A/C's in the chain. If the EOL is missing or in the wrong location, the symptoms described above can occur.

1. Power reset. The Gateway can “go to sleep”. To wake it up, remove all power (12V & 120V) from the unit for 60 seconds by unplugging the shoreline cord and turning off the Battery Disconnect (if equipped) or removing the positive cable from the battery. After power is restored, turn on the DC, if the symptom readings remain, proceed to step 2.
2. Verify the EOL Resistor is installed in the last A/C in the chain of A/C's on this unit. (1. Roof A/C-EOL in Gateway of the only A/C; 2. Roof A/C's-EOL in Gateway of 2nd A/C; 3. Roof A/C's-EOL in Gateway of 3rd A/C) See Figure 2.

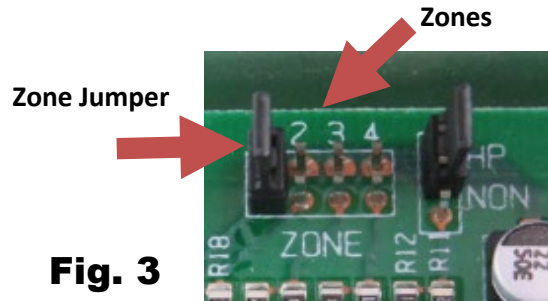
Fig. 3

4. If all RVC-Network cables have proper resistance, go to the A/C Controller for the Zone showing ' - F°'. Remove the cover of the A/C Controller and verify the black "Zone Jumper" is installed on the pins for the correct Zone (1, 2 or 3). See Figure 3.

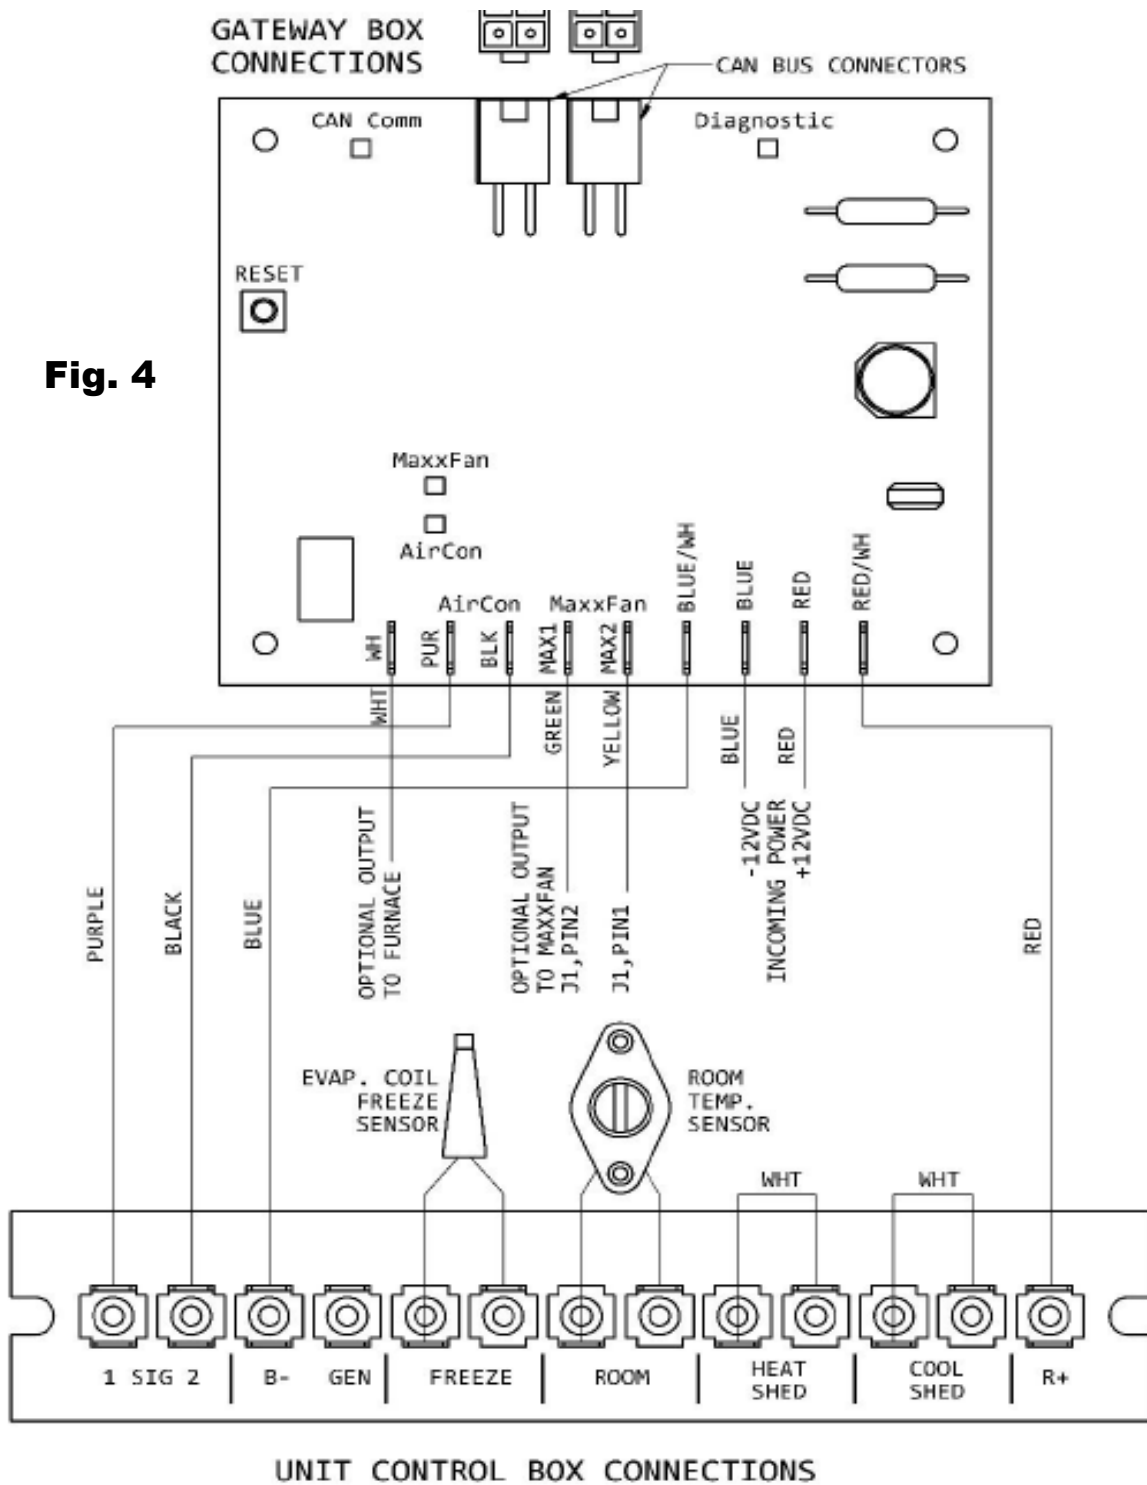
Fig. 4

- 5. If Zone Jumper is in correct Zone, then verify the wiring connecting the A/C Gateway to the A/C Controller are attached to the correct terminals, spades are connected nice and tight, wires are crimped tight to spades. See Figure 4.

6. If the problem remains, replace the A/C Gateway for the Zone showing the symptom readings on the DC.
7. Last, a "Reset" is needed to clear all systems and components. Remove all power from unit by unplugging shore cord, turning off battery disconnects for a minimum of one minute before restoring all power, turning on battery disconnects. Test to verify symptom(s) no longer exists. Over the next 24 hours, periodically validate correct readings on DC to confirm resolution.
