992 GT3 – DME Fault P310B00 – ‘Fuel Low Pressure – Implausible’

Vehicles Affected

Models	Model Year	Model Type	VIN Range	Vehicle-Specific Equipment
911	2021 - 2023	992810 992820	n/a	n/a

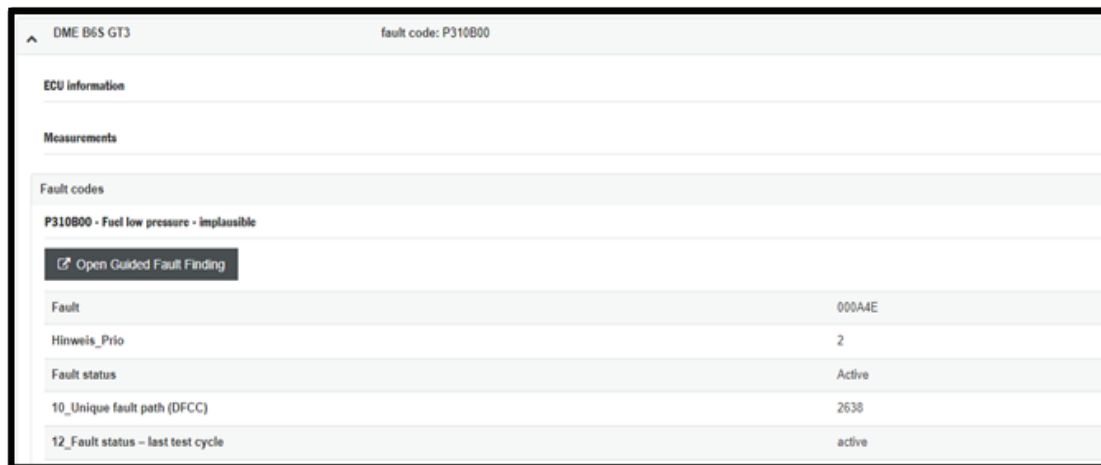
Figure 1

The diagnostic responsible for this fault monitors supply deviation within a finite time between the demanded or target low-pressure requested of the low-pressure fuel pump and that of the actual supplied quantity to meet the request, as correlated to pressure. In some instances, manufacturing tolerances for the low-pressure pump result in the actual supplied fuel quantity exceeding the DME’s requested quantity, in other words, the pump’s operation is ‘too effective.’ By consulting the Vehicle Analysis Log (VAL) containing the fault it is possible to see if the supplied fuel quantity exceeded the requested quantity in the low-pressure system to cause the fault.

In the example provided below of Figure 2, with imperial units provided, it is apparent the excess low-pressure fuel supply caused the fault. Specifically, the value “B220_Fuel pressure actual value” of 10653.7 lbf/ft² exceeds “B221_Fuel low pressure setpoint” of 10442.7 lbf/ft². This deviation occurred despite the DME regulating the demand downwards (-) by 1948.6 lbf/ft² or 14.99% to compensate for the excess supply, but the regulation could not compensate enough to prevent the fault.

If the fault data is consistent with the condition exemplified in Figure 1, please replace the fuel pump, **NOT** the fuel pressure sensor.

1. Follow the instructions from Guided Fault Finding to rule out any other possible fault causes.
2. Referring to Figure 2. Identify measurement values for **XX_Adaption value for low fuel pressure and A260_Fuel pump control unit activation**.
3. Follow **WM 206619 – Removing and installing fuel pump** to replace the fuel pump.
4. Verify the repair by monitoring the low-pressure fuel delivery under the engine operating parameters of the fault's environmental data.
