May 26, 2023

SUBJECT: **Customer Satisfaction Program 22N12 – Supplement #1**
 Certain 2015-2018 Model Year Edge, 2019-2020 Fusion and MKZ Vehicles Equipped with a 2.0L EcoBoost Engine and 6F35 Transmission
 Rattle Noise at the Transmission Bellhousing Area – Flexplate Cracks

CERTAIN 2015-2018 MODEL YEAR EDGE, 2019-2020 FUSION AND MKZ VEHICLES EQUIPPED WITH A 2.0L ECOBOOST ENGINE AND 6F35 TRANSMISSION RATTLE NOISE AT THE TRANSMISSION BELLHOUSING AREA — FLEXPLATE CRACKS

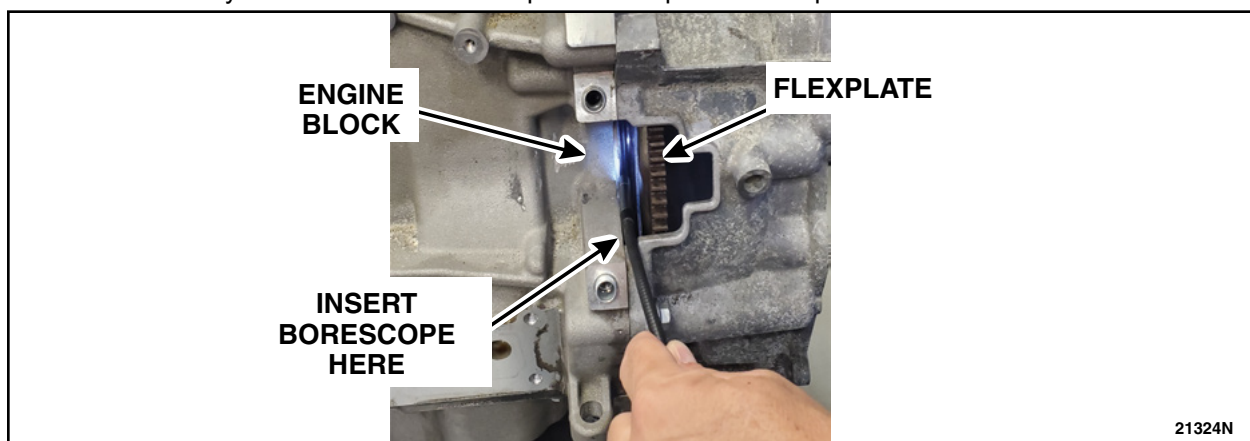
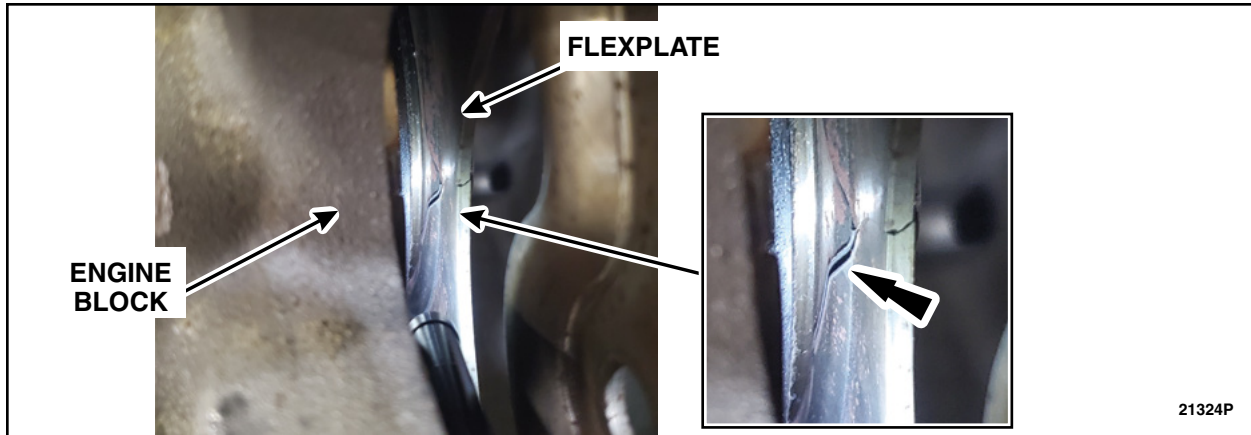
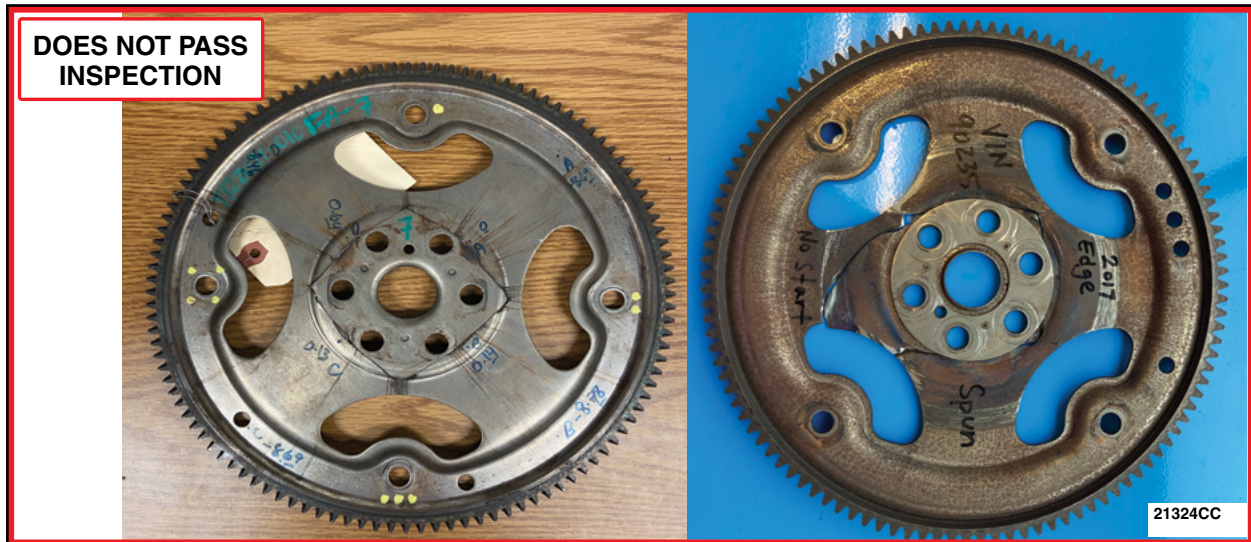
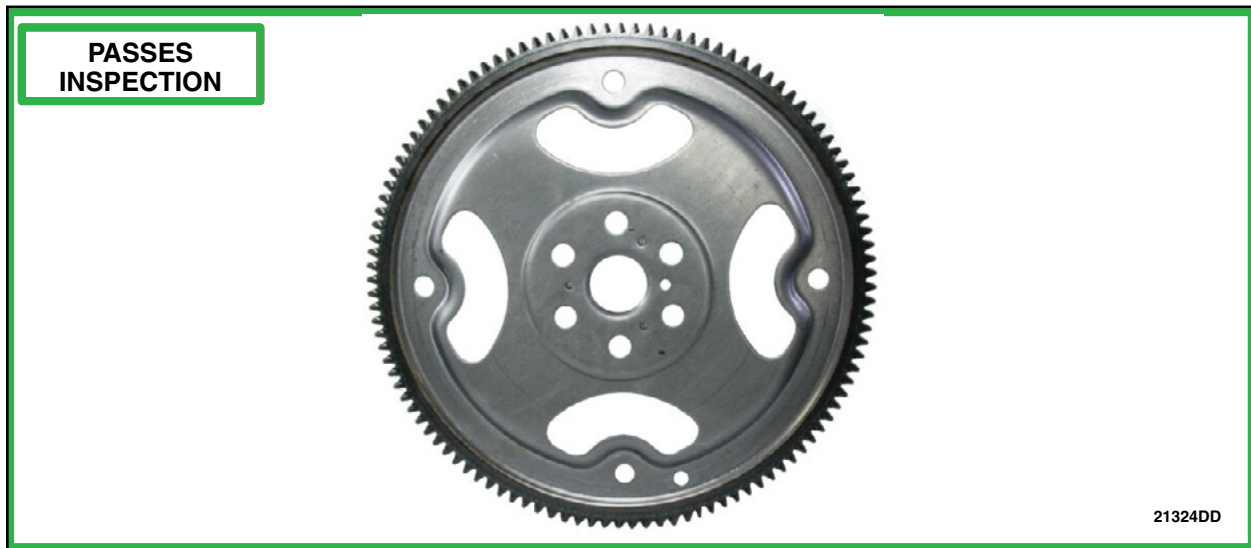
7. Placing a borescope between the engine block and flexplate, inspect the flexplate for cracks near the crankshaft. Are there any cracks present in the flexplate? See Figures 2 through 5.

NOTE: It may be necessary to rotate the engine crank to find the cracks in the flexplate.

Yes - Take a picture of the suspect flexplate and submit an SSSC part order form along with the photo attachments for further review.

9. Replace the torque converter, flexplate, flexplate bolts, and transmission front pump. Refer to WSM, Section 307-01A for torque converter and transmission front pump replacement and Section 303-01A for flexplate and flexplate bolt replacement. If dowel pins are damaged or missing, replace as needed.

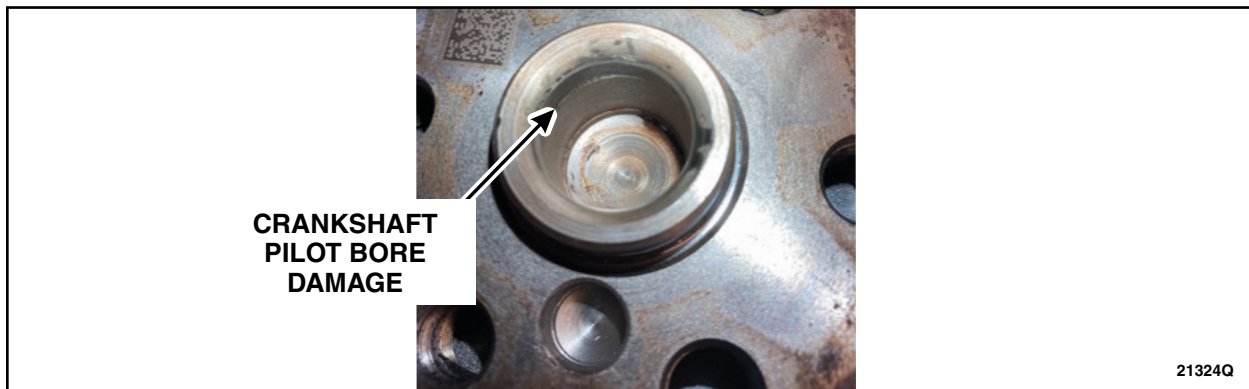
FIGURE 6

10. Inspect for damage on the crankshaft pilot bore. Is there damage? See Figure 6.
