WPFO - Replacing Rear Wing Circlips (Stop Delivery)

Model Line: **911 GT3 RS (992)**

Model Year: **As of 2023 up to 2024**

Concerns: **Rear wing**

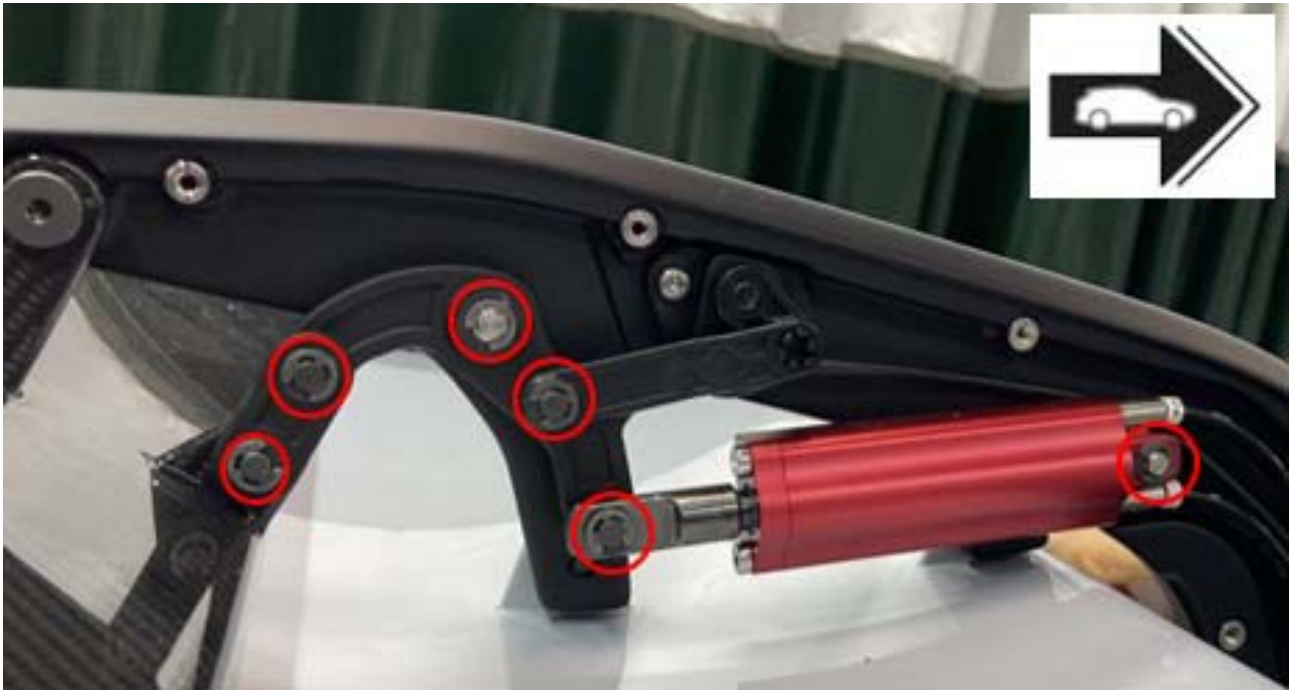
Cause: **On the affected vehicles, the circlips securing the rear spoiler bearing pins may not have been fitted according to specifications.**

In this case, the rear spoiler bearing pin is not secured sufficiently axially in the bearing block and may slip out of the bearing over the service life of the vehicle. This may cause noticeable rear end vibrations when the vehicle is in operation.

Circlip installation positions - left wing strut shown

- 3.1 Replace circlips at the marked positions using a suitable tool. On each wing strut, 6 circlips must be replaced.

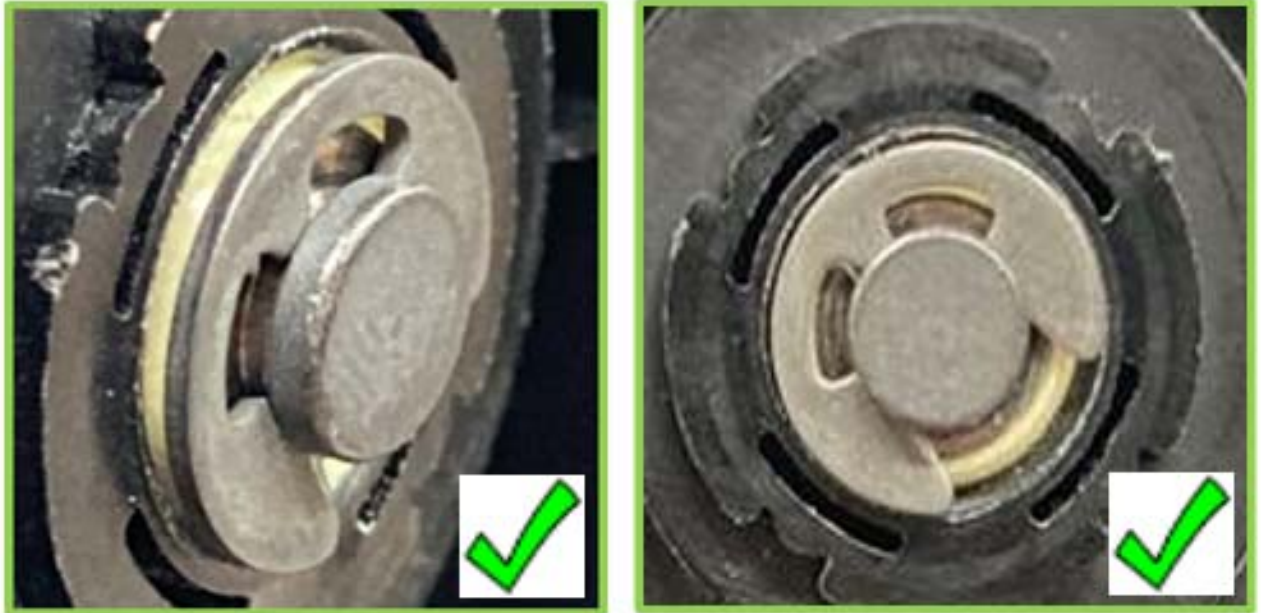
After fitting the new circlips, it is essential to check that they are installed correctly. The circlips must be in the groove.

Example: Correct circlip installation

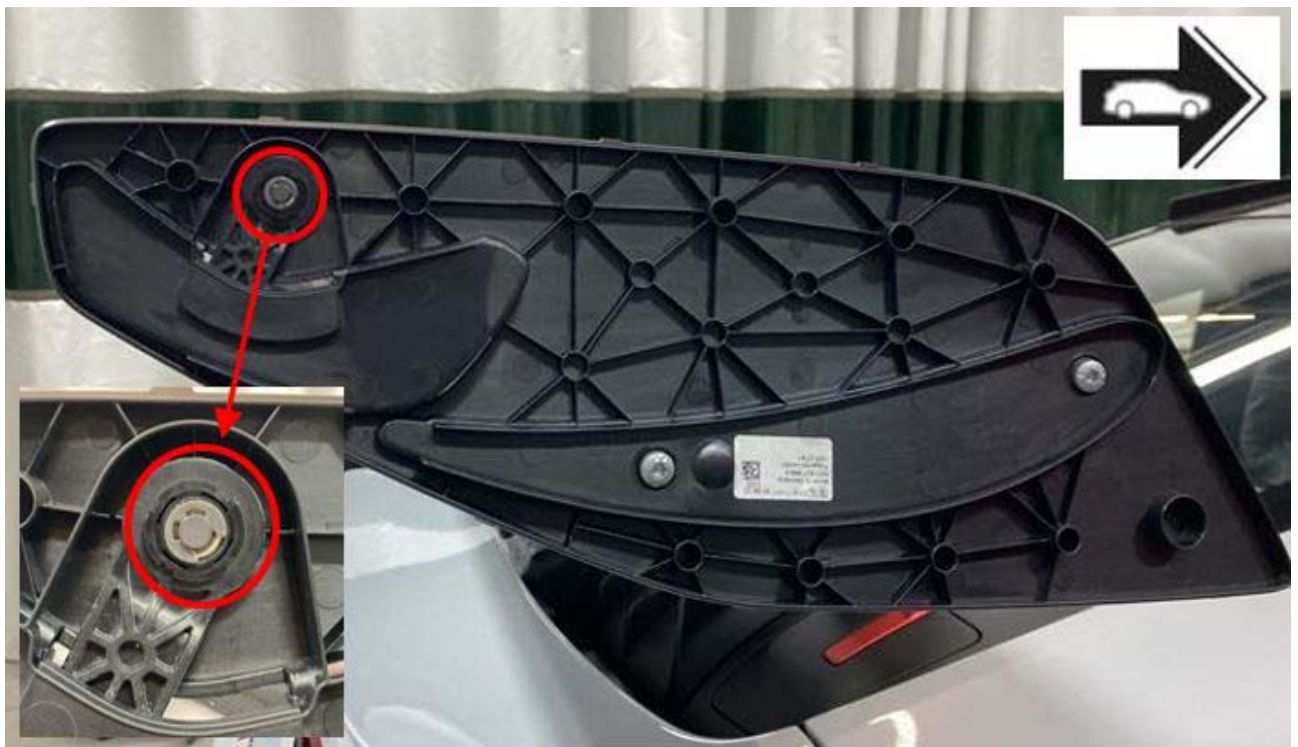
Circlip installation position - right side cover shown

- 3.2 Replace circlips on the outer left and right wing. One circlip must be replaced on each outer side of the wing.

If one or both bearing pins are missing from the side covers, retrofit the corresponding bearing pins and circlips. Invoice the bearing pins via a reimbursement claim.

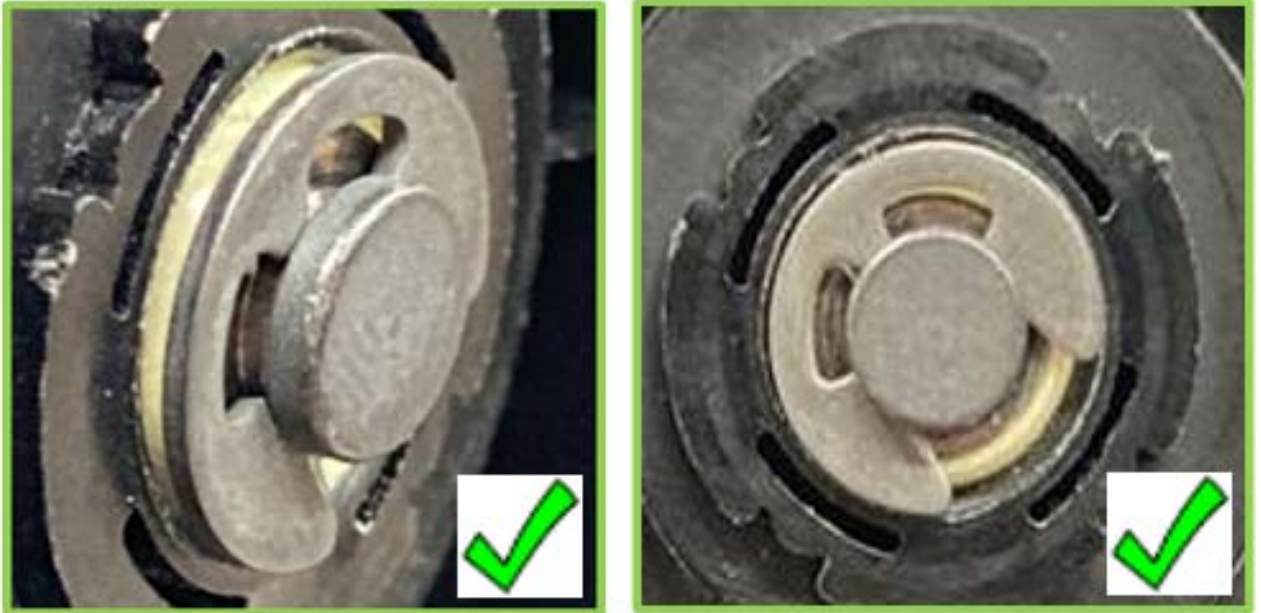
After fitting the new circlips, it is essential to check that they are installed correctly. The circlips must be in the groove.

Example: Correct circlip installation
