Technical product information

Topic	New Continental GT / GTC and New Flying Spur - Exhaust Flap - Diagnostic Trouble Code
Market area	Russische Föderation (5RU),Australia E04 Bentley rest Asia and Australia (6E04),China 796 VW Import Comp. Ltd (Vico), Beijing (6796),Germany E02 Bentley rest Europe (6E02),Japan E03 Bentley Japan (6E03),Korea, (South) E08 Bentley South Korea (6E08),United Arab Emirates E06 Bentley Middle East and Africa (6E06),United Kingdom E01 Bentley UK (6E01),United States E05 Bentley USA and rest America (6E05)
Brand	Bentley
Transaction No.	2060432/6
Level	EH
Status	Approval
Release date

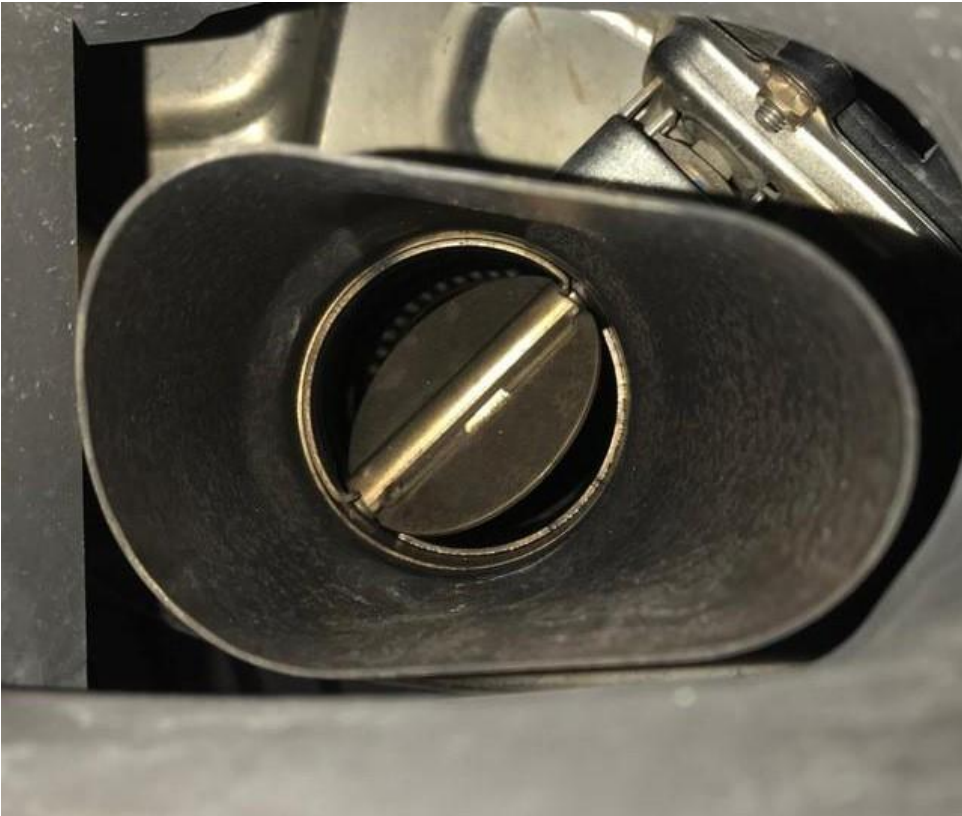
If an Exhaust Flap is stuck in an open, closed, partially closed position or does not achieve a full range of motion continue to follow the instructions within this Technical Product Information (TPI) document - Figure 2

Remove the suspected Exhaust Flap Control Unit – Refer to **Repair Group. 26 Exhaust system – Exhaust flap control units (J883, 945) – To remove and fit**

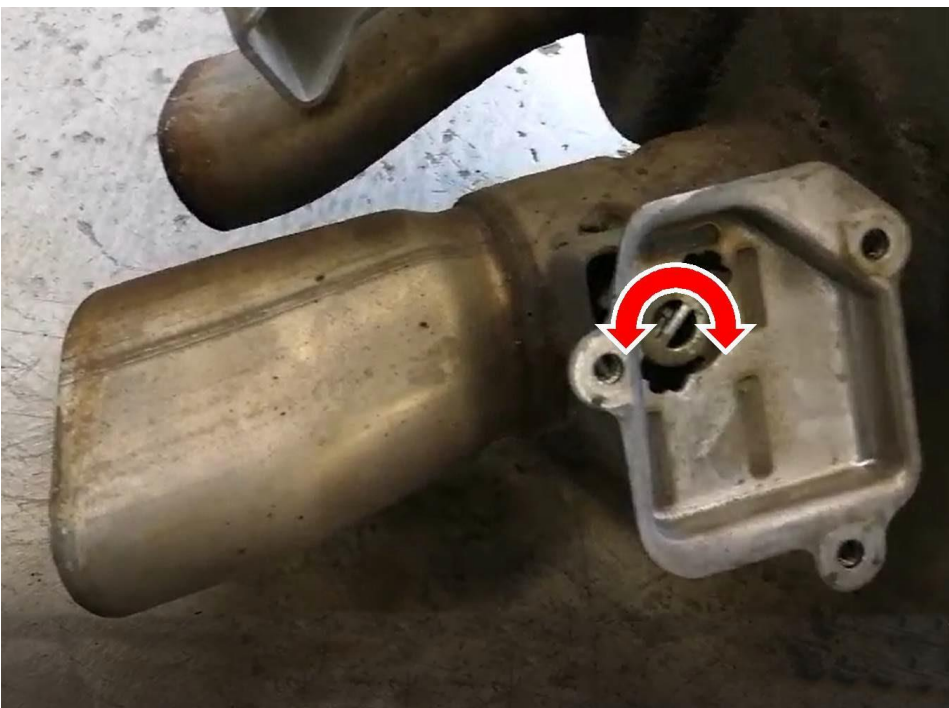
Check and confirm the Exhaust Flap spindle is free to open and close by hand - Figure 3

If no issue is evident and the Exhaust Flap oscillates freely by hand - replace the defective Exhaust Flap Control Unit, refer to **Repair Group. 26 Exhaust system - Exhaust flap control units (J883, 945) - To remove and fit**
