# **Technical product information**

Bentley dynamic ride system warning displayed - DTC P0B2500: Hybrid/EV Battery "A" Voltage low' stored (48 volt system)

Transaction No.: 2068946/2

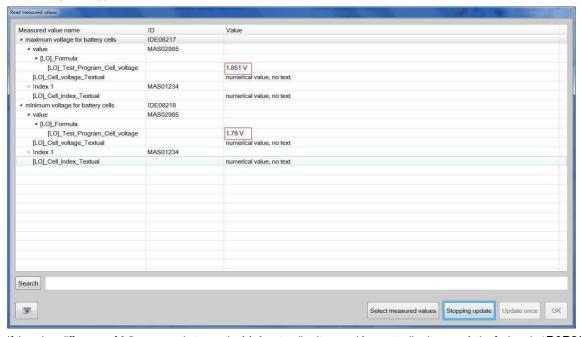
Possible internal fault with super capacitor, refer to the Measure section of this TPI

Read the following MVB's to check the difference between the highest cell voltage and the lowest cell voltage.

21-Battery Energy Control Module 2 -→ MVB -→ IDE08217 and IDE8218

If there is a difference of 0.5v or more between the highest cell voltage and lowest cell voltage and the fault code 'POB2500: Hybrid/EV Battery "A" Voltage low' is stored in address 21-Battery Energy Control Module 2 - Referring to the applicable Rep. Gr 93 - Replace the Super capacitor
