TECHNICAL SERVICE BULLETIN

Classification: HA23-004A	Reference: NTB23-032A	Date: May 11, 2023
------------------------------	--------------------------	-----------------------

HVAC BLOWER DOES NOT OPERATE ON COLD STARTS

APPLIED VEHICLES: 2021-2023 Rogue (T33)

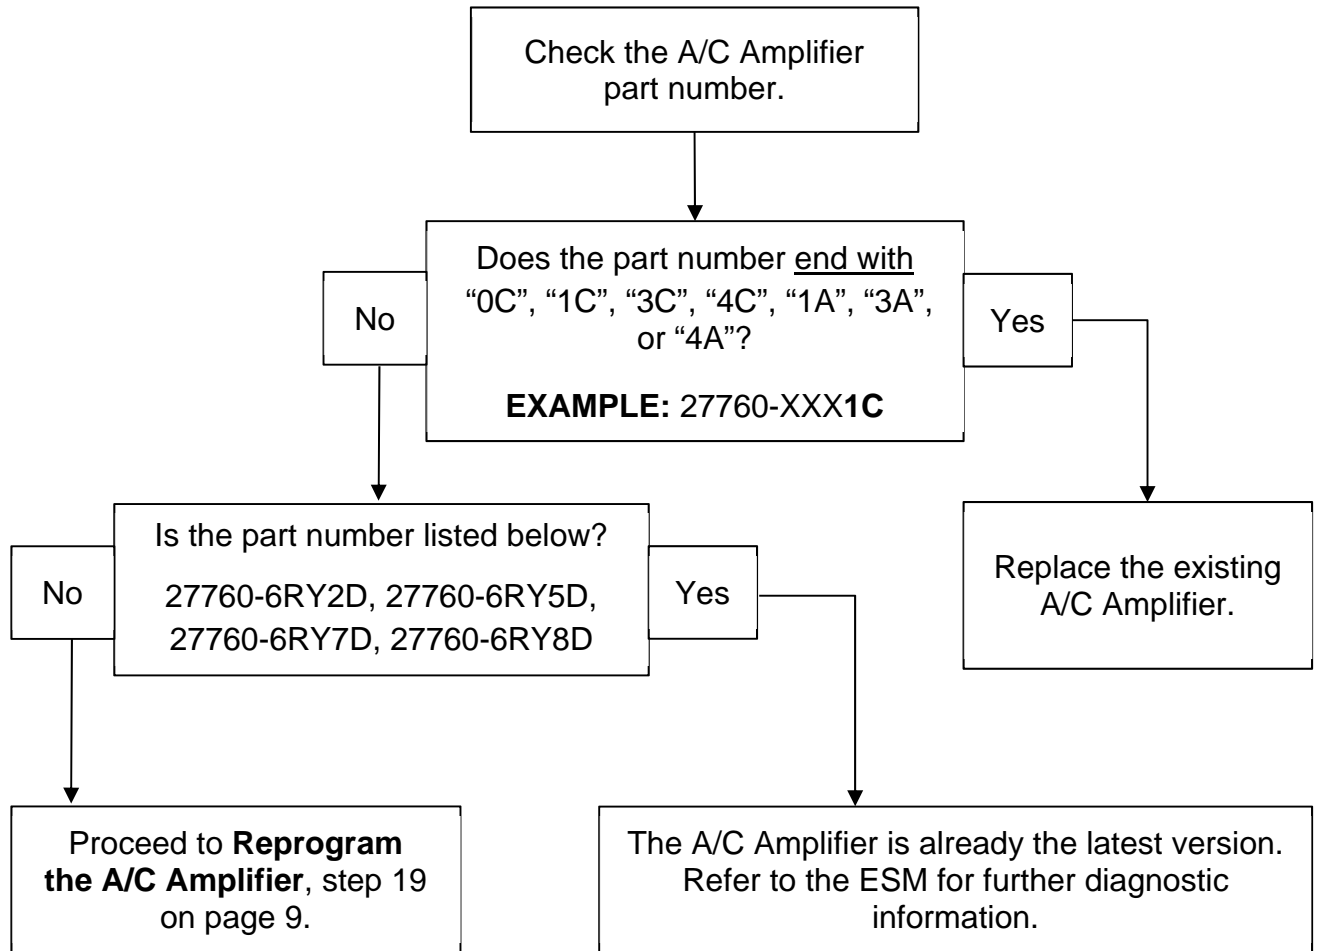
Part Number Inspection

17. Are the last two (2) characters of the part number "0C", "1C", "3C", "4C", "1A", "3A", or "4A"?

18. Is the part number 27760-6RY2D, 27760-6RY5D, 27760-6RY7D, or 27760-6RY8D?

YES: Replace the A/C Amplifier.

YES: The A/C Amplifier is already the latest version. Refer to the ESM for further diagnostic information.

NO: Proceed to step 19 on page 9 to perform **Reprogram the A/C Amplifier**.

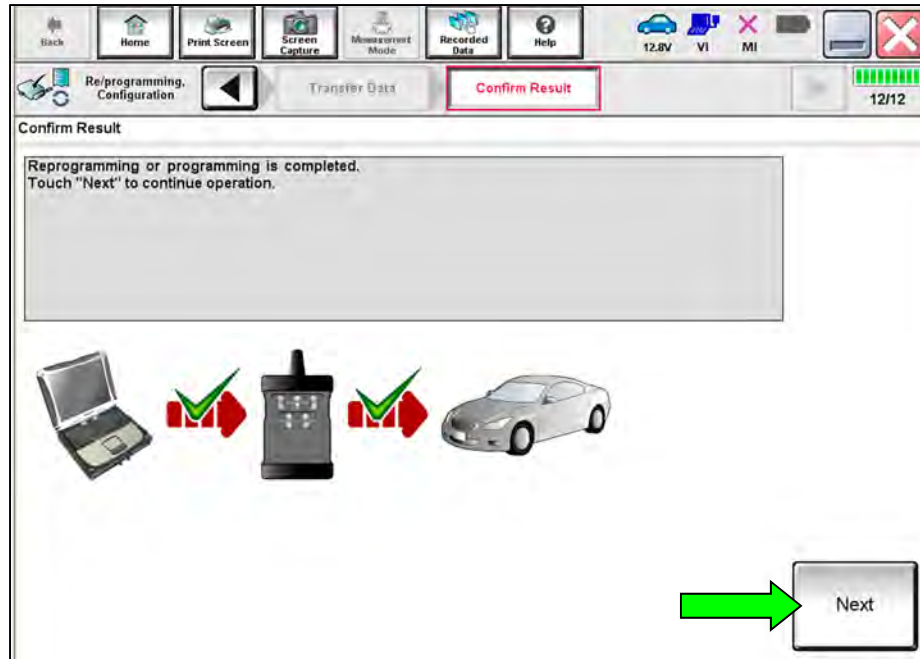
HINT: When the screen in Figure 11 displays, A/C Amplifier reprogramming is complete. If the screen in Figure 11 does not display (indicating that reprogramming did not complete), refer to the information on the next page.

21. Follow the on-screen instructions to perform **Erase All DTCs**.
22. Print a copy of the confirmation screen and attach it to the repair order for warranty documentation, and then select **Confirm**.

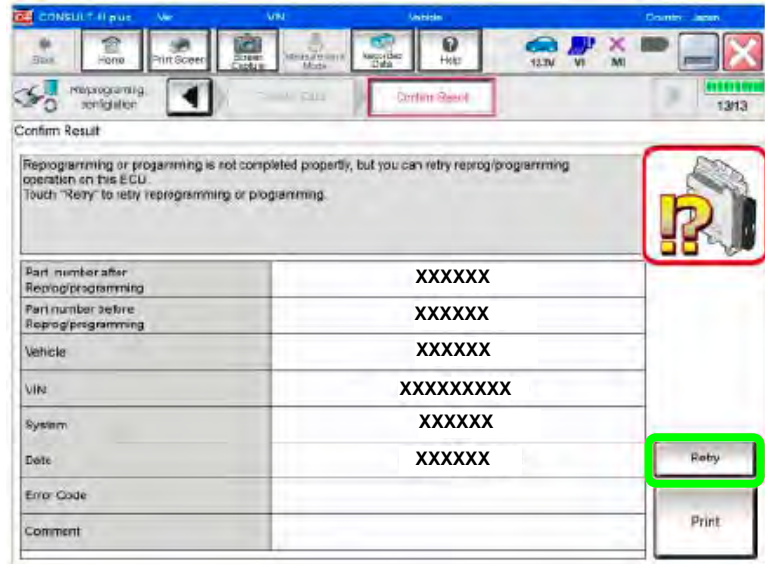
Figure 12

If reprogramming does not complete, and the “!?” icon displays as shown in Figure 12:

- Check battery voltage (12.0 V – 15.5 V).
- Ignition is ON, engine is OFF.
- External Bluetooth® devices are OFF.
- All electrical loads are OFF.
- Select retry and follow the on screen instructions.
- “Retry” may not go through on first attempt and can be selected more than once.

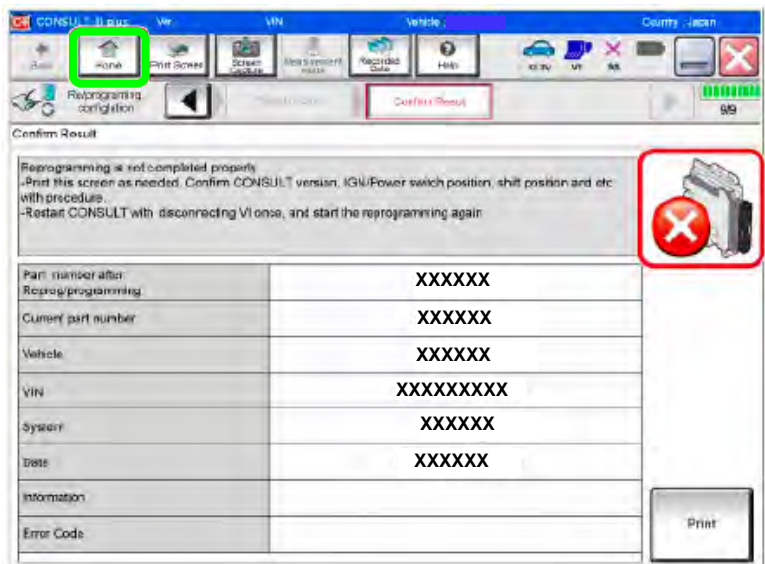
Figure 13

If reprogramming does not complete, and the “X” icon displays as shown in Figure 13:

- Check battery voltage (12.0 V – 15.5 V).
- CONSULT A/C adapter is plugged in.
- Ignition is ON, engine is OFF.
- Transmission is in Park.
- All C-III plus / VI cables are securely connected.
- All C-III plus updates are installed.
- Select Home, and restart the reprogram procedure from the beginning.
