Preliminary Information

PIP5921 Diagnostic Tip: Possible No Start, Engine Noise Or SES Lamp with DTC P0011 P0016 Current Or History

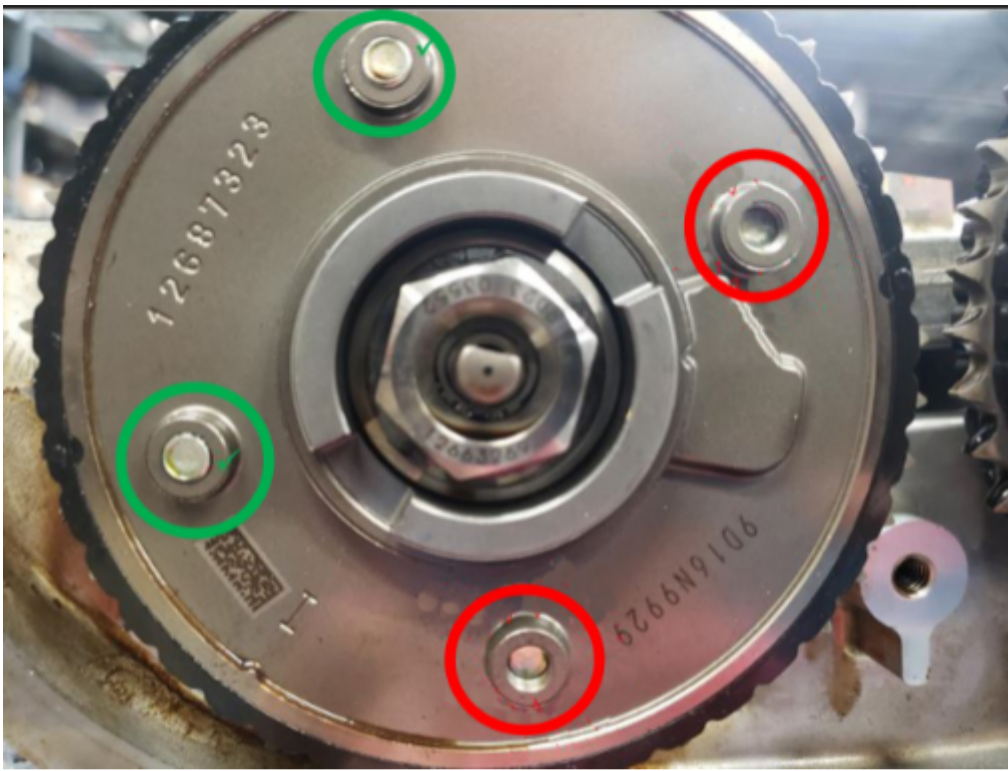
Picture below showing front side of Intake Cam Actuator. Circled in green and red are the actuator screws. Note: Circled in red the threaded portion of the screws are below the surface indicating these are loose and have likely made contact with the Cam Carrier face.

If the Cam Carrier face is not damaged and there is no abnormal metal in the engine oil then replace the Intake Cam Actuator, any necessary components and change engine oil and filter.

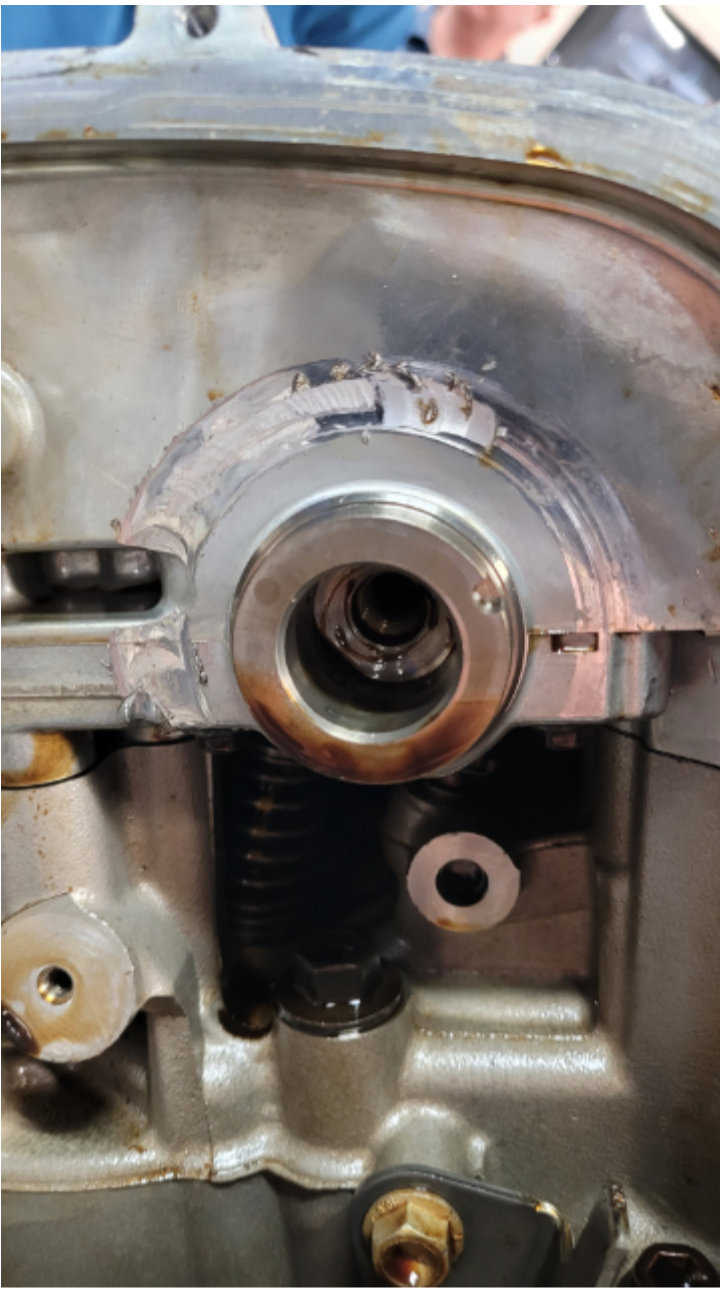
Picture below showing damage done to front face of Cam Carrier when the Intake Cam Actuator cover plate screws come loose and make contact.

If the Cam Carrier face has been damaged from an Intake Cam Actuator cover plate screw backing out then replacement of the engine assembly and turbocharger will be recommended due to metal debris in the engine from Cam Carrier face.

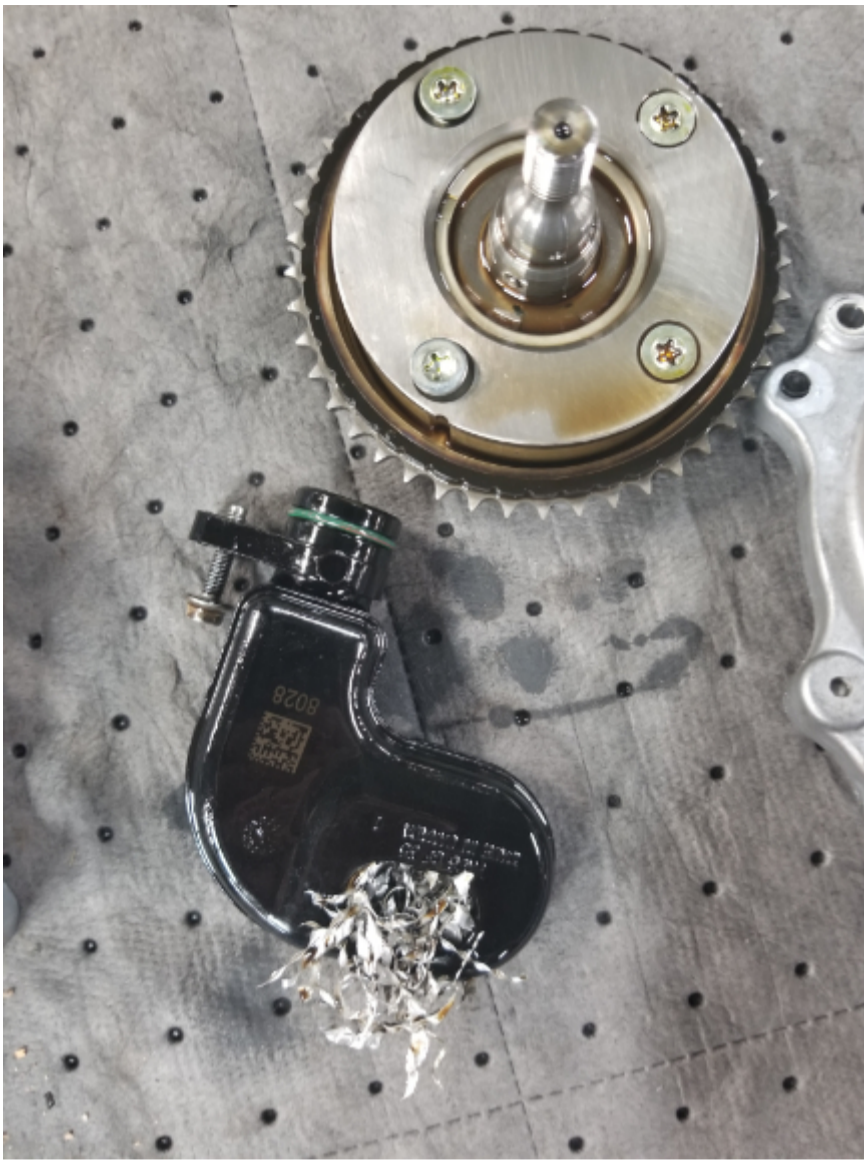
Picture below showing torx screws on the Intake Cam Actuator that have come loose and the amount of aluminum debris in the pick up tube that's possible when the screws contact the Cam Carrier face.
