Tech Tips

TT 72-12-02

Date: November 2, 2012

2011-2012 Touareg – Front Seat Backrest is in a Different Position When Re-entering the Vehicle

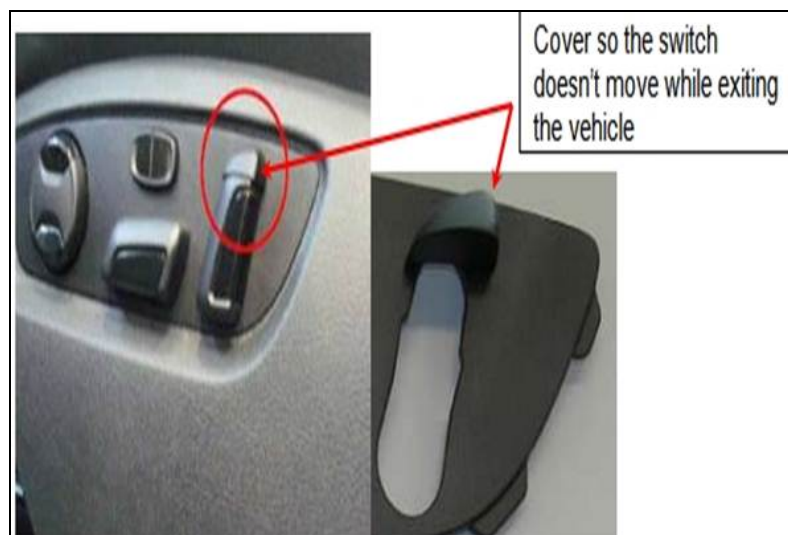
Customer concern of seat backrest in a different position when re-entering the vehicle may be caused by customer contacting backrest adjustment switch while exiting the vehicle. To prevent contact with switch, install updated switch trim panel with added cover over backrest adjustment switch as shown below. Be aware that the trim panel part number is based on vehicle trim level. Part numbers are as follows.

7P6.882.515E (driver side) / 7P6 882 516E (passenger side) Sport trim level

7P6.882.515D (driver side)/ 7P6 882 516D (passenger side) Lux, Executive and Hybrid trim levels
