June 2, 2023

Version 2

Accord CAN Gateway Errors DTC B2B05-92 and Code K201

Supersedes 23-045, dated May 23, 2023, to revise the information highlighted in **yellow**.

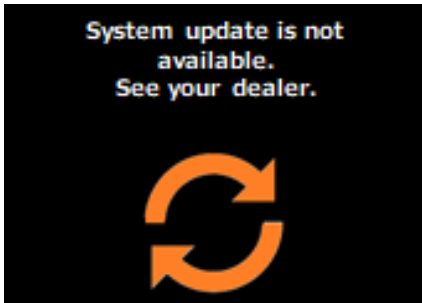
In all trims, the message “System update is not available. See your dealer” may appear in the gauge. When i-HDS is used to perform an All DTC Scan, the DTC B2B05-92 will be returned.

A software issue in the Telematics unit causing the error to occur. Under certain conditions, if the Power Mode is set to Off while a software update is preparing for installation, the DTC and Code can appear.

Restart the OTA System, then update the Telematics unit to the latest software version. If the software is up to date, and the DTC returns, follow the trouble shooting steps for DTC B2B05-92.

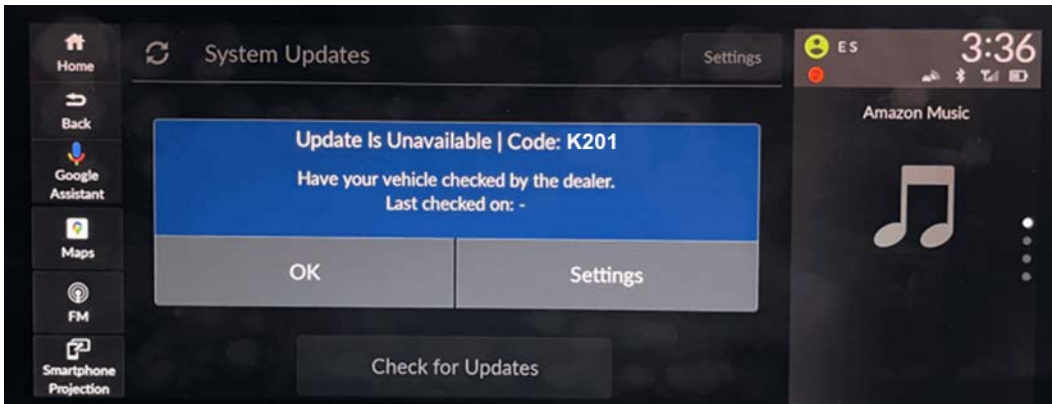
In Hybrid trims, the audio unit may also display Code K201.
