Service Bulletin

Bulletin No.: 23-NA-074

Subject: Service Engine Soon (SES), Reduced Power, Service Brake, Reduced Steering and/or Stabilitrak Message Illuminated on Driver Information Center (DIC), DTCs P0232, P023F, P0641, P0651, P06A3, P0697, P07BE, P1000, P1009, P2535, P129D, P12A6, P12A8, P2635, P3051, P3052, P3055, P3056, P305B, U0074, U0077, U0121, U0131, U0151, U0415, U0420, U0672, U111A, U18A2, U18C6, U18D2, U2502, U2616 Set

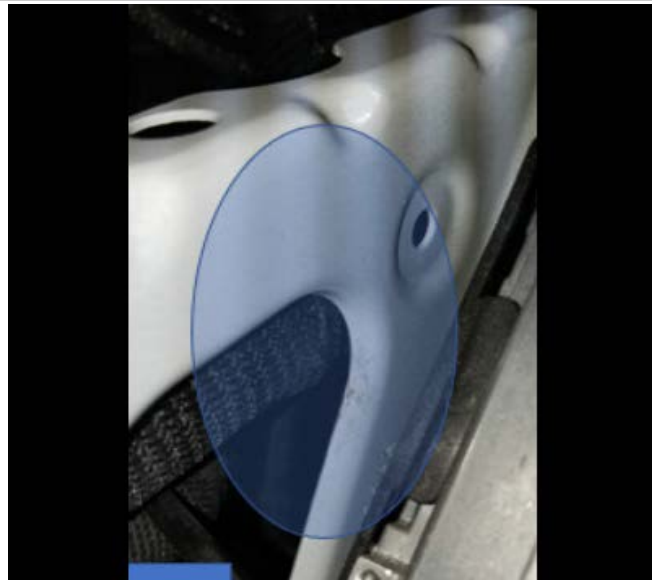
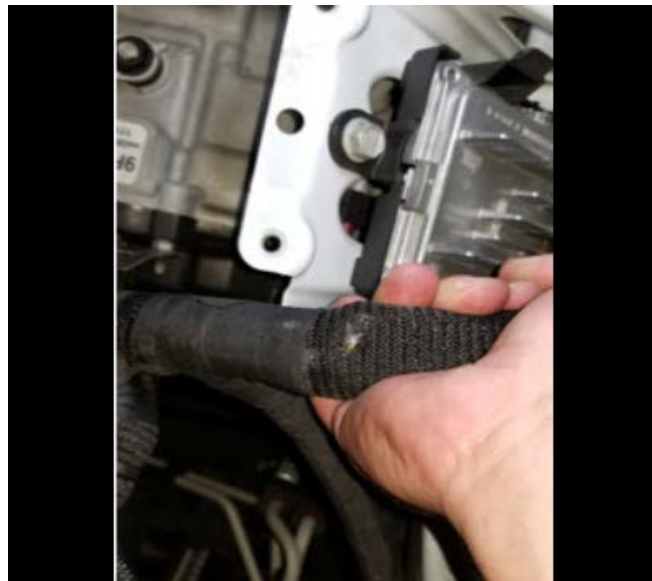
This condition may be caused by wire chafing on the battery tray support bracket.
