Service Bulletin

Bulletin No.: 21-NA-049

Subject: Diagnostic Aid – PicoScope Information and Setup for Transmission Related Concerns

Brand:	Model:	Model Year:		VIN:		Engine:	Transmission:
		from	to	from	to		
Chevrolet	Corvette	2020	2023	—	—	All	All

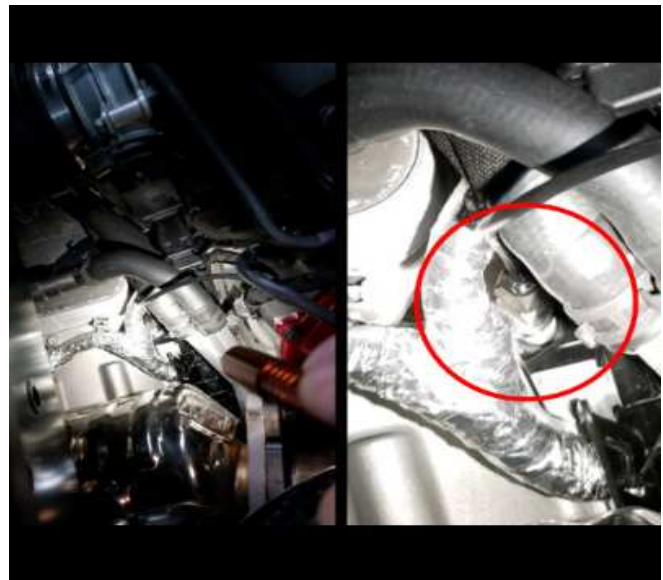
5751814

1. Place the PicoScope sensor on the bolt head shown in the image above. This is located on the right side of the transmission, near the transmission cooler. This bolt is used to secure a bracket for the wire harness. The sensor cable can be run into the passenger compartment with the engine compartment closed.

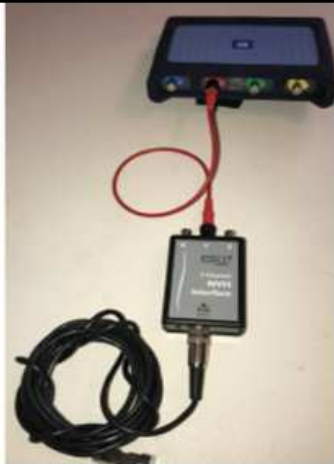
5751816

3. After completing the wizard, go back into the setup tab under Vibration Signal and select Single Channel. Select TA148 Interface in the “Box” dropdown and TA144 Microphone for the “Sensor” Drop down. Select the Location as Engine Compartment. Set the Diff Ratio to 3.55.

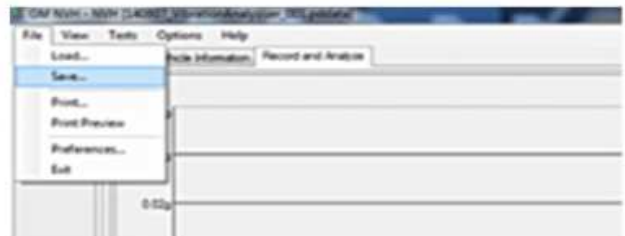
5751819

5. While the reviewed file is on the screen, click File Save. It should be formatted as .pddata

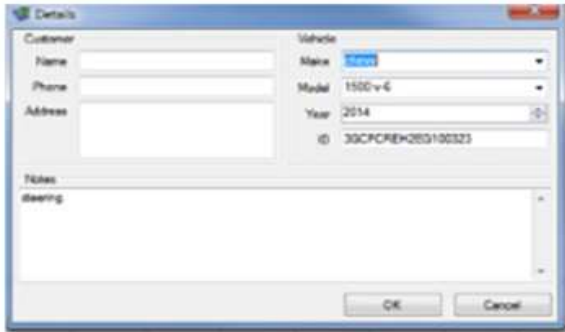
5751820

6. The next box allows you to save the vehicle information as well as customer information and notes in the Notes box. This could be sensor location, sensor direction and even road surface name, etc. Click Ok when you are done adding information.
7. If PICO scope data shows readings under 85 decibels, vehicle noise is deemed as a normal characteristic.
8. Create an e-mail to TACSNAPSHOT@gm.com in the U.S. and TACSNAPSHOTCANADA@gm.com in Canada and in the subject line Put Vibration, your BAC, and last 8 of the VIN.
