Technical Bulletin

46 13 02 April 19, 2013 **2015173** Supersedes T. B. V461005 dated October 25, 2010 to remove Canadian market and include additional models and model year applicability.

Brake Disc, Pulsation, All Vehicles except Routan (U.S. Only)

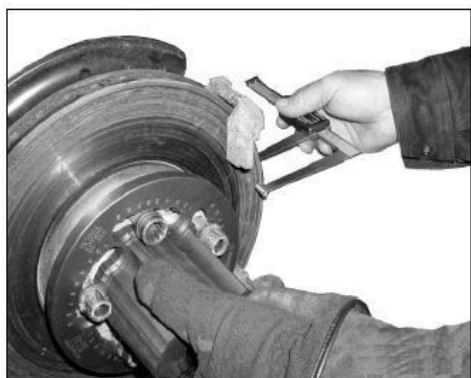
- Inspect brake disc friction surfaces on both sides of the brake disc for:
 - Severe discoloration (bluing)
 - High heat surface damage (raised hard spots)
 - Visible cracks

Brake discs showing any of the above described conditions **MUST** be replaced.

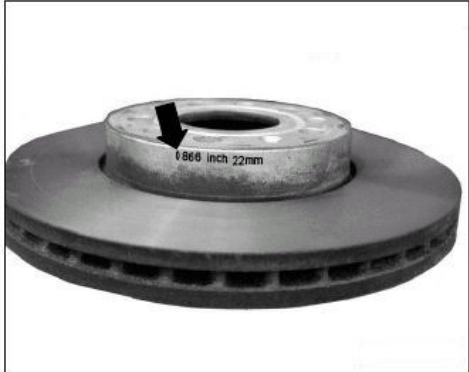
- Measure the brake disc thickness in 4 locations using either the Pro Cut International™ disc thickness measuring tool Part No. 50-902 or the Hunter Engineering Company disc thickness measuring tool Part No. 25-99-2 . Measurements **MUST** be taken the same distance from the brake disc outer circumference to ensure consistency.

The brake disc thickness measurement must exceed the minimum thickness specification after the machining process is completed in order to be reused.

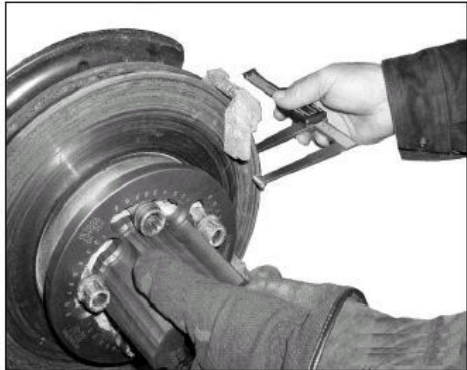
- Re-measure brake disc thickness in 4 locations using either the Pro Cut disc thickness measuring tool Part No. 50-902 or the Hunter disc thickness measuring tool Part No. 25-99-2, to verify that minimum thickness is still exceeded. If recorded brake disc measurement is less than the minimum thickness, the brake disc **MUST** be replaced.

Always replace brake discs in pairs (front axle or rear axle).

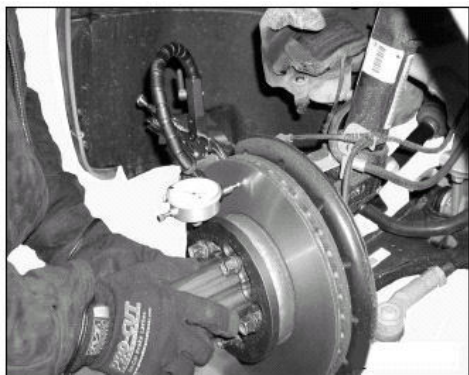
- Measure brake disc lateral run out using Pro Cut Disc Lateral run out measuring kit Part No. 50-700FC or the Hunter Disc Lateral run out measuring kit Part No. 25-128-2 with a dial indicator.
- Run out must not exceed 0.1mm.
