Technical Bulletin

46 13 03 May 22, 2013 2015173 Supersedes T. B. V461302 dated April 19, 2013 to update rear disc brake turn labor operation in warranty table.

Brake Disc, Pulsation, All Vehicles except Routan (U.S. Only)

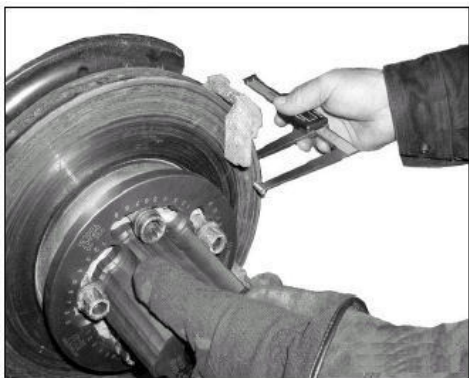
- Inspect brake disc friction surfaces on both sides of the brake disc for:
- Severe discoloration (bluing)
- High heat surface damage (raised hard spots)
- Visible cracks

Brake discs showing any of the above described conditions **MUST** be replaced.

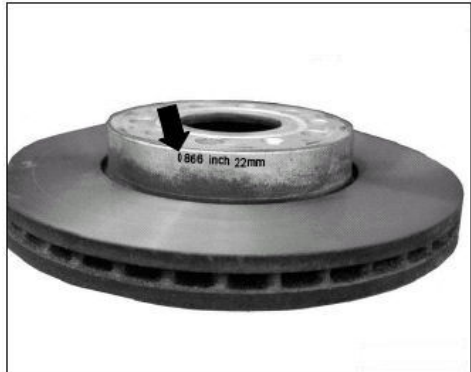
Disc Thickness Measuring

Each brake disc has the minimum allowed thickness cast, stamped or laser-etched into the disc hub.

- Measure the brake disc thickness in 4 locations using either the Pro Cut International™ disc thickness measuring tool Part No. 50-902 or the Hunter Engineering Company disc thickness measuring tool Part No. 25-99-2 . Measurements **MUST** be taken the same distance from the brake disc outer circumference to ensure consistency.

The brake disc thickness measurement must exceed the minimum thickness specification after the machining process is completed in order to be reused.

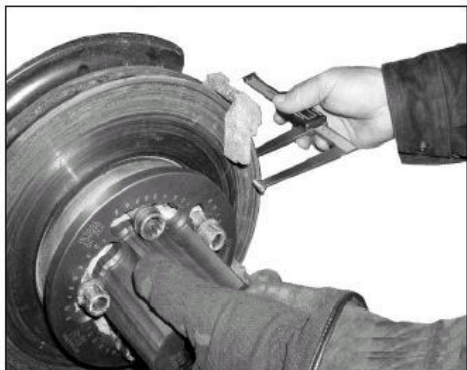
- Re-measure brake disc thickness in 4 locations using either the Pro Cut disc thickness measuring tool Part No. 50-902 or the Hunter disc thickness measuring tool Part No. 25-99-2, to verify that minimum thickness is still exceeded. If recorded brake disc measurement is less than the minimum thickness, the brake disc **MUST** be replaced.

Always replace brake discs in pairs (front axle or rear axle).

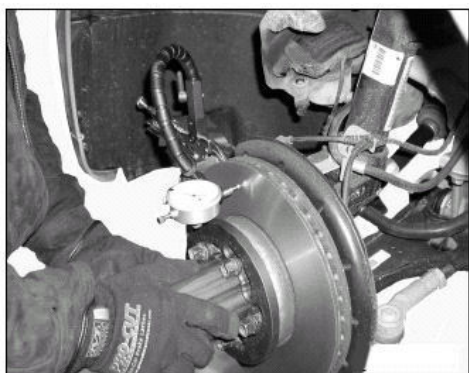
- Measure brake disc lateral run out using Pro Cut Disc Lateral run out measuring kit Part No. 50-700FC or the Hunter Disc Lateral run out measuring kit Part No. 25-128-2 with a dial indicator.
- Run out must not exceed 0.1mm.
