Technical Bulletin

Model(s)	Year	Eng. Code	Trans. Code	VIN Range From	VIN Range To
Passat Wagon	1998 – 2005	All	All	All	All

55 14 07 December 16, 2014 2038993

Corrosion on Rear Lid at Rear Window Area

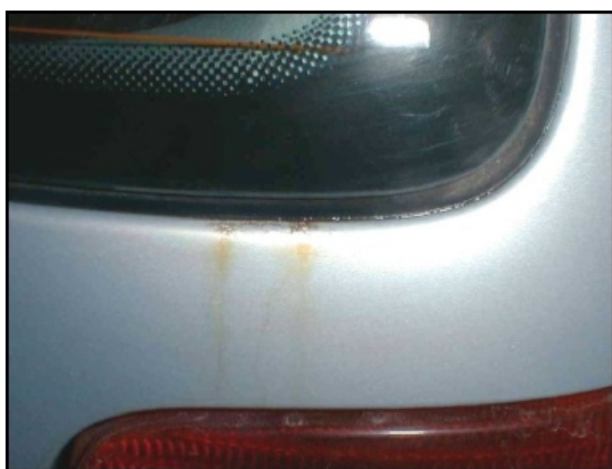
Figure 1

When the rear window heater is switched ON, power is transmitted to the outer sealing lip of the rear window. In some places the window sealer makes contact with the bus bar of the rear window heater.

1a. Repair rear lid and replace rear window Only perform this operation if the total repair cost is 80% or less of the total replacement cost.

1b. replace rear lid and replace rear window

Install a new rear glass in every case, since the complete removal of the sealer from the bus bar cannot be guaranteed. Use sealer part number DH 009 100 03 or DA 004 600 A2 - for sealing the window.

To avoid repeat cases make sure that no sealer gets on the bus bar of the rear window. Cover the bus bar with masking tape during installation and remove the tape after sealing.
