SIB 51 08 23

DIAGNOSIS RESOURCE: CREAKING SOUND FROM EXT MIRROR ASSEMBLY WHEN FOLDING IN/OUT

F95 (X5 M Sports Activity Vehicle)	F96 (X6 M Sports Activity Coupe)	F97 (X3 M Sports Activity Vehicle)	F98 (X4 M Sports Activity Coupe)
G01 (X3 Sports Activity Vehicle)	G02 (X4 Sports Activity Coupe)	G05 (X5 Sports Activity Vehicle)	G06 (X6 Sports Activity Coupe)
G07 (X7 Sports Activity Vehicle)	G09 (XM Sports Activity Coupe)

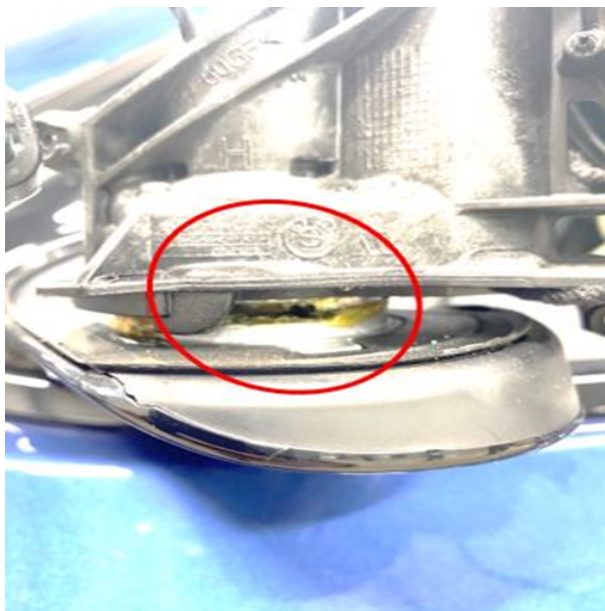
Debris trapped inside of the exterior mirror assembly pivot area.

5. Clean and remove any debris from the mirror assembly.

Note: Compressed air can be used.
