Technical Service Bulletin

42 Booming noise from rear area while vehicle is moving (depending on vehicle speed/wheel speed) DTC P18F100

42 23 52 2068250/2 June 6, 2023. Supersedes Technical Service Bulletin Group 42 number 22-50 dated November 4, 2022, for reasons listed below.

Model(s)	Year	VIN Range	Vehicle-Specific Equipment
Q4 e-tron, and Q4 Sportback e-tron	2022 – 2024	All	Not Applicable

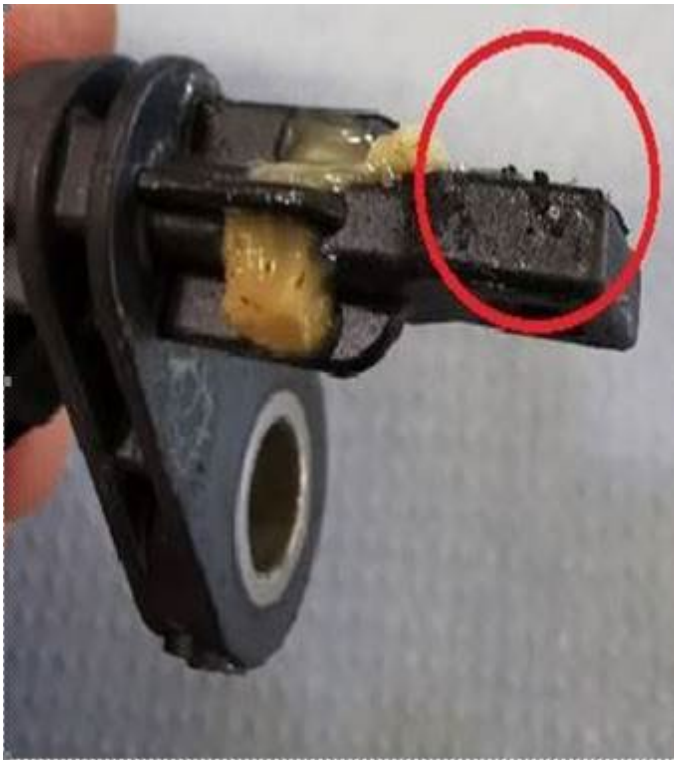
Foreign metallic particles in the area of the wheel speed sensor/wheel hub/wheel bearing/drive shaft (see figure 1, red circle) lead to implausible wheel speed signals.

Figure 2: *Metallic particles in the speed sensor.*

- a. Thoroughly remove foreign metallic particles from the components with workshop materials.

Note: Do not use magnetic tools to remove metallic particles from components.

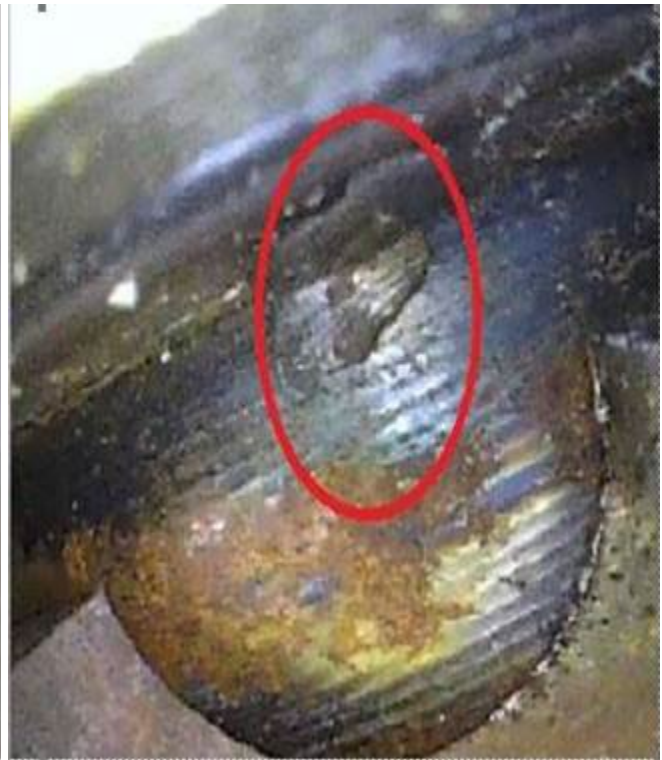
Figure 3: *Metallic particles in the hub.*

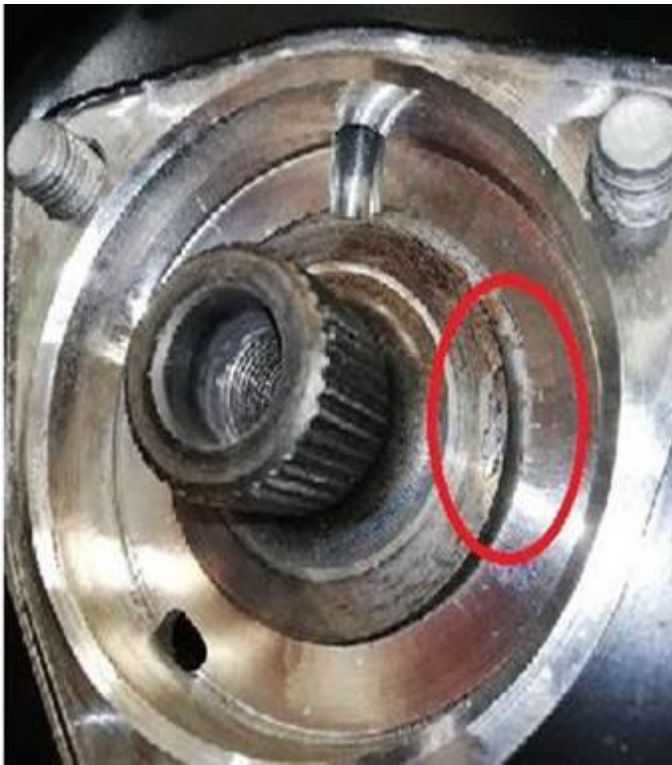
Figure 4: Metallic particles/damage in the wheel hub/bearing.

- a. If there is damage to the components, replace them according to the Repair Manual (only if necessary).
- b. Delete all DTCs.

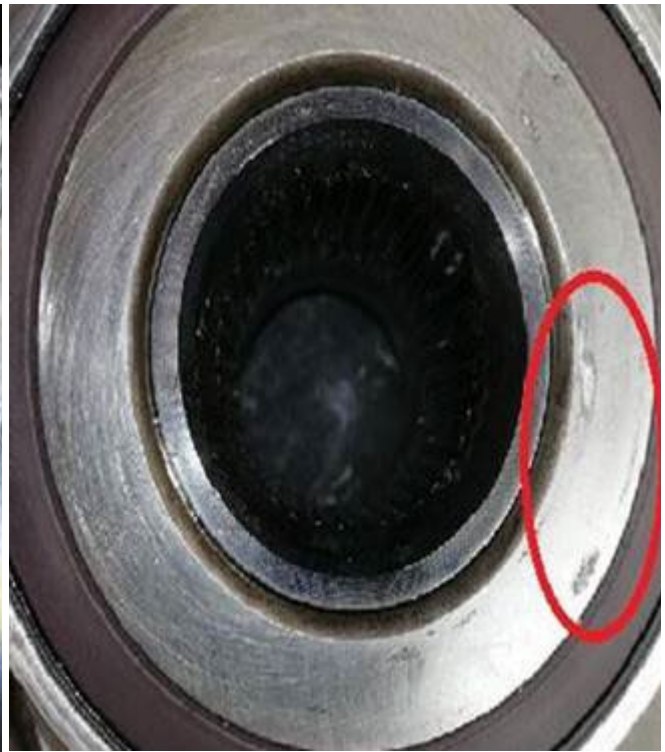
Figure 5: Metallic particles/damage in the wheel hub/bearing.
