GLOBAL SAFETY FIELD INVESTIGATIONS DCS6609 URGENT - DISTRIBUTE IMMEDIATELY

- Subject: N232408020 Customer Satisfaction Program Missing Front License Plate Bracket
- Models: 2023 Chevrolet Blazer Equipped with License Plate Front-Frt Mounting Pkg (RPO VK3)
- To: All General Motors Dealers

N232408020 Missing Front License Plate Bracket

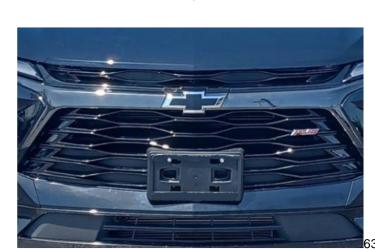
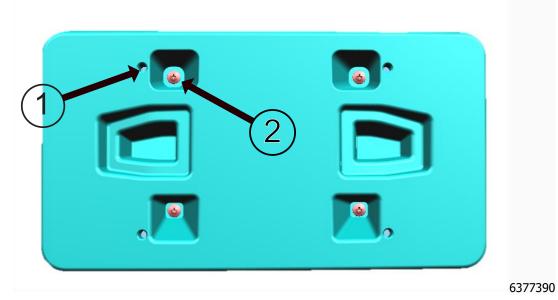
6376233

Condition	Certain 2023 model year Chevrolet Blazer vehicles may have been shipped from the assembly plant without the front license plate bracket.	
- [Correction	Dealers will install the front license plate breaket

- 1. Center license plate bracket with the middle of the front emblem at the bottom of the upper grille.
- 2. While holding the bracket in place, install the 4 self-tapping screws (2) in the bracket to the grille.
- 3. Be sure the 4 bolts (1) for securing the license plate are either installed on the bracket or given to the customer.
