Technical Service Bulletin

90 Driver Assist Systems various improvements (DTC C12D5FA, B200FF9, B107A16, intersection assist arrows flicker)

90 23 29 2069244/2 June 12, 2023. Supersedes Technical Service Bulletin Group 90 number 23-99 dated February 2, 2023, for reasons listed below.

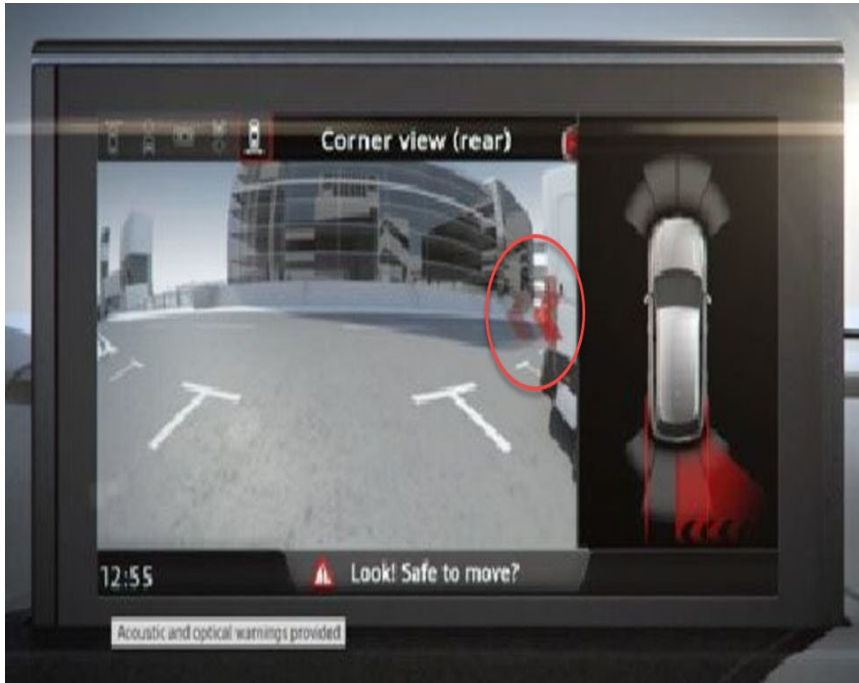
- The intersection assist arrows flicker for a short period after the vehicle has started (figure 1).

Figure 1: RCTA/Intersection assist arrows.

The complaints listed have been observed with prior versions of the control unit software.

1. Follow all instructions in TSB 2011732: *00 Software Version Management (SVM), operating instructions.* The update may take, depending on the vehicle equipment and prior software level, between 30 and 90 minutes.
2. Update the vehicle using the SVM action code as listed in the table below, if necessary:
