Technical Service Bulletin

91 Emergency call warning in instrument cluster when out of cellular coverage U153E00

91 23 03 2070046/2 June 8, 2023. Supersedes Technical Service Bulletin Group 91 number 23-90 dated April 17, 2023, for reasons listed below.

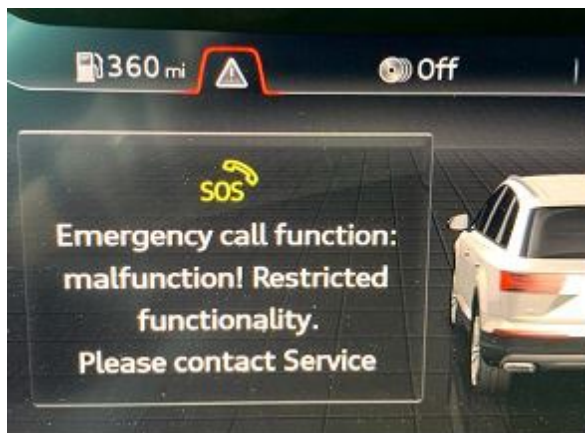
Figure 1: SOS Malfunction A4/A5/Q5

Emergency call function: malfunction! Restricted functionality. Please contact service.

The connectivity box Low logs an event memory entry after 5 unsuccessful login attempts to the cellular network (rejects from the mobile network).

Due to restrictions by the cellular network provider, it may take up to an hour for the ConBox to log back into the cellular network when it comes back into range.

1. Do not perform any repairs. Any repairs for this concern may be denied.

Instruct the customer that this condition is normal.

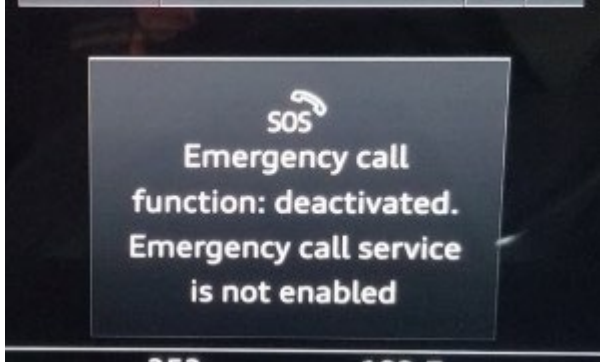
Figure 2: SOS Malfunction A6/A7/A8/Q7/Q8

Emergency call function: deactivated. Emergency call service is not enabled.

The message may not disappear until after a one-hour bus sleep when reentering cellular coverage.
