Technical Service Bulletin

40 Front shock absorber cap, cracking noises/spring jumps when steering or when maneuvering 40 23 63 2047758/11 June 29, 2023. Supersedes Technical Service Bulletin Group 40 number 23-59 dated June 6, 2023, for reasons listed below.

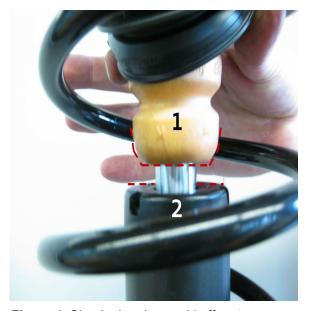
Figure 1. Shock absorber and buffer stop.

The buffer stop for the shock absorber (Figure 1, 1) can cause noises if it touches the front shock absorber cap (Figure 1, 2).

Lightly lubricate the contact surface (red dotted line) between the buffer stop for the shock absorber (Figure 1, 1) and the front shock absorber cap (Figure 1, 2) with 5 grams grease G 000 405 A2 per side.

Tip: Check the protective sleeve of the front shock absorber for correct fit, they should turn easily in the axial deep-groove ball bearing/sleeve bearing.
