HYUNDAI Technical Service Bulletin	GROUP CAMPAIGN	NUMBER 23-01-036H-1
	DATE JUNE 2023	MODEL(S) ELANTRA (CN7A) SONATA (DN8A) SANTA FE (TMA)
SUBJECT: HECU MODULE DARK CURRENT MEASUREMENT AND REPLACEMENT (SERVICE CAMPAIGN 990)

Description: Some Elantra (CN7A), Sonata (DN8A) and Santa Fe (TMA) vehicles may exhibit the Electronic Parking Brake (EPB) warning light on due to brake fluid entering the HECU electrical connector. DTC C1501 (EPB Switch Failure) may be present, but EPB performance remains unaffected. This bulletin describes the procedure to inspect, and if necessary, replace the Hydraulic Electronic Control Unit (HECU).

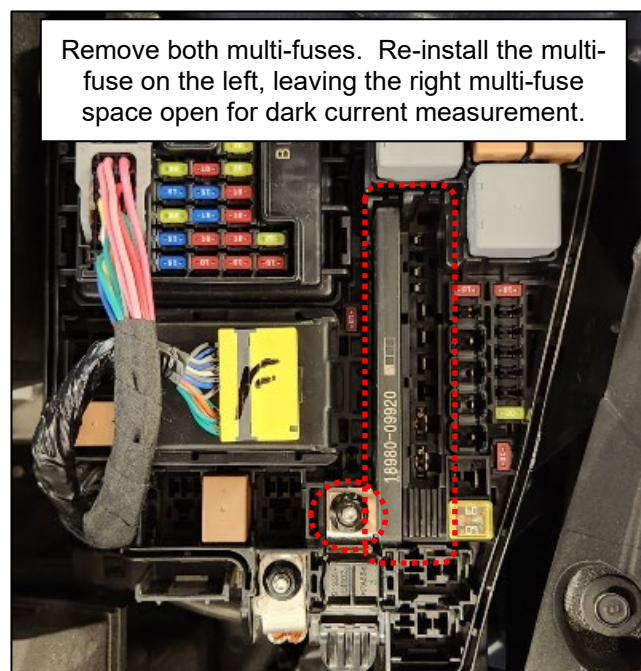
DN8A vehicles: The ABS fuse measurement location is under the right multi-fuse bar.

3. **Sonata (DN8A) vehicles:**

Remove the 10 mm multi-fuse mounting nut.

Remove both multi-fuses.

Locate the ABS fuse location in the junction box (see the *Fuse Box Measurement Point Guide*).

Re-install the multi-fuse on the left, as shown in the image.

Re-install the multi-fuse mounting nut.

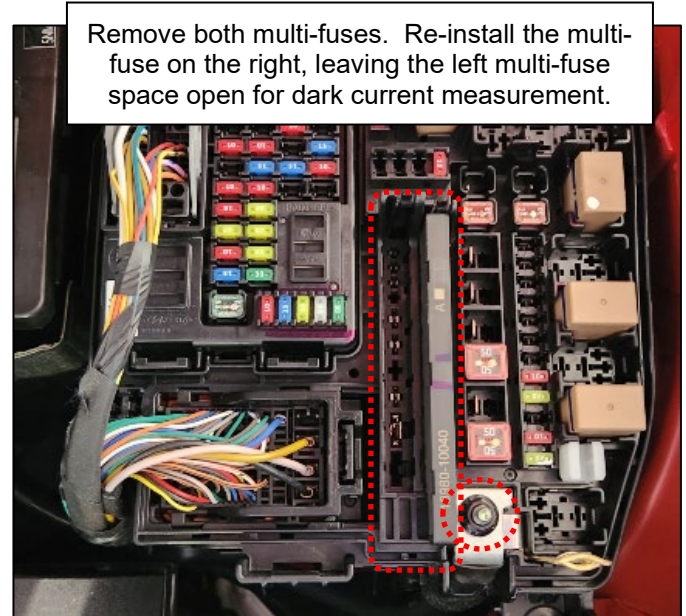
TMA vehicles: The ABS fuse measurement location is under the left multi-fuse bar.

Santa Fe (TMA) vehicles:

Remove the 10 mm nut and lift the junction cable over the stud.

Remove both multi-fuses.

Locate the ABS fuse location in the junction box (see the *Fuse Box Measurement Point Guide*).

Re-install the multi-fuse on the right, as shown in the image.

Reconnect the junction cable using the 10mm nut.

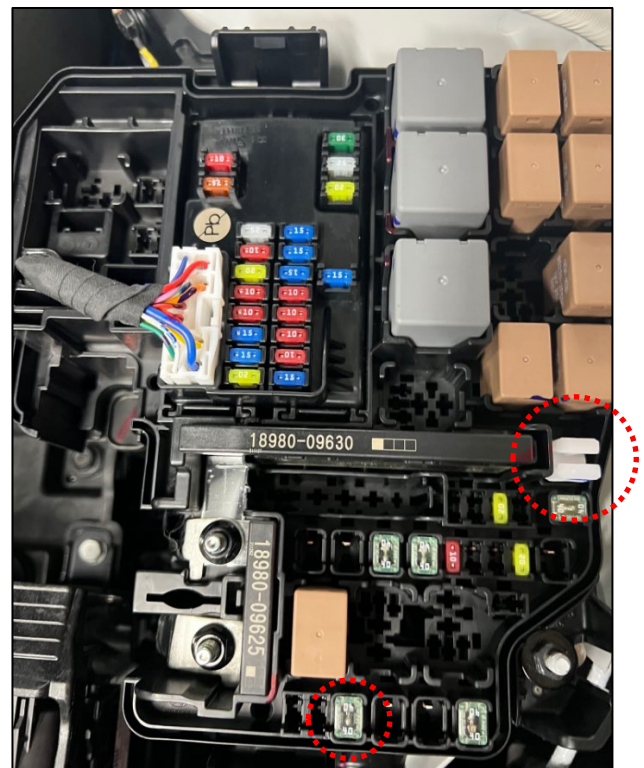
Elantra (CN7A) vehicles:

Locate the ABS fuse location in the junction box (see the *Fuse Box Measurement Point Guide*).

Use the fuse puller to remove the 40A ABS fuse.

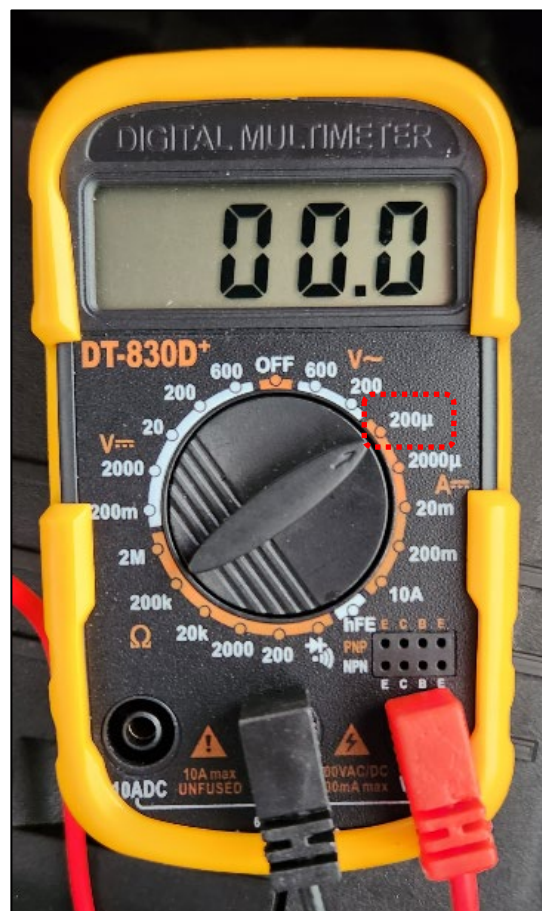
5. Set the multimeter to the 200 μ A setting.
Connect the probe leads as shown – black in the center **COM** terminal, red on the right side **V Ω mA** terminal.

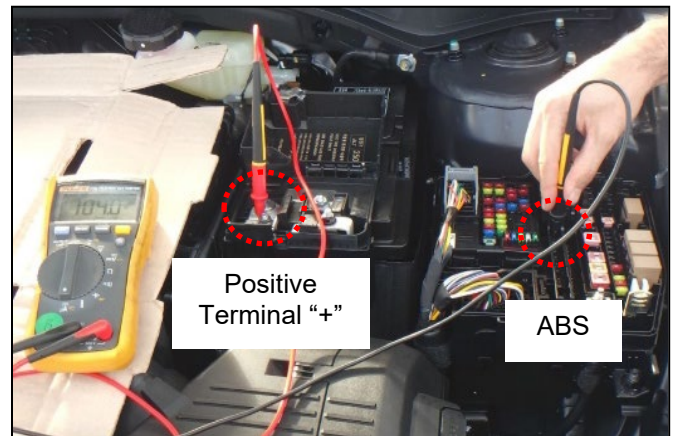
6. Contact the red lead to the positive (+) battery terminal.

Contact the black lead to the appropriate ABS fuse location (see the *Fuse Box Measurement Point Guide*).

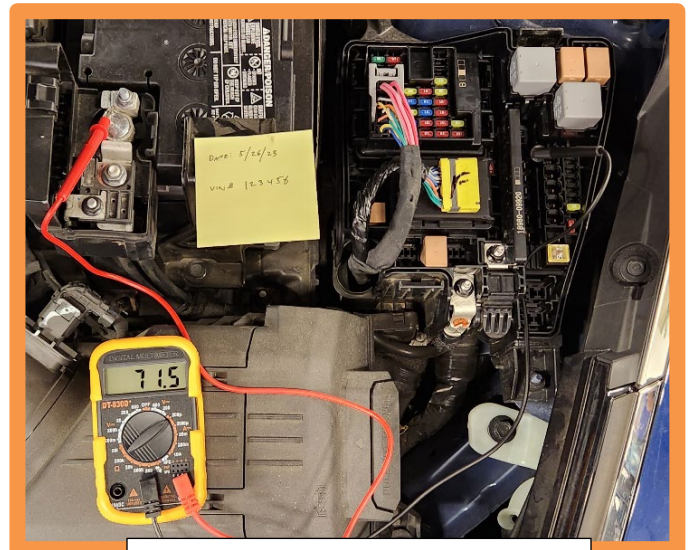
Example of STUI Photo

Using STUI, take a photo showing the multimeter dark current reading, and the open junction box. Include the last 6 digits of the VIN and the date of repair on a piece of paper.

9.
 - If current draw value is **below** the maximum dark current value as listed above in the **Service Inspection Guidance** on page 4:
 - Reinstall the removed parts in the reverse order. No further action is required.
 - If current draw value is **equal to OR over** the maximum dark current value as listed above in the **Service Inspection Guidance** on page 4:
 - Replace the Hydraulic Electronic Control Unit Assy (HECU) by referring to the shop manual.

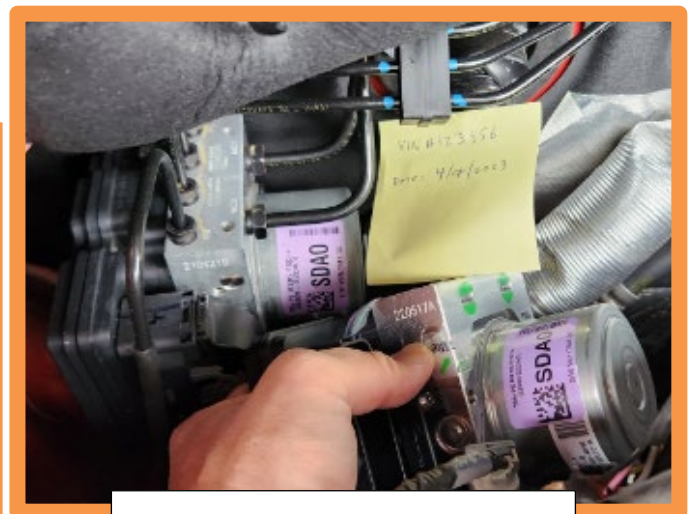
Example of STUI Photo

If HECU is replaced: Using STUI, take a photo showing the newly installed HECU, along with the removed original HECU. Include the last 6 digits of the VIN and the date of repair on a piece of paper.
