Volvo Car USA LLC

Technical Journal

Technical Journal Title		Ref. No.	
Incorrect fuel level or tank capacity		TJ 36647.1.0	
Issuer (Dept.)		Issue Date	Status Date
Technical Service		6/27/23	6/30/23
Car Market	Partner	Function Group	
United States and Canada	3 US 7510 Volvo Car USA	2341	
Function Description		Page	
Fuel tank		Page 1 of 3

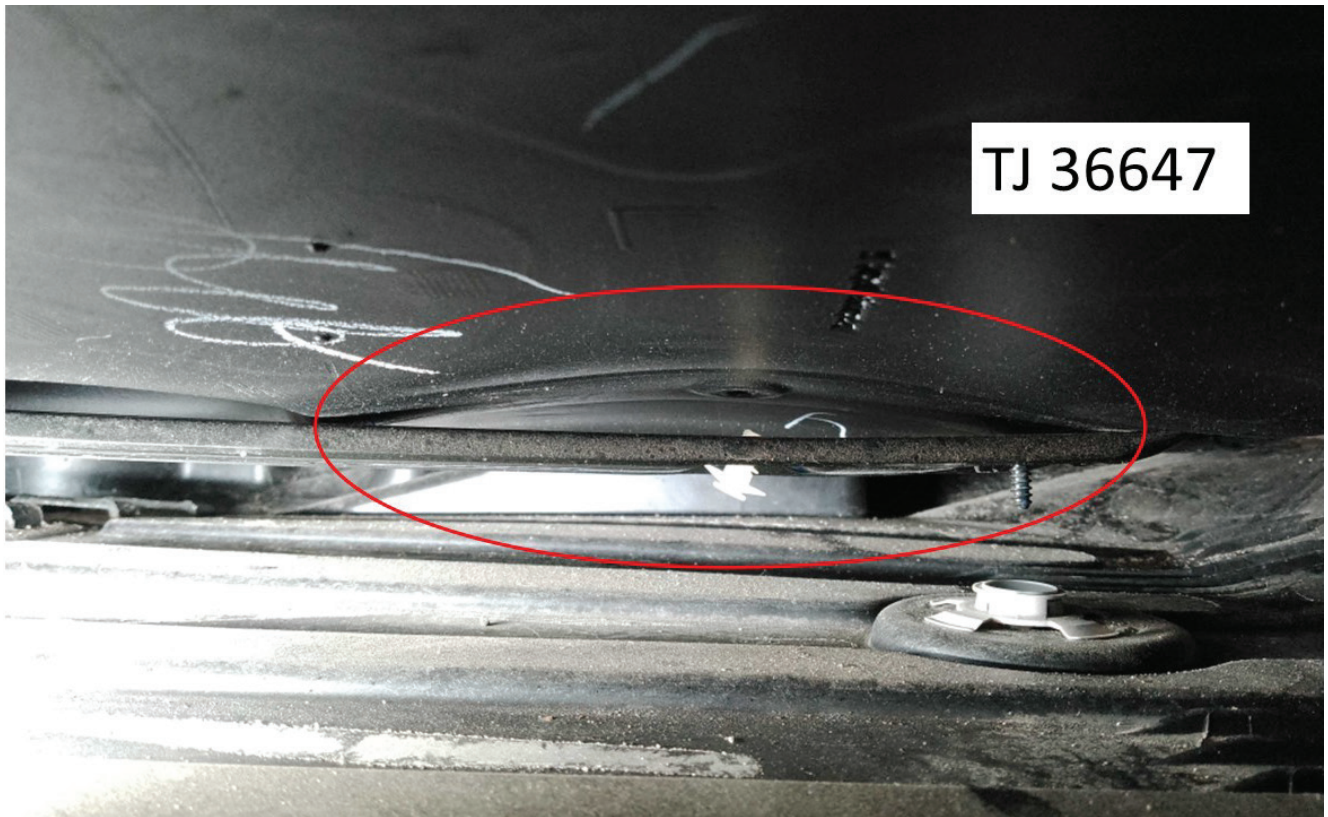
File Name	File Size
TJ 36647.jpg	0.1883 MB

If customer complains that fuel level indicator is showing incorrect values or that it is not possible to fill the correct amount of fuel, please follow advice under "Service".

See attached photo TJ 36647.jpg to confirm if the tank has been deformed. If deformed as shown, replace fuel tank according to VIDA.

VST Operation Number	Description
23428-2	Fuel Tank Install - Remove/Replace
