volvo Car USA LLC	lechnicai Journai		
Technical Journal Title	Ref. No.		
Front door decor panel, noi	TJ 32037.4.0		
Issuer (Dept.)		Issue Date	Status Date
Technical Service	6/19/23	6/30/23	
Car Market	Partner	Function Group	
United States and Canada	3 US 7510 Volvo Car USA	8316	
Function Description		Page	_
COMP INNER DOOR	Page 1 of 3

TJ32037

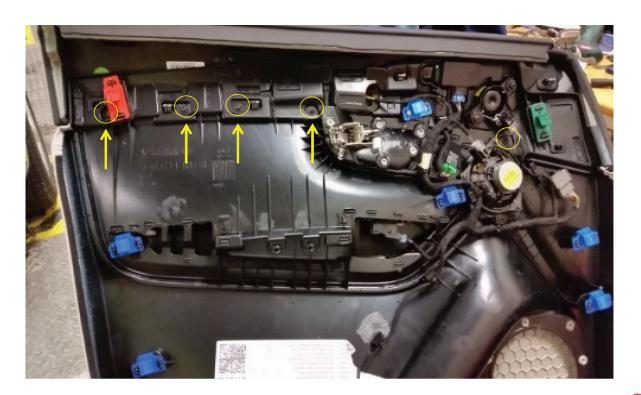
Noise from front door Decor panel when playing music or closing door. The noise may be coming from loose washers on the screws, see attachment.

Tap on the panel and listen for a rattling noise, if a noise is heard, tighten the screw slow and gently.
