# Technical Service Bulletin

## 68 Noises from the front center console

69 23 93 2063737/3 June 30, 2023. Supersedes Technical Service Bulletin Group 68 number 22-35 dated April 16, 2022, for reasons listed below.

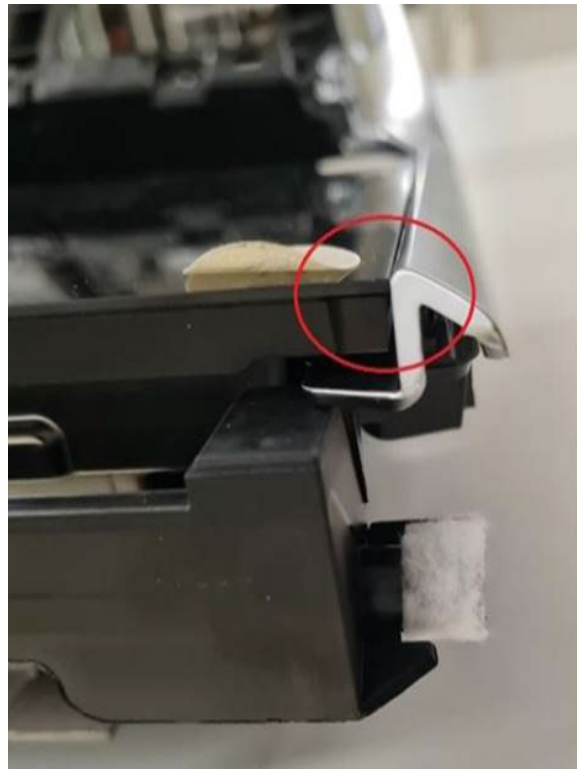
- There is hard contact between the lower MMI display and the front center console insert/trim.

Due to the tight assembly tolerances, the lower MMI display may make contact with the center console insert/trim (Figure 1).

**Figure 1.** Hard contact between lower MMI display and center console insert/trim.

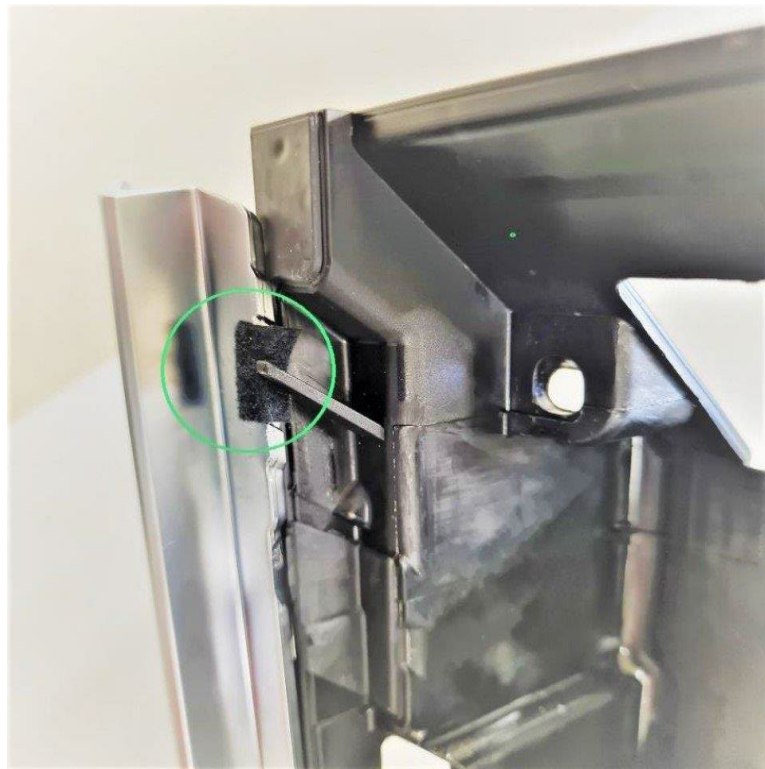
**Figure 2.** Felt tape applied between the rib of the display mount and the trim frame.

4. Only on the side of the contact, apply a strip of felt tape (approx. 3/4 x 3/8 inch) between the rib of the display mount and the trim frame to increase the gap to the display on that side only (Figure 2).
