SERVICE INFORMATION BULLETIN

NUMBER: 16-132-20R

SUBJECT: Diagnostic Information for Alleged Chain Slip Condition on TR580 / TR690 Transmissions

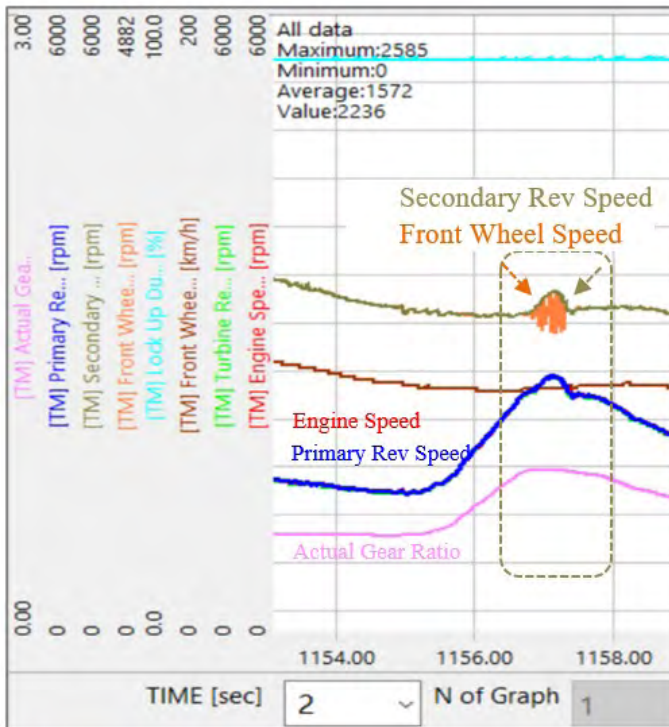
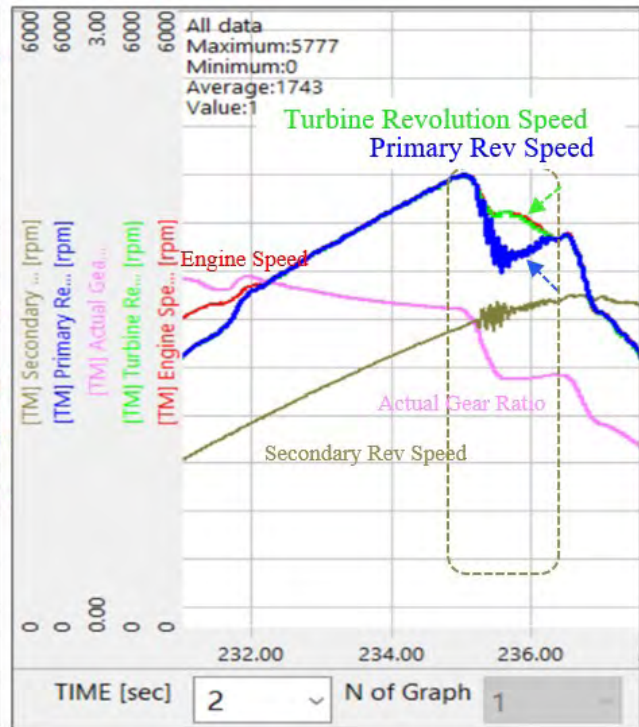
1. Forward Clutch Slip Shock:

The rotation speeds for the upstream and downstream sides of the forward clutch do not synchronize when driving.

This shock can occur when the forward clutch slips. If this situation is reported, reprogram the TCM with new software if it is available.
