SERVICE BULLETIN

APPLICABILITY: 2023MY Outback & Legacy
2023MY Ascent

NUMBER: 15-311-23

SUBJECT: FOTA (Firmware Over-The-Air) Reprogramming for DENSO Gen 4.5 Audio Navigation Infotainment Systems via DCM

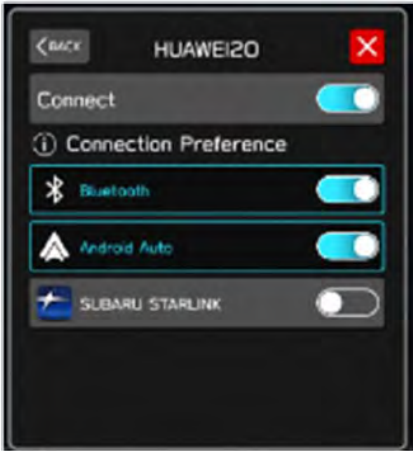
20	<p>On the “Manage Devices” screen Bluetooth cannot be selected as connection preference.</p>

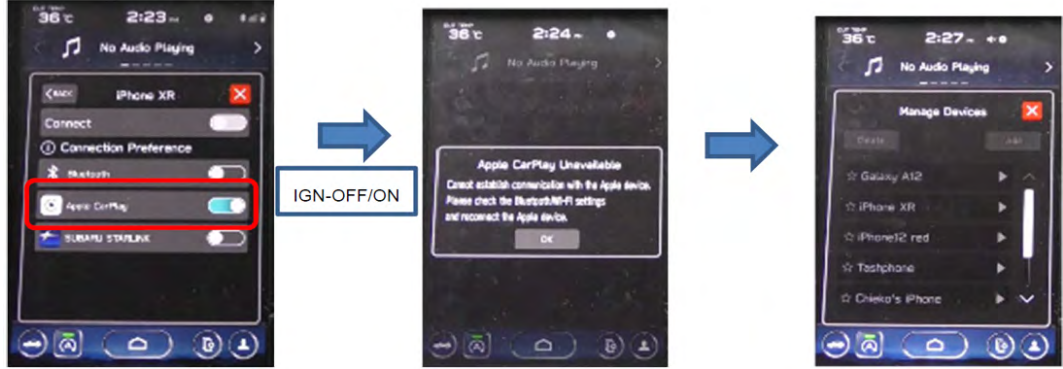
No	Conditions/Symptoms to be improved
25	<p>Manage Device Screen becomes dark and inoperative when Ignition Switch is turned Off and On while starting CarPlay by CID operation.</p>

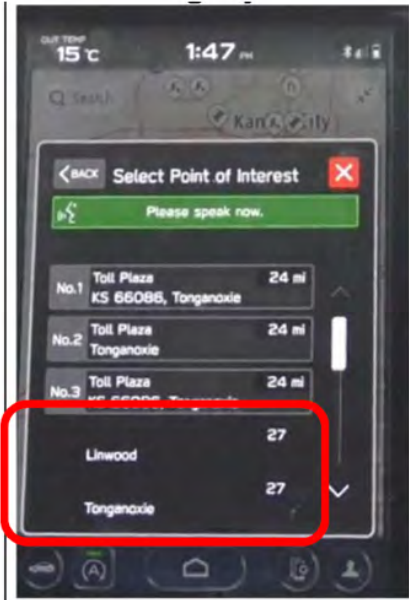
26	<p>Cannot connect to CarPlay via wireless connection. This symptom possibly occurs after the Ignition Switch was turned Off and On abruptly.</p>
27	<p>POI Search Result shows only city names and distances (without unit) when voice recognition POI search with Category name like "Find toll gate" is used.</p>
