SERVICE BULLETIN

APPLICABILITY: 2016-18MY Crosstrek
 2016-18MY Forester
 2016-18MY Impreza
 2016-18MY Legacy & Outback
 2017-18MY WRX

NUMBER: 15-312-23R

SUBJECT: Data Control Module (DCM)
 Dark Current Diagnosis

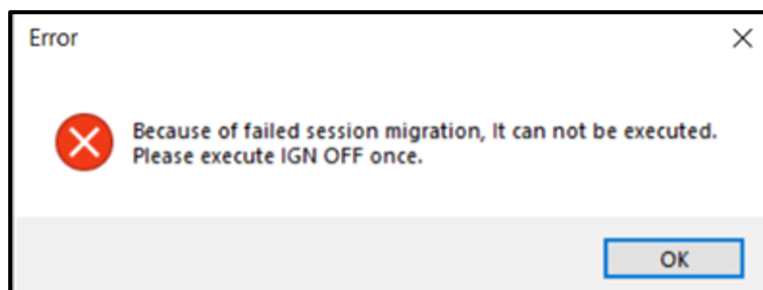
4. Click the Mode Check button to ensure the Current Mode is Factory Mode.
 - A. If any mode is displayed other than Factory, attempt the Mode Setting again to see if it is successful on a second attempt.
 - B. If, after multiple Mode Setting attempts, the Current Mode is not Factory Mode or the error message below is displayed, then the DCM must be replaced to correct the excessive parasitic draw.

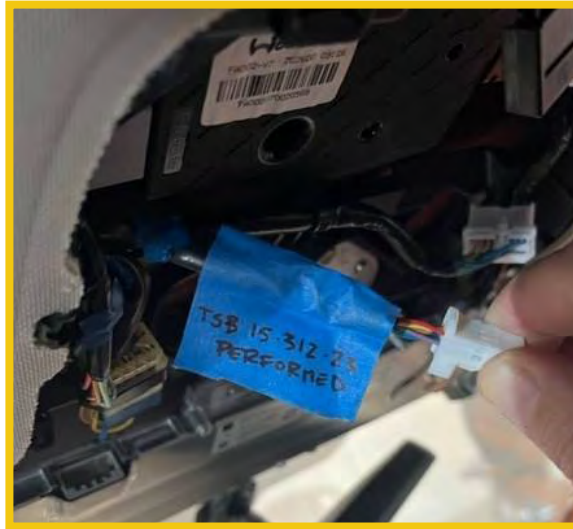
- C. A DCM successfully moved to Factory Mode will have the Green Telematics LED illuminated whenever the key is on. This Green indicator LED does not indicate a valid subscription, it indicates a non-comm checked DCM in Factory Mode. **DO NOT** perform a comm check to a DCM in Factory Mode.
5. Once the Current Mode is confirmed as Factory Mode, remove the overhead trim panel and disconnect the SOS / i-Button switch so it is not accidentally depressed.
 6. Wrap the switch assembly connector using a tape that can be written on, leaving a pigtail piece accessible to write the TSB number on. Use a permanent marker like a “Sharpie” to indicate this TSB number for future reference. This tape will prevent any unwanted electrical connections and identify the TSB that indicates why it should remain disconnected. **See the example image below.**
