APA4 - Check Connection Points on the Body and Rework if Necessary (Recall Campaign)

Vehicle Type: **911 Carrera (992) / 911 Carrera S (992)
911 Carrera 4 (992) / 911 Carrera 4S (992)
911 GT3 (992)**

Model Year: **As of 2020 up to 2023**

Concerns: **Connecting points on the body**

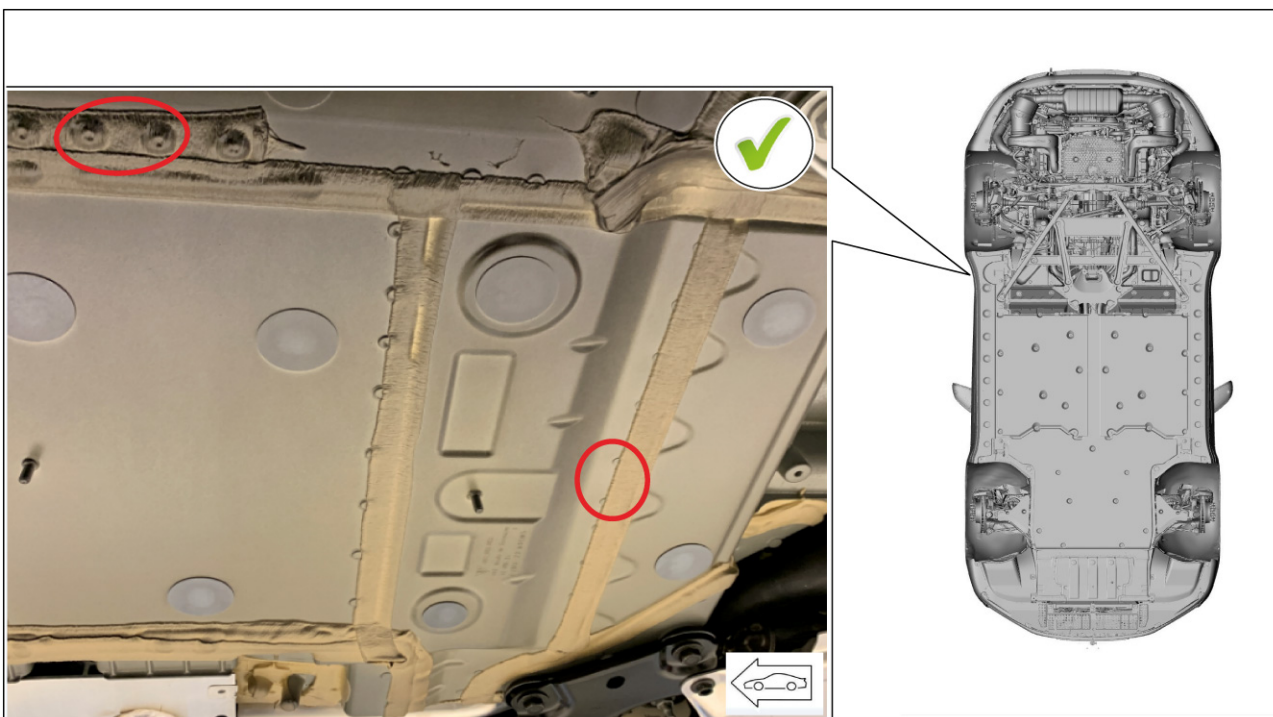
Visual inspection of punch rivets/screws on underbody

Assessment	Action
There are tapping screws and punch rivets on the underbody.	All connection points are set according to specifications and do not have to be reworked. End of remedial action. ⇒ Continue with Step 3 [Scope 3]
No connection points present on the underbody on the left.	Connecting points are not set according to specifications. Parts of the underbody must be reworked . ¹ ⇒ Continue with repair instructions from APA4 PPN document [Scope 4]

¹ Perform photo documentation and upload the clearly identifiable pictures to the PCCS quality line with the relevant **description** of the affected side, e.g. **underbody left_VIN_Figure 1**

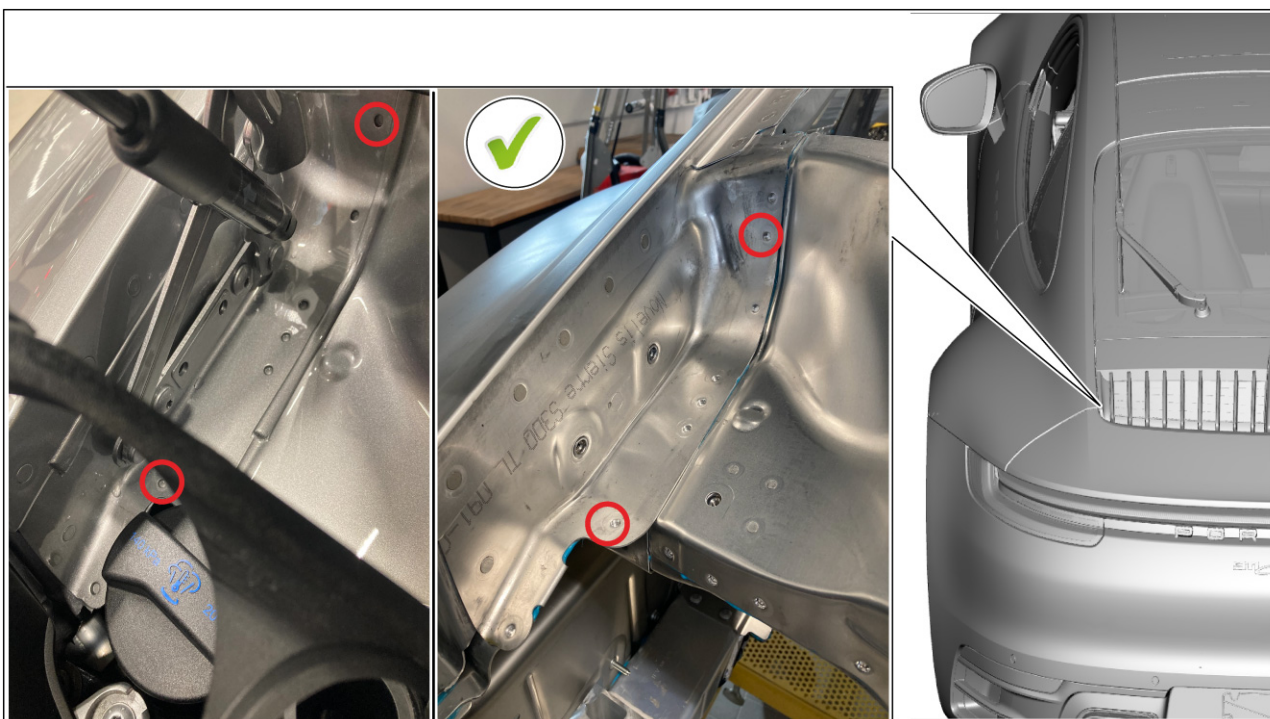
Visual inspection of rear side section clinch points

Assessment	Action
<p>There are clinch points on the side section.</p>	<p>All clinch points are set according to specifications and do not have to be reworked.</p> <p>End of remedial action. ⇒ Continue with Step 4</p> <p>[Scope 5]</p>
<p>No connection points present on the side section.</p>	<p>Connecting points are not set according to specifications. Parts of the body must be reworked.² ⇒ Continue with repair instructions from APA4 PPN document</p> <p>[Scope 6]</p>

² Perform photo documentation and upload the clearly identifiable pictures to the PCCS quality line with the relevant **description** of the affected side, e.g. **side panel left_VIN_Figure 1**
