iLok Fastener Torque

PIL-149037

PC28, PC04, Introduced 23w05. All models.

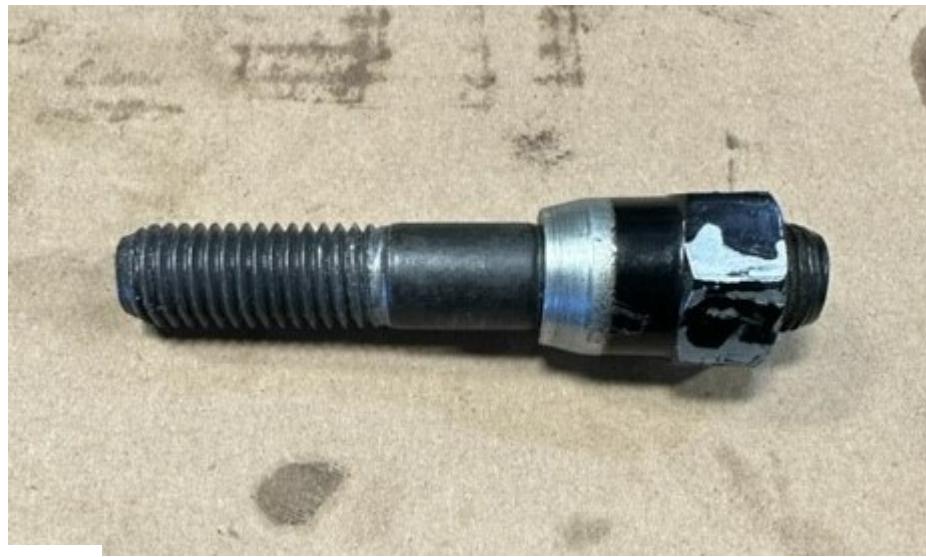
The iLok fastener installation torque may cause the iLok fastener to deform to the stud. Breakaway torque is higher than stud installation torque.

If the stud screws out when removing the iLok cone fitting carefully hold the stud by the center shank and remove the iLok fastener. Reinstall undamaged studs in hub, torque to 65 lb-ft.

The iLok installation torque has been reduced from **180 lb-ft** to **168 ft-lb ± 6 lb-ft**.

If damage to the iLok fastener or the stud occurs replacement will be necessary. See parts list below.
