Vehicles With Back-Of-Cab SCR - Exhaust Stack Replacement Information, PM Sensor Failure Repair Information

There has been a change in the design of the vertical exhaust stack for vehicles built prior to mid-March (Week 11) 2018 with a back-of-cab SCR. This change addresses PM Sensor failures caused by water contamination.

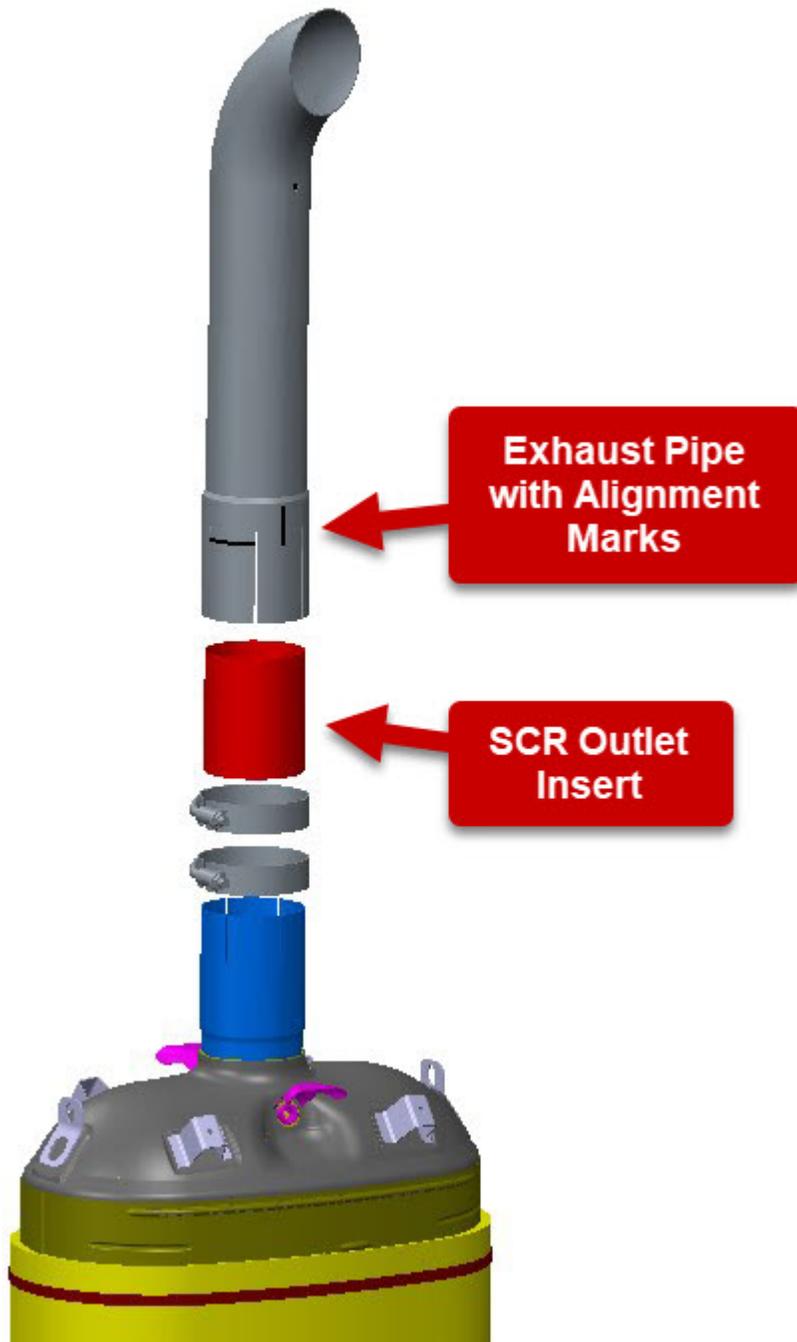
The solution introduces a two part configuration: a new exhaust pipe with alignment marks and an insert for the outlet of the SCR, shown in the diagram below.

Note that the old pipe is not compatible with this new configuration.
