Water Ingress in Interior: Check Seam Seal on Front Wall at Front Left and Rework if Necessary (53/23)

Model Line: **911 (992)**

Model Year: **As of 2021 up to 2023**

Concerns: **Front panel seam sealing on the front left side**

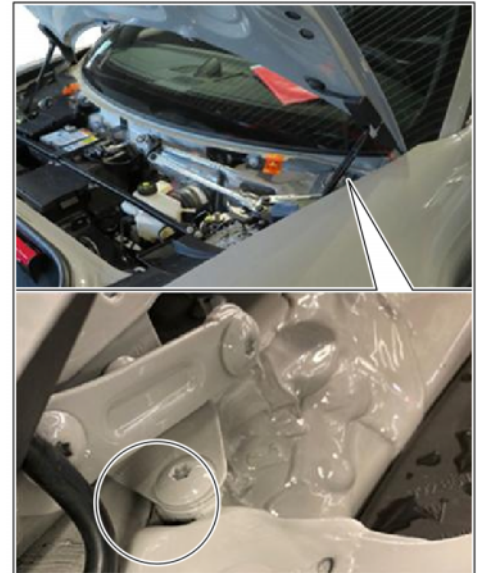
Work Procedure: 1 Visually inspect seam sealing behind the lid hinge on the front panel on the front left side. ⇒ *Seam sealing incomplete*

Seam sealing incomplete

Assessment	Action
The affected area is completely sealed. (area around the connection of the screw point is completely filled with sealing compound)	Check whether water can leak in at another location.
Affected area is not completely sealed. (area around the connection of the screw point is not completely filled with sealing compound) ⇒ <i>Seam sealing incomplete</i>	Continue with ⇒ <i>Technical Information '508719 reworking seam sealing'</i> .
