Lightweight Glass Panes Cracked – Identification and Possible Causes

Vehicles Affected

Condition

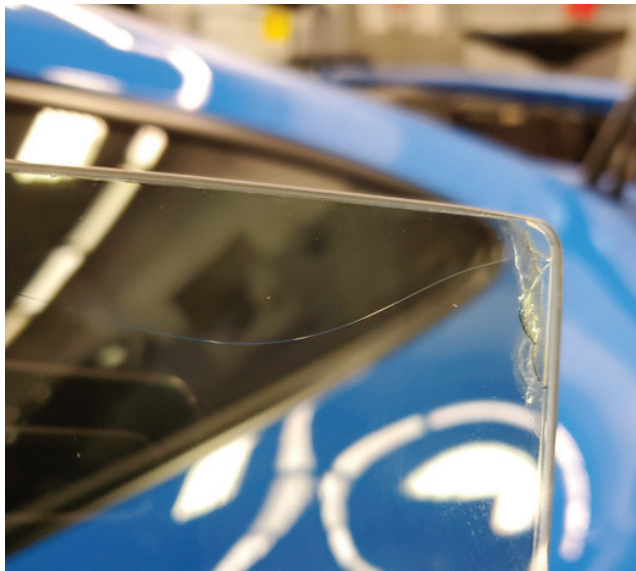
Figure 1 - Door glass: cracks in the top corner

There are two main causes for this condition:

- > The door glass is misaligned, which can cause contact between the door glass and the rear quarter glass, or
- > Force applied to the glass (i.e., instead of the door sill) throughout the door closing process can bend the glass enough to cause contact with the rear quarter glass, despite a proper window alignment with no force applied.

Updated lightweight door glass parts have been developed to address this complaint. Please see the *Door glass: cracks in the top corner* section of the Service Information for repair instructions.

Please replace the affected glass pane(s) with the updated parts (index "H"), as instructed in *WM 644019 – Removing and installing door window glass*.

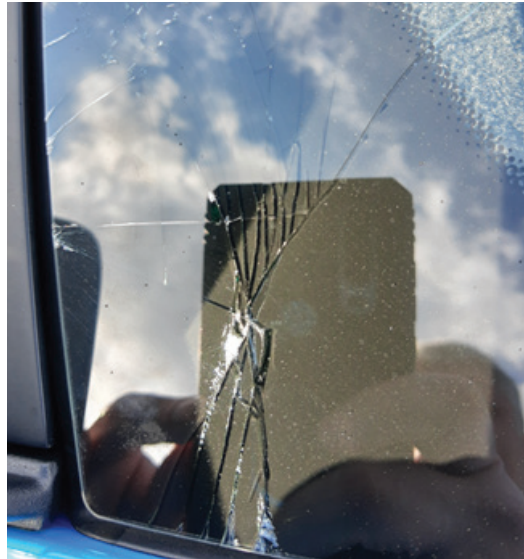
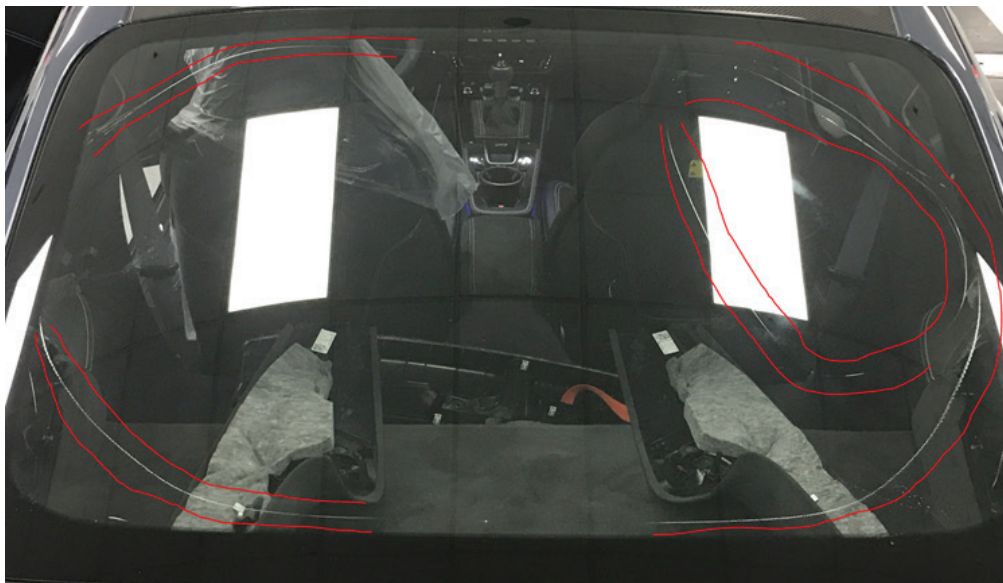
Figure 3 - Rear window glass: various cracks

Stress cracks in the rear window glass are currently being analyzed by Porsche. The root causes for the different kinds of stress cracks are unknown at the time of publication of this document.

Please replace the rear window glass as instructed in *WM 648619 – Removing and installing rear window*.

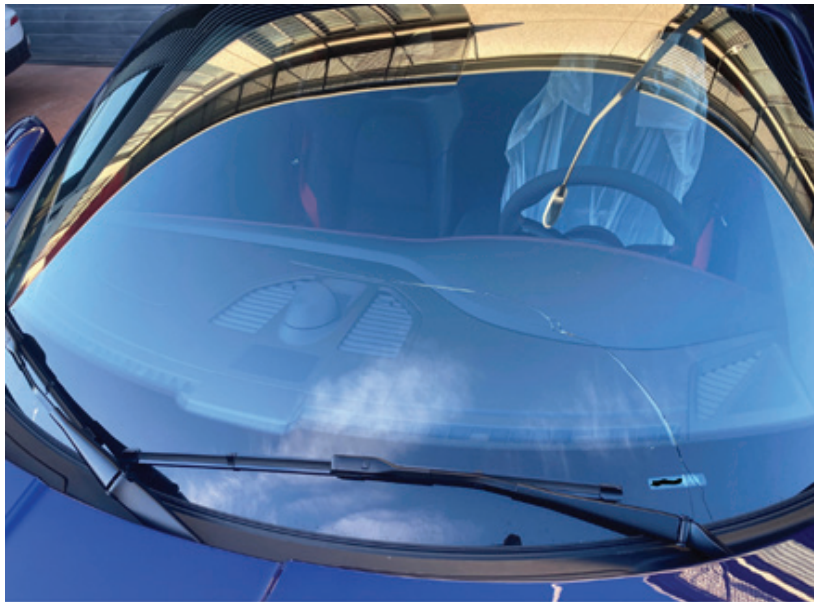
Figure 4 - Front windshield: various cracks

Stress cracks in the front windshield are currently being analyzed by Porsche. The root causes for the different kinds of stress cracks are unknown at the time of publication of this document.

Please replace the front windshield as instructed in *WM 641219 – Removing and installing rear windscreen*.
